HAZARDOUS MATERIALS ASSESSMENT REPORT

Client: Cape Cod Australia Pty. Limited

Location: 73 Jennings Street, Matraville NSW

Date of assessment: 9th June 2015

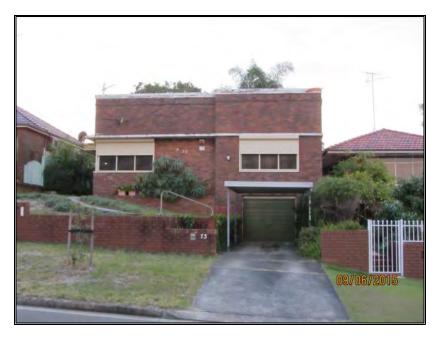
Front western elevation of the residence
