HAZARDOUS MATERIALS ASSESSMENT REPORT

Client: Cape Cod Australia Pty. Limited

Location: 14d Dudley Street, Randwick NSW

Our reference: HM04080715

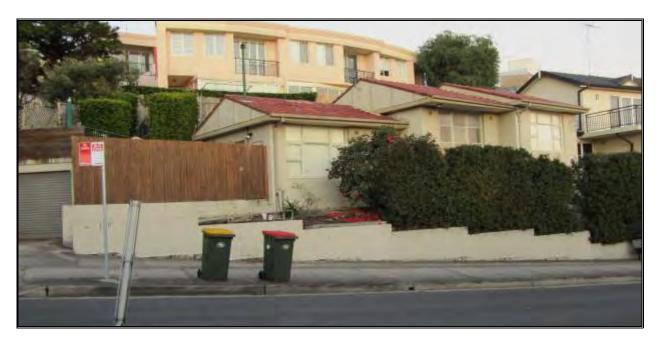
Front north eastern elevation of the residence
