HAZARDOUS MATERIALS ASSESSMENT REPORT

Client: Cape Cod Australia Pty. Limited

Location: 9 Catherine Street, St Ives. NSW.

Date of assessment: 25th October 2016

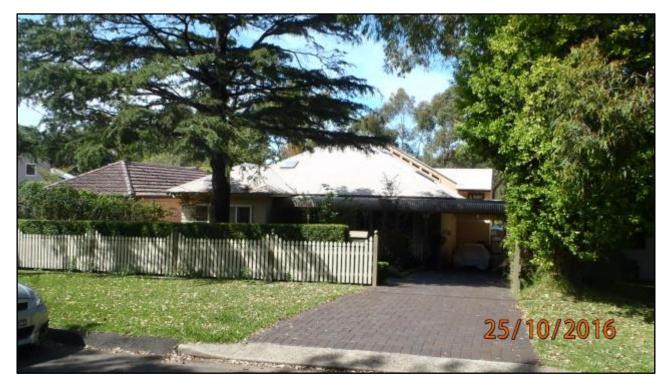
Front northern elevation of the residence
