HAZARDOUS MATERIALS ASSESSMENT REPORT

Client: Cape Cod Australia Pty. Limited

Location: 10 College Street, Gladesville.

Date of assessment: 1st July 2017

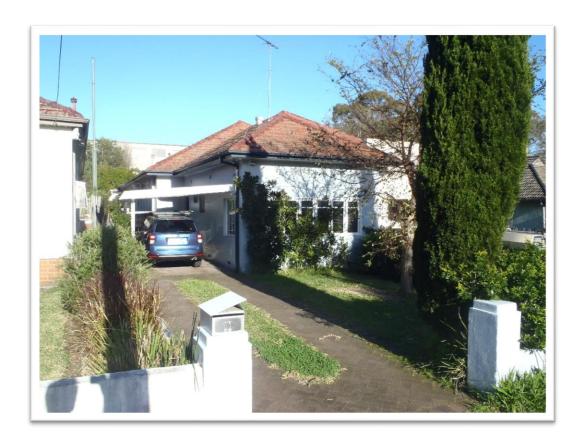
Front north eastern elevation of the residence
