HAZARDOUS MATERIALS ASSESSMENT REPORT

Client: Cape Cod Australia Pty. Limited

Location: 10 Tipper Avenue, BRONTE.

Our reference: HM04990716

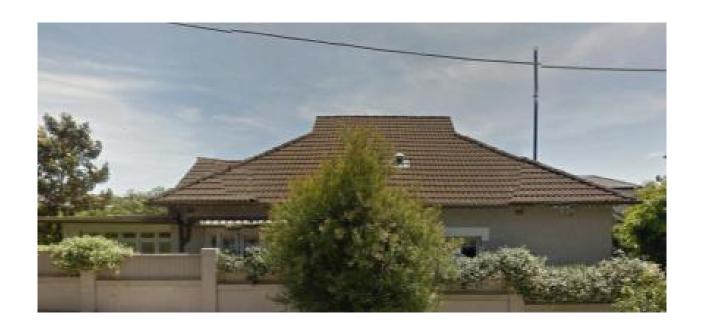
Front southern elevation of the residence
