HAZARDOUS MATERIALS ASSESSMENT REPORT

Client: Cape Cod Australia Pty. Limited

Location: 55 Churchill Drive, Winston Hills.

Date of assessment: 21st March 2017

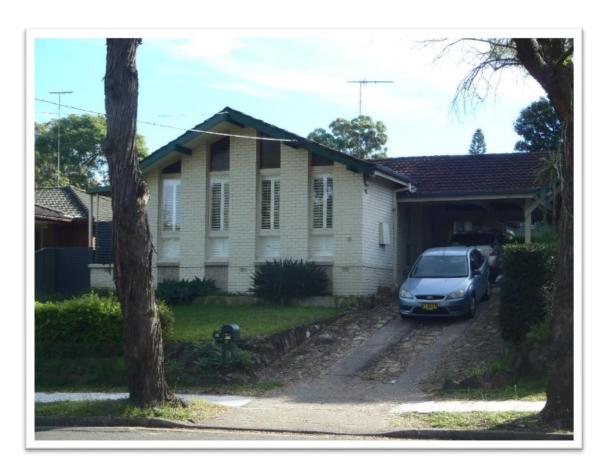
Front southern elevation of the residence
