HAZARDOUS MATERIALS ASSESSMENT REPORT

Client: Cape Cod Australia Pty. Limited

Location: 32 Denver Road, St Clair.

Our reference: HM05850717

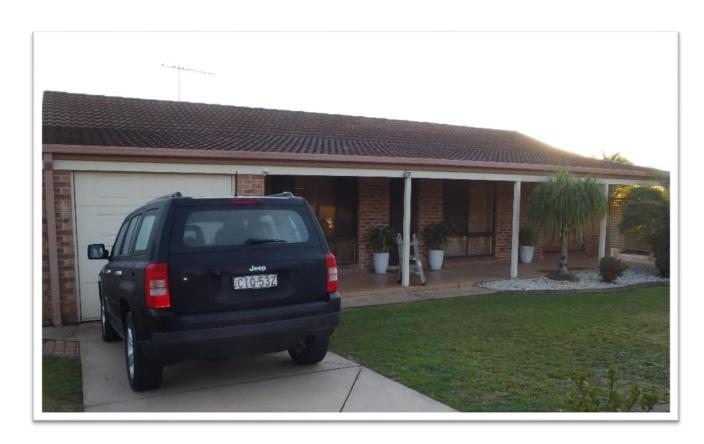
Front southern elevation of the residence
