HAZARDOUS MATERIALS ASSESSMENT REPORT

Client: Cape Cod Australia Pty. Limited

Location: 18 Mary Street, Merrylands 2160

Our reference: HM04331015

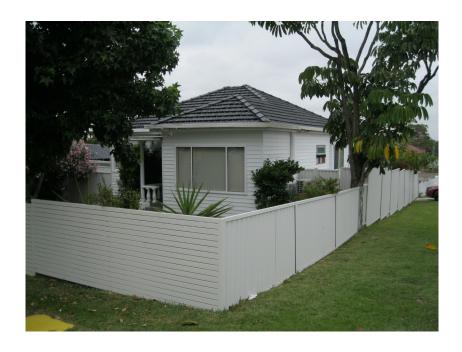
Front elevation of the residence
