# **HAZARDOUS MATERIALS ASSESSMENT REPORT**

Client: Cape Cod Australia Pty. Limited

Location: 269 Botany Street, KINGSFORD.

Our reference: HM04890616

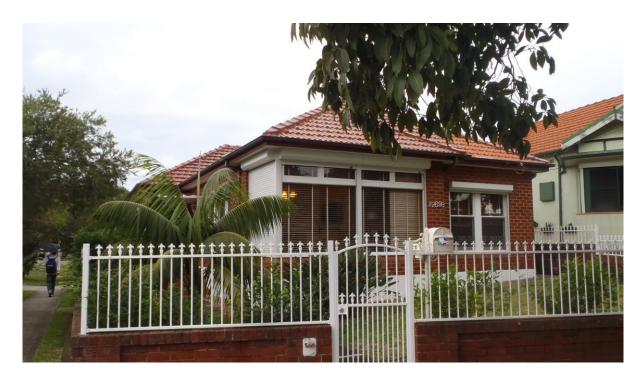
Front western elevation of the residence
