HAZARDOUS MATERIALS ASSESSMENT REPORT

Client: Cape Cod Australia Pty. Limited

Location: 14 Yethonga Avenue, Lane Cove West.

Our reference: HM04980716

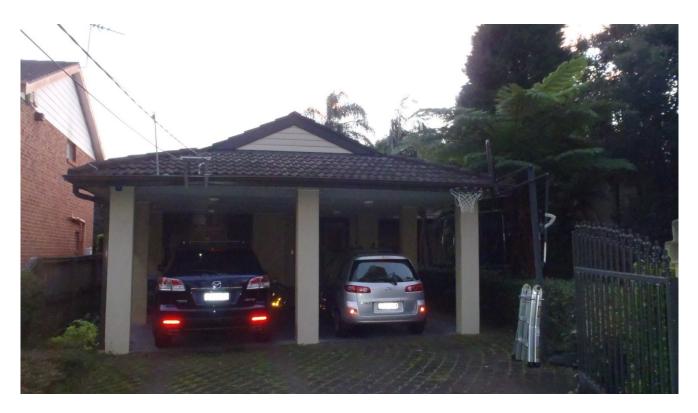
Front southern elevation of the residence
