HAZARDOUS MATERIALS ASSESSMENT REPORT

Client: Cape Cod Australia Pty. Limited

Location: 2 Nanbaree Road, Ryde NSW

Date of assessment: 13th November 2014

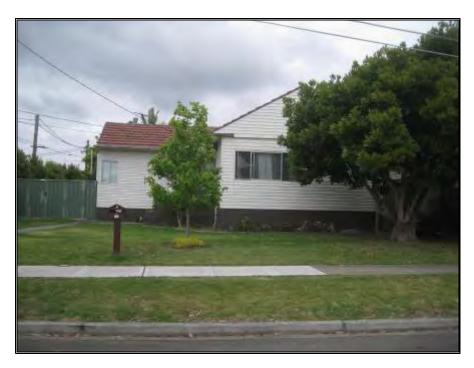
Front north eastern elevation of the residence
