# HAZARDOUS MATERIALS ASSESSMENT REPORT

Client: Cape Cod Australia Pty. Limited

Location: 5 Jacques Street, KINSFORD.

Our reference: HM05080716

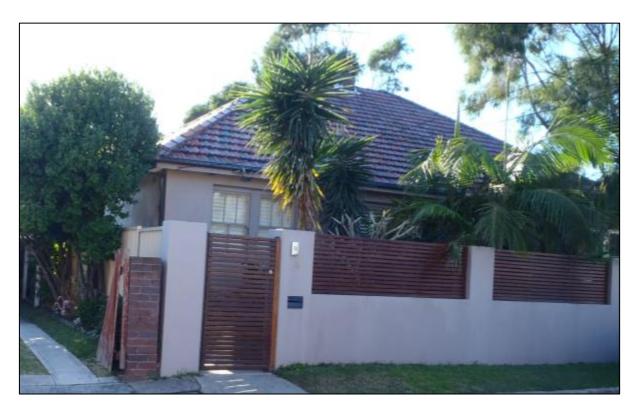
Front south western elevation of the residence
