# **HAZARDOUS MATERIALS ASSESSMENT REPORT**

Client: Cape Cod Australia Pty. Limited

Location: 36 Glasgow Avenue, Bondi Beach

Our reference: HM03910415

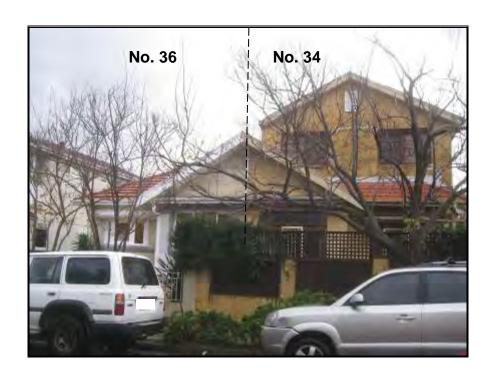
Front south western elevation of the adjoining properties: No. 34 and No. 36 Glasgow Avenue, Bondi Beach
