HAZARDOUS MATERIALS ASSESSMENT REPORT

Location: 1 Chircan Street, Old Toongabbie.

Date of assessment: 8th November 2016

Our reference: HM05311116

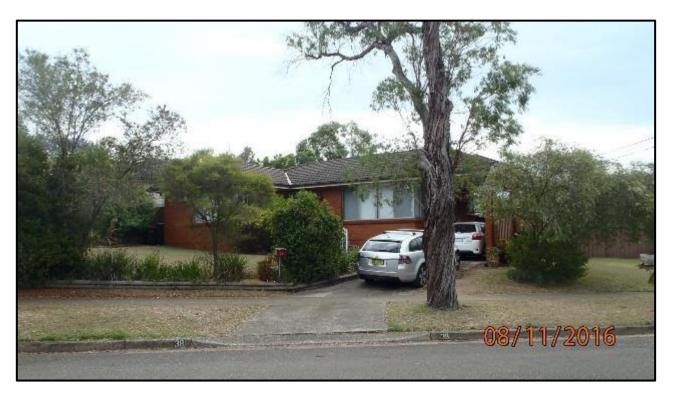
Front eastern elevation of the residence
