HAZARDOUS MATERIALS ASSESSMENT REPORT

Location: Unit 2/3 Streatfield Road, Bellevue Hill

Our reference: HM04511215

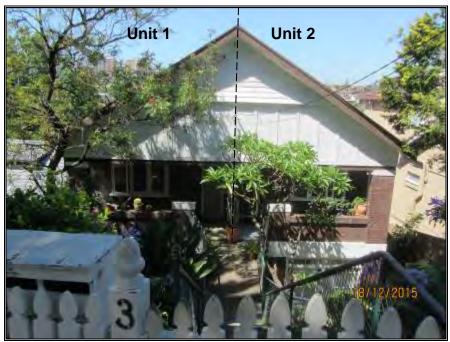
Front north east elevation of the adjoining properties: Unit 1 & Unit 2 / 3 Streatfield Road, Bellevue Hill
