HAZARDOUS MATERIALS ASSESSMENT REPORT

Client: Cape Cod Australia Pty. Limited

Location: 19 Morrice Street, Lane Cove.

Our reference: HM05461216

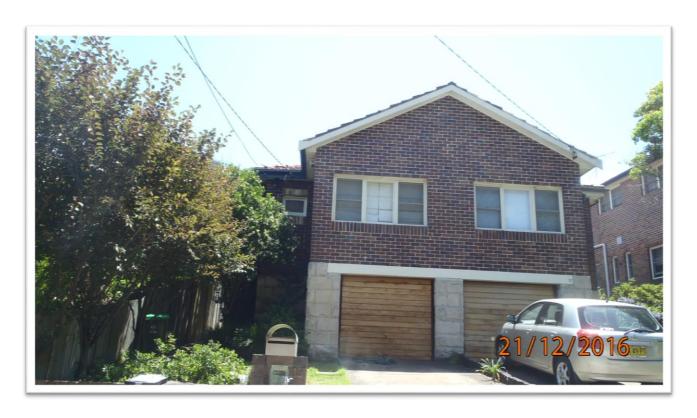
Front eastern elevation of the residence
