HAZARDOUS MATERIALS ASSESSMENT REPORT

Client: Cape Cod Australia Pty. Limited

Job details: Owner: Mr. F. & Mrs. M. Passicot.

Location: 73 Clovelly Road, Randwick.

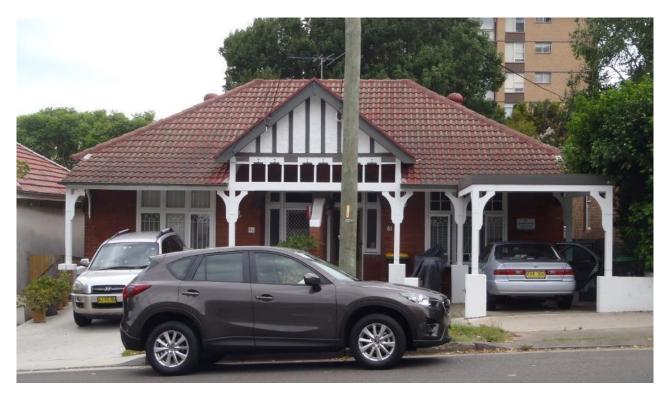
Front western elevation of the adjoining properties No. 79 and No. 81 Clovelly Road, Randwick.
