HAZARDOUS MATERIALS ASSESSMENT REPORT

Client: Cape Cod Australia Pty. Limited

Location: 12 The Chase Road, Turramurra.

Date of assessment: 19th October 2016

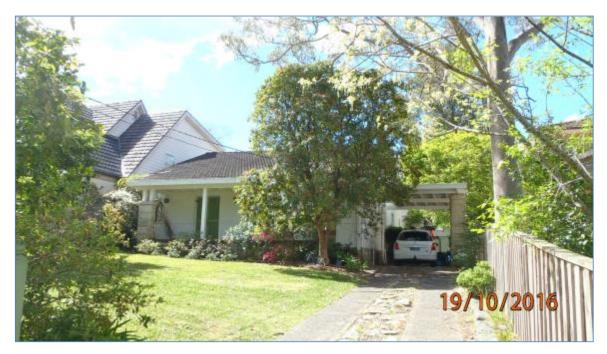
Front southern elevation of the residence
