## **HAZARDOUS MATERIALS ASSESSMENT REPORT**

Client: Cape Cod Australia Pty. Limited

Location: 260 Willoughby Road, Naremburn.

Our reference: HM05580217

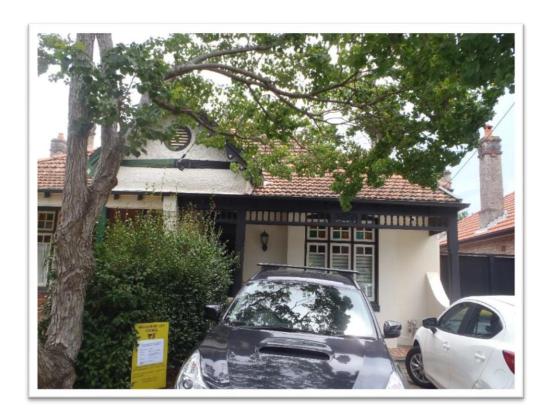
Front eastern elevation of the residence
