HAZARDOUS MATERIALS ASSESSMENT REPORT

Client: Cape Cod Australia Pty. Limited

Location: 5A Darling Street, Bronte.

Our reference: HM05590317

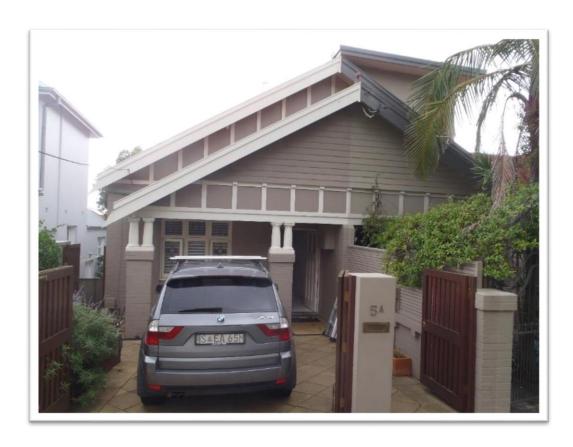
Front northern elevation of the residence
