HAZARDOUS MATERIALS ASSESSMENT REPORT

Client: Cape Cod Australia Pty. Limited

Location: 7 Wewak Place, Bossley Park NSW

Our reference: HM04540116

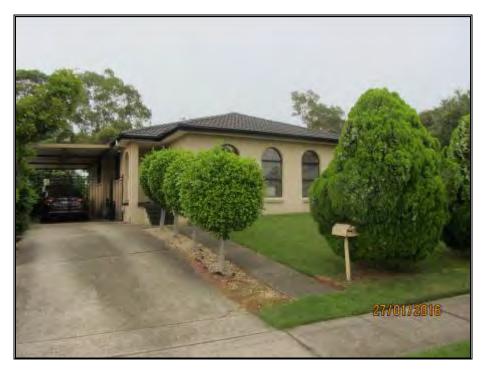
Front north eastern elevation of the residence
