HAZARDOUS MATERIALS ASSESSMENT REPORT

Client: Cape Cod Australia Pty. Limited

Location: 21 Merric Court, Oakhurst.

Our reference: HM05760617

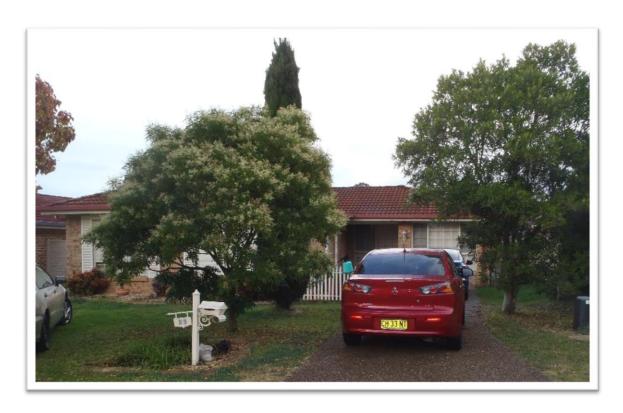
Front north elevation of the residence
