Asbestos Inspection and Condition Report (Sampling)

Inspection Date: Mon., 06 Mar. 2017

Property Address: 1 Mocatta Ave, Pymble NSW 2073, Australia

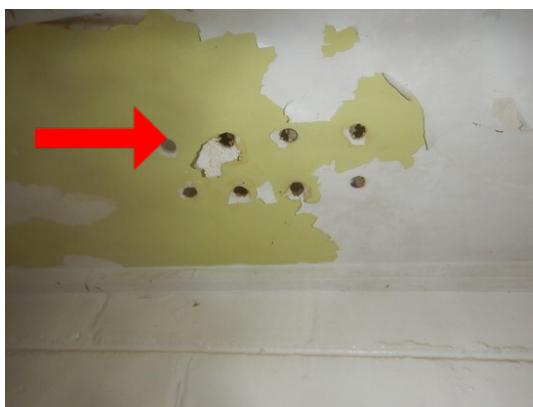
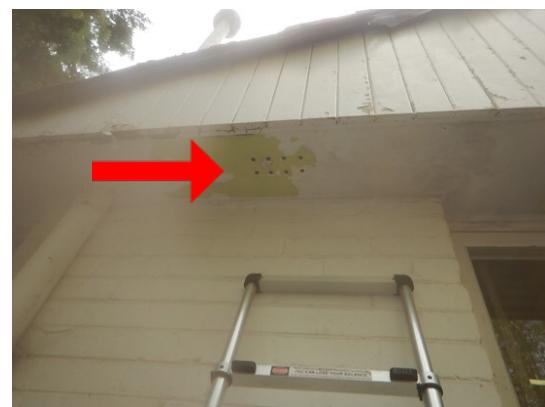
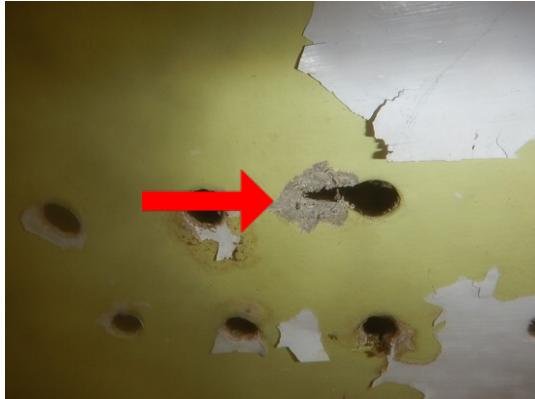
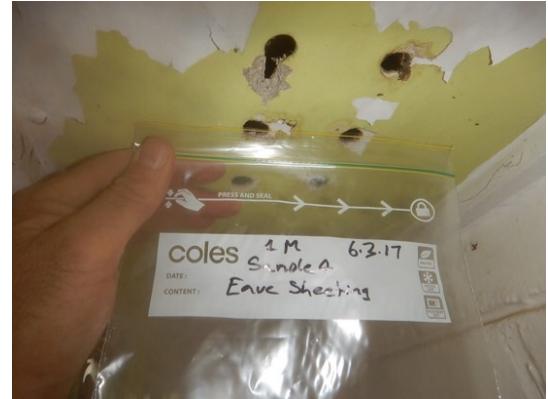
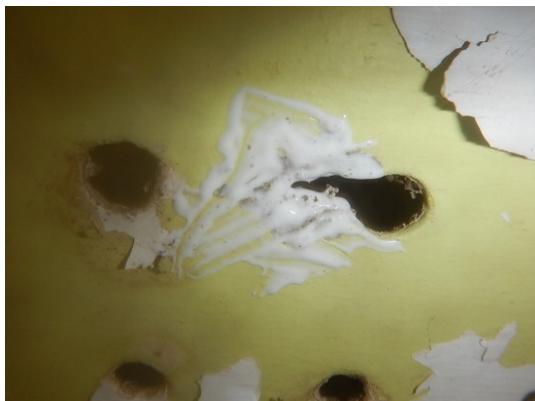
Location: Eaves

Finding: ACM Suspected Eave Sheets - Poor Condition

Information: The eaves sheeting in place appear to be an asbestos containing material (ACM) and are hence considered a health hazard. Some sections of the eave sheeting appear to have become damaged and deteriorated. Damaged and deteriorated ACMs have a higher probability of releasing airborne asbestos fibres creating a significant health safety risk.

A sample for lab analysis to confirm the presence of asbestos was taken from this location. The client is advised to assume that the affected area and construction material contains Asbestos until the lab analysis results are available. The area should be isolated and no works should be undertaken on the area until lab analysis results are available. Removal by a Licensed Asbestos Removal firm would be the only option advised.

No works should be carried out to the ACM or associated building elements without further specialist advice.

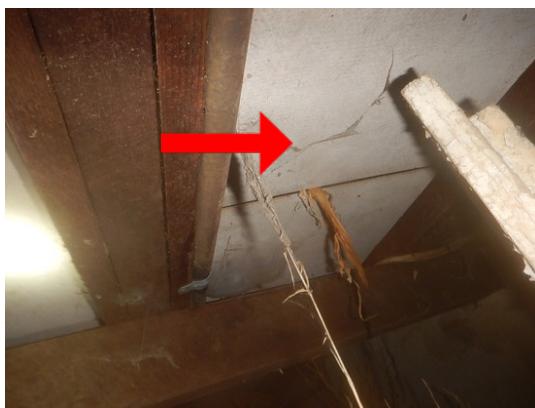
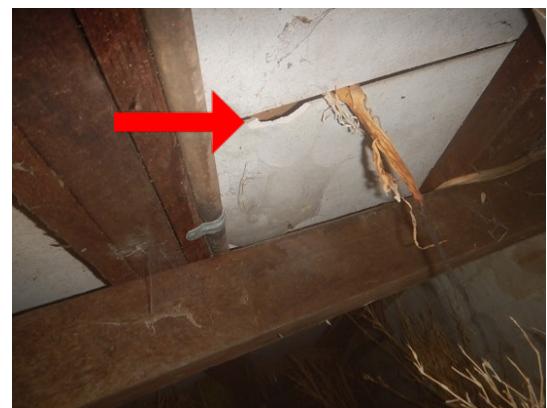
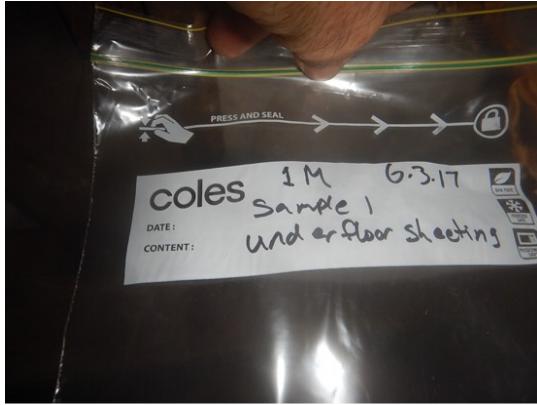
Location: Subfloor

Finding: ACM Suspected subfloor Fibre Cement Cladding

Information: At the time of the inspection, it was observed that a section of the subfloor framing was clad with suspected asbestos-containing fibre cement sheet style materials. The observable areas of the sheeting appears to have no obvious signs of damage or deterioration, indicating that the asbestos is currently encapsulated and contained. Damaged and deteriorated ACMs have a higher probability of releasing airborne asbestos fibres, creating a significant health safety risk.

A sample for lab analysis to confirm the presence of asbestos was taken from this location. The client is advised to assume that the affected area and construction material contains Asbestos until the lab analysis results are available. The area should be avoided and no works should be undertaken on the area until lab analysis results are available. Removal by a Licensed Asbestos Removal firm would be advised.

Where the client elects to retain the ACM, the client should regularly monitor the condition of the materials to identify any further damage or deterioration. Such monitoring should occur at least annually, but more frequently should damage or evidence of deterioration occur. Additional remedial work is a potential short- to medium-term solution to reduce the risk presented by the ACM.

No works should be carried out to the ACM or associated building elements without further specialist advice.

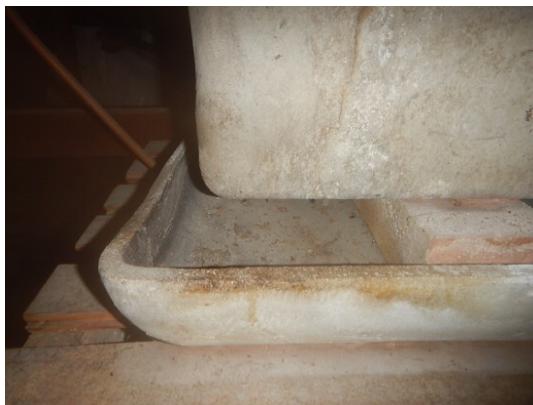
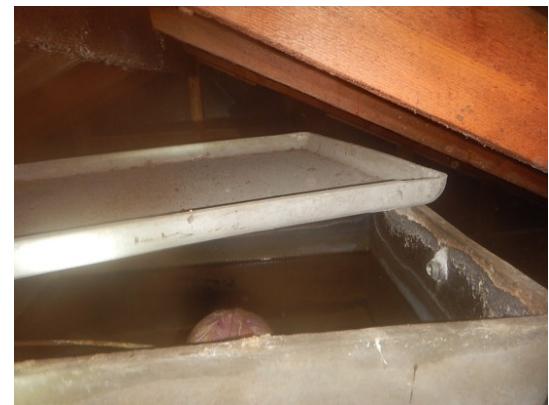
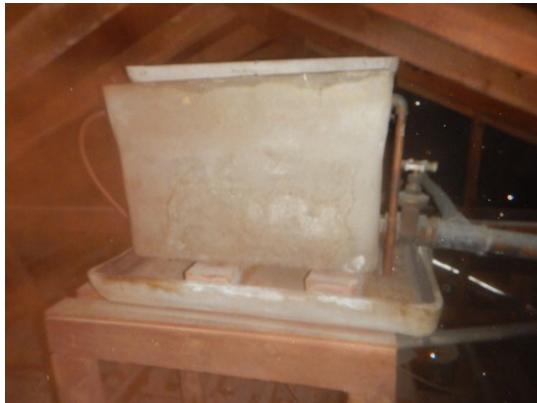
Building: Main Building
Location: Roof Void
Finding: ACM Suspected HWS Tank
Information: During the inspection it was observed that an old hot water service tank was present in the roof space. This is suspected of being made up from asbestos containing material.

The observable areas of the tank were found to be free of damage or deterioration at the time of inspection. Damaged and deteriorated ACMs have a higher probability of releasing airborne asbestos fibres creating a significant health safety risk.

Where the client elects to retain the ACM, the client should regularly monitor the condition of the pipework. Such monitoring should be conducted at least annually, but more frequently should damage or evidence of deterioration occur.

No works should be carried out to the ACM or associated building elements without further specialist advice.

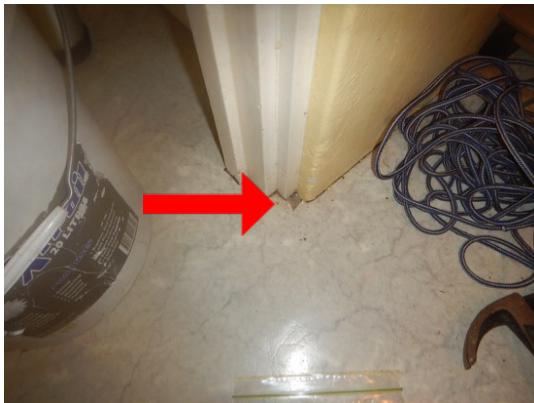
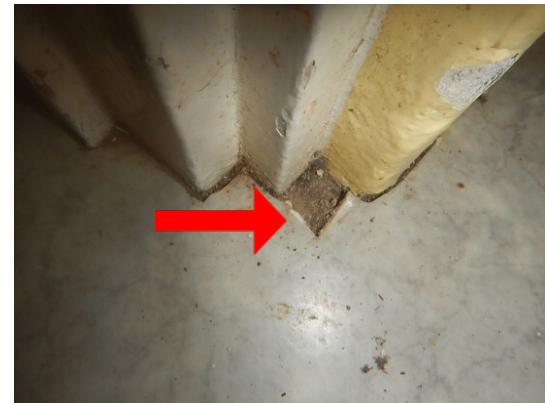
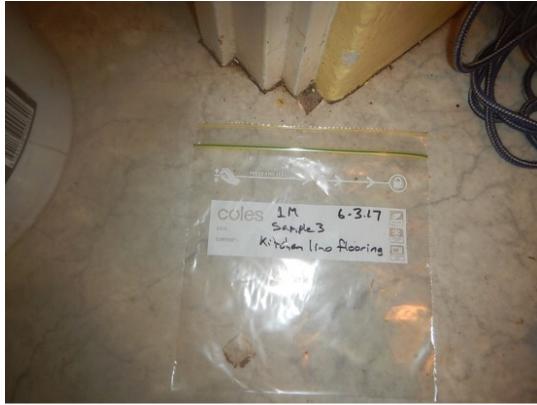
Building: Main Building
Location: Kitchen/Laundry
Finding: ACM Suspected Vinyl Floor Covering
Information: Vinyl floor covering may have several asbestos containing materials (ACM), including within the vinyl body of the tiles/sheeting, as a fibrous backing to the tiles, or as an asbestos-based adhesive used to fix the tiles to the adjoining floor. At the time of the inspection, the observable areas of vinyl flooring appear to be free of damage or deterioration. Damaged and deteriorated ACMs have a higher probability of releasing airborne asbestos fibres, creating a significant health safety risk.

Where the client elects to retain the ACM, the client should regularly monitor the condition of the vinyl flooring to identify any further damage or deterioration. Such monitoring should be conducted at least annually, but more frequently should damage or evidence of deterioration occur. This is particularly important where the vinyl flooring is present in high traffic areas.

No works should be carried out to the ACM or associated building elements without further specialist advice.

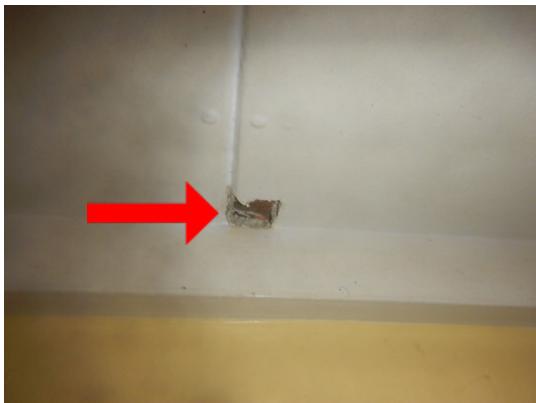
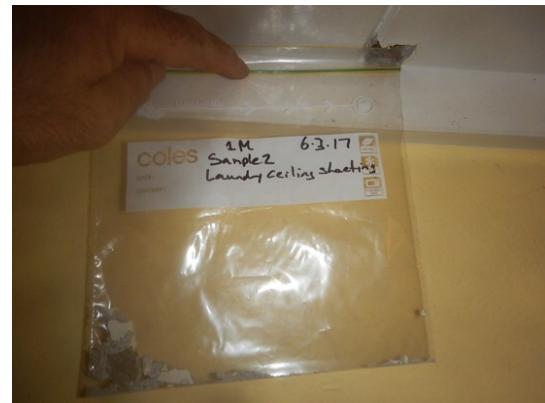
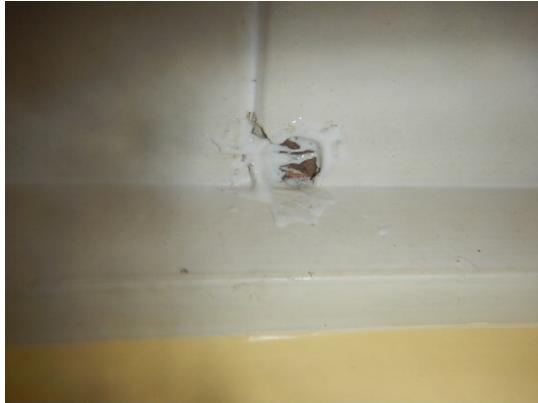
Building: Main Building
 Location: Laundry
 Finding: ACM Suspected Ceiling Sheets
 Information:

The ceiling lining throughout the laundry of the property appears to have been constructed with the use of asbestos-containing materials (ACM). At the time of inspection, the observable areas of the ceiling sheets were free of damage and deterioration, representing a lesser health and safety risk than if they were in a poor, damaged or deteriorating condition.

Removal by a Licensed Asbestos Removal firm would be strongly advised. Where the client elects to retain the ACM, the client should regularly monitor the condition of the ceiling sheets to identify any further damage or deterioration. Such monitoring should be conducted at least annually, but more frequently should damage or evidence of deterioration occur.

Inspection should also cover factors that may lead to the deterioration of the ceilings, such as minor roof leaks or structural movement. Additional remedial work is a potential short- to medium-term solution to reduce the risk presented by the ACM. Where possible, the encapsulation of the asbestos materials using an appropriate sealant, again by a specialist contractor, can be considered.

No works should be carried out to the ACM or associated building elements without further specialist advice.

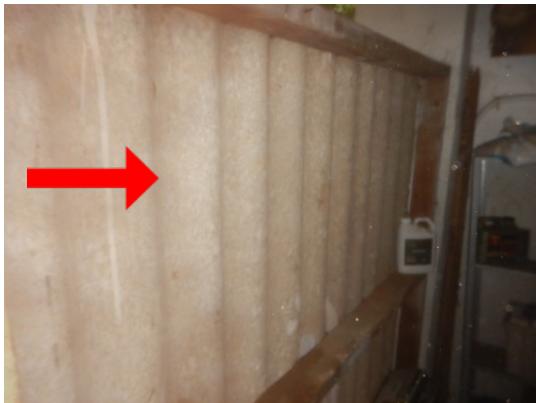
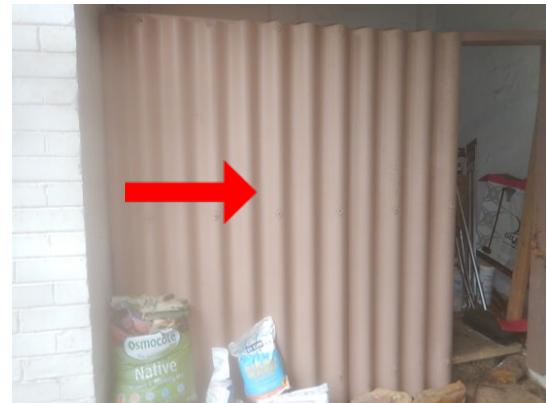
Finding: ACM Suspected Partition Sheeting

Information: The partition sheeting, in the subfloor of the garage, is suspected to be an asbestos-contain material (ACM). The observable areas of sheeting appear to be free of damage and deterioration, which represents a lesser health and safety risk than if they were in a poor or deteriorating condition. A sample for lab analysis to confirm the presence of asbestos was not taken from this location. The client is advised to assume that the affected area and construction material contains Asbestos until the lab analysis results are available. The area should be avoided and no works should be undertaken on the area until lab analysis results are available. Removal by a Licensed Asbestos Removal firm would be advised.

Where the client elects to retain the ACM, the client should regularly monitor the condition of the roof sheeting to identify any further damage or deterioration. Such monitoring should be conducted at least annually, but more frequently should damage or evidence of deterioration occur.

Additional remedial work is a potential short- to medium-term solution to reduce the risk presented by the sheeting. The encapsulation of the asbestos materials using an appropriate sealant, again by a specialist contractor, can be considered.

No works should be carried out to the roof sheeting or associated building elements without further specialist advice.

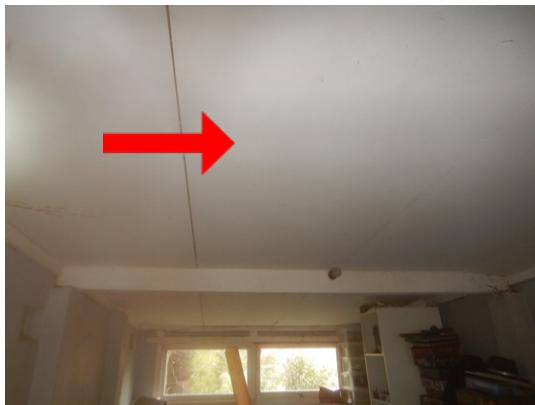
Building: Garage
Location: All Internal Areas
Finding: ACM Suspected Ceiling Sheets
Information: Ceilings throughout the interior of the garage appear to have been constructed with the use of asbestos-containing materials (ACM). At the time of inspection, the observable areas of the ceiling sheets were free of damage and deterioration, representing a lesser health and safety risk than if they were in a poor, damaged or deteriorating condition.

Removal by a Licensed Asbestos Removal firm would be strongly advised. Where the client elects to retain the ACM, the client should regularly monitor the condition of the ceiling sheets to identify any further damage or deterioration. Such monitoring should be conducted at least annually, but more frequently should damage or evidence of deterioration occur.

Inspection should also cover factors that may lead to the deterioration of the ceilings, such as minor roof leaks or structural movement. Additional remedial work is a potential short- to medium-term solution to reduce the risk presented by the ACM. Where possible, the encapsulation of the asbestos materials using an appropriate sealant, again by a specialist contractor, can be considered.

No works should be carried out to the ACM or associated building elements without further specialist advice.

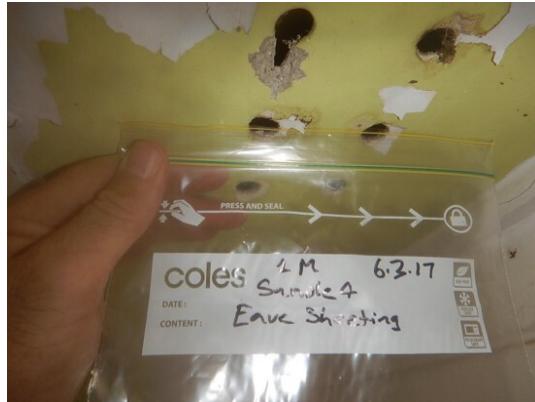
Information: A sample of suspected Asbestos Containing Material (ACM) was removed from the eave sheeting for analysis by a NATA accredited laboratory. The sample results confirmed that the material tested does contain Asbestos. The results indicated that the type of Asbestos is Chrysotile and Amosite.

Consequently, the client is advised to consider relevant risk reduction strategies, including removal by a licensed Asbestos Removal firm.

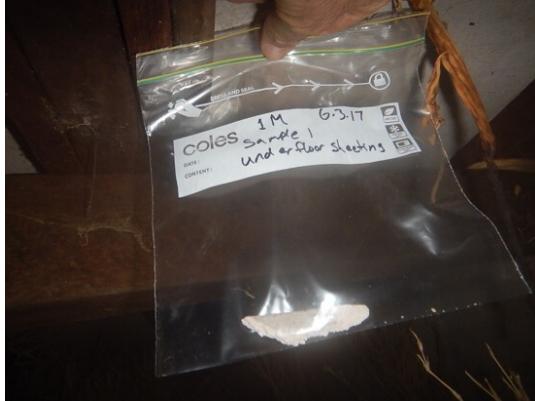
Information: A sample of suspected Asbestos Containing Material (ACM) was removed from the under floor sheeting for analysis by a NATA accredited laboratory. The sample results confirmed that the material tested does contain Asbestos. The results indicated that the type of Asbestos is Chrysotile and Amosite.

Consequently, the client is advised to consider relevant risk reduction strategies, including removal by a licensed Asbestos Removal firm.

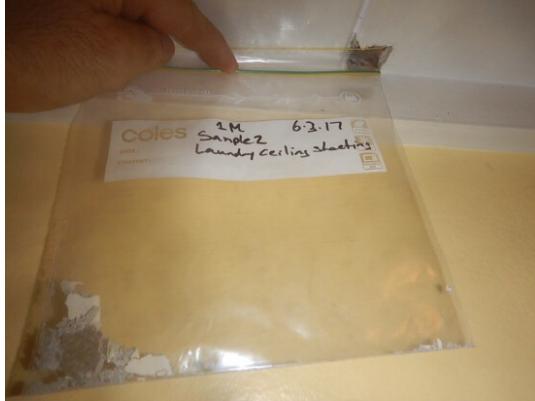
Information: A sample of suspected Asbestos Containing Material (ACM) was removed from the laundry ceiling sheeting for analysis by a NATA accredited laboratory. The sample results confirmed that the material tested does contain Asbestos. The results indicated that the type of Asbestos is Chrysotile and Amosite.

Consequently, the client is advised to consider relevant risk reduction strategies, including removal by a licensed Asbestos Removal firm.

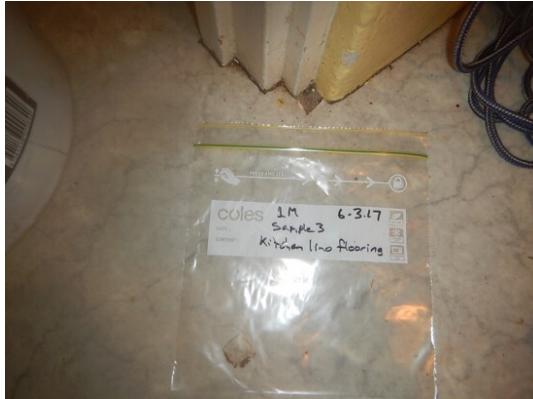
Information: A sample of suspected Asbestos Containing Material (ACM) was removed from the kitchen/ laundry flooring for analysis by a NATA accredited laboratory.

The sample analysed was free of Asbestos fibres.
