Dilapidation Assessment Report

Job address: No. 102 Murrivierie Rd, North Bondi.

Date of assessment: 20th January 2017

Re: Dilapidation Report – No. 102 Murriverie Road, North Bondi.

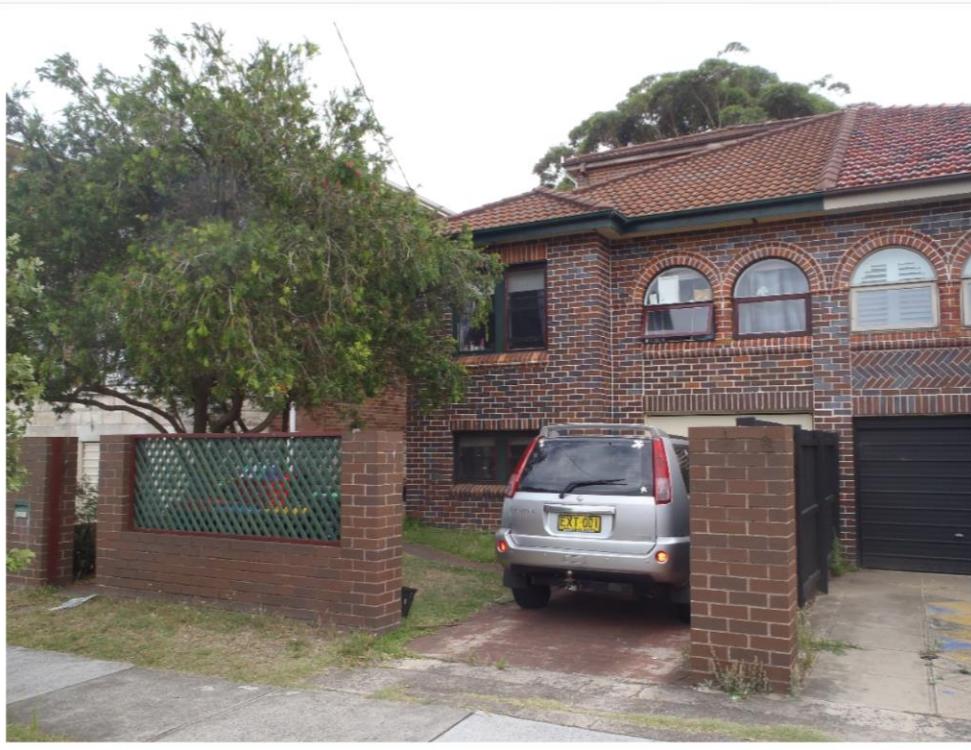
Shows the front southern elevation of the adjoining properties:
 No.102 and No.102A Murrivierie Road, North Bondi.

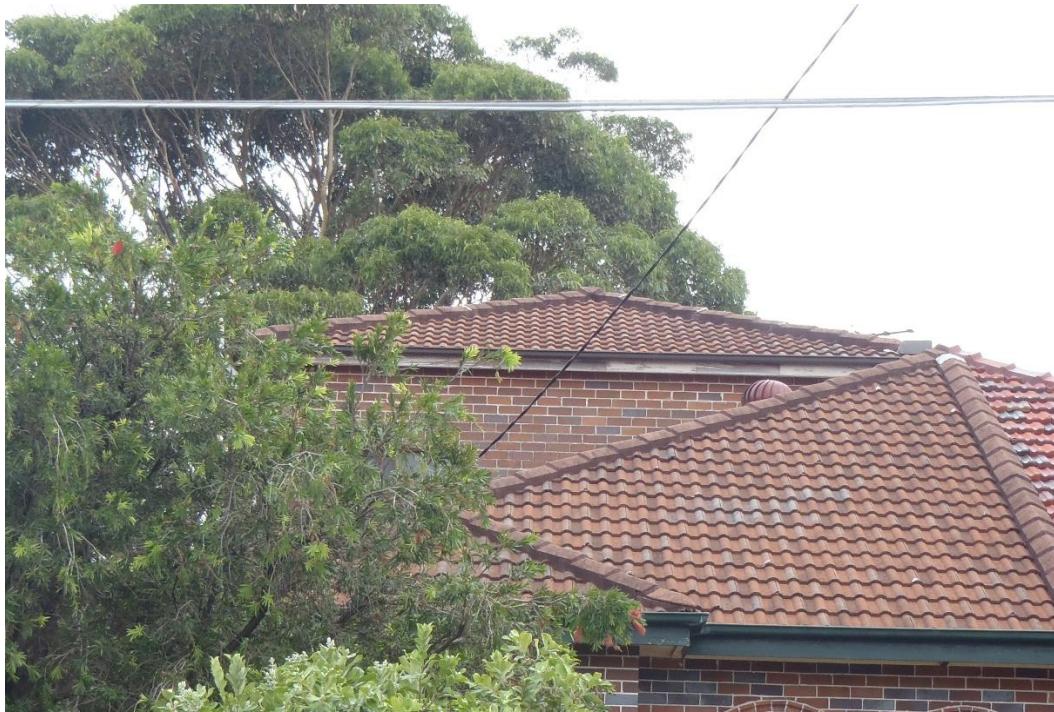
We observed that the concrete roof tiles to the roof surfaces are generally interlinked and securely bedded, in our opinion forming a weather resistant cover to the residence. **[Photograph 1]**

We noted deterioration to the surface coating on the front third storey timber fascia. **[Photograph 1]**

Photograph 1 shows the general condition of the front roof tiles, and deterioration of the surface coating on the front fascia board.

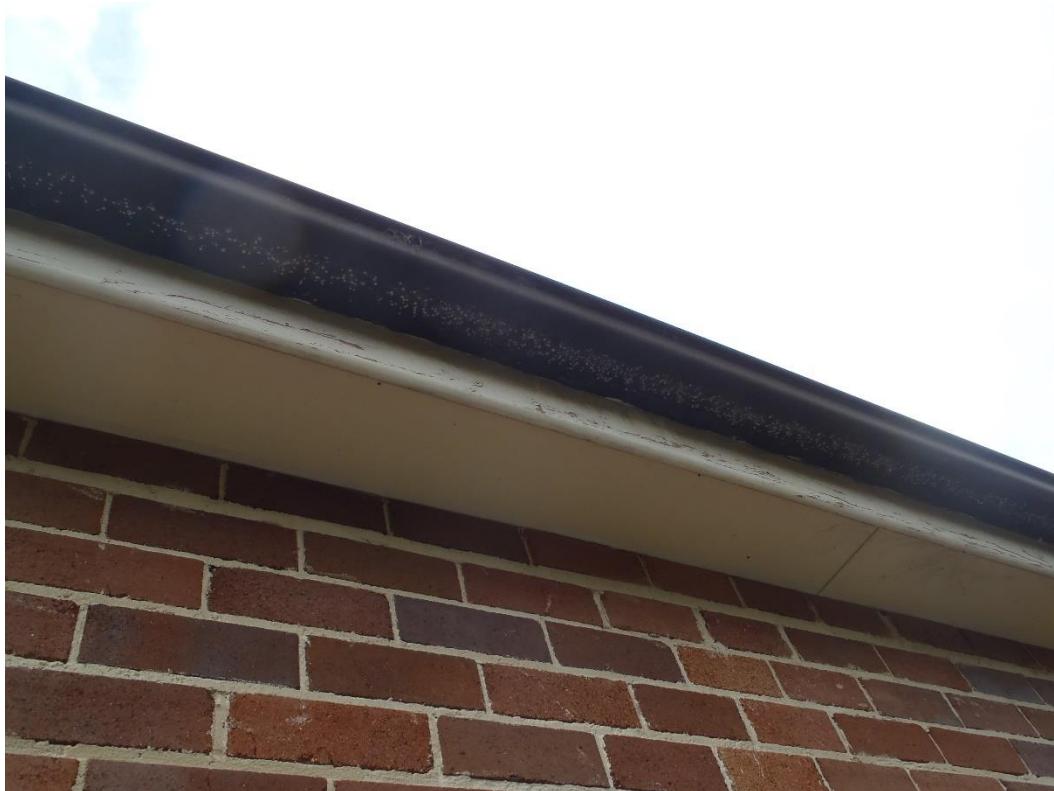
We noted deterioration to the surface coating on the rear third storey timber fascia. **[Photograph 2]**

Photograph 2 shows deterioration to the surface coating on the rear timber fascia.

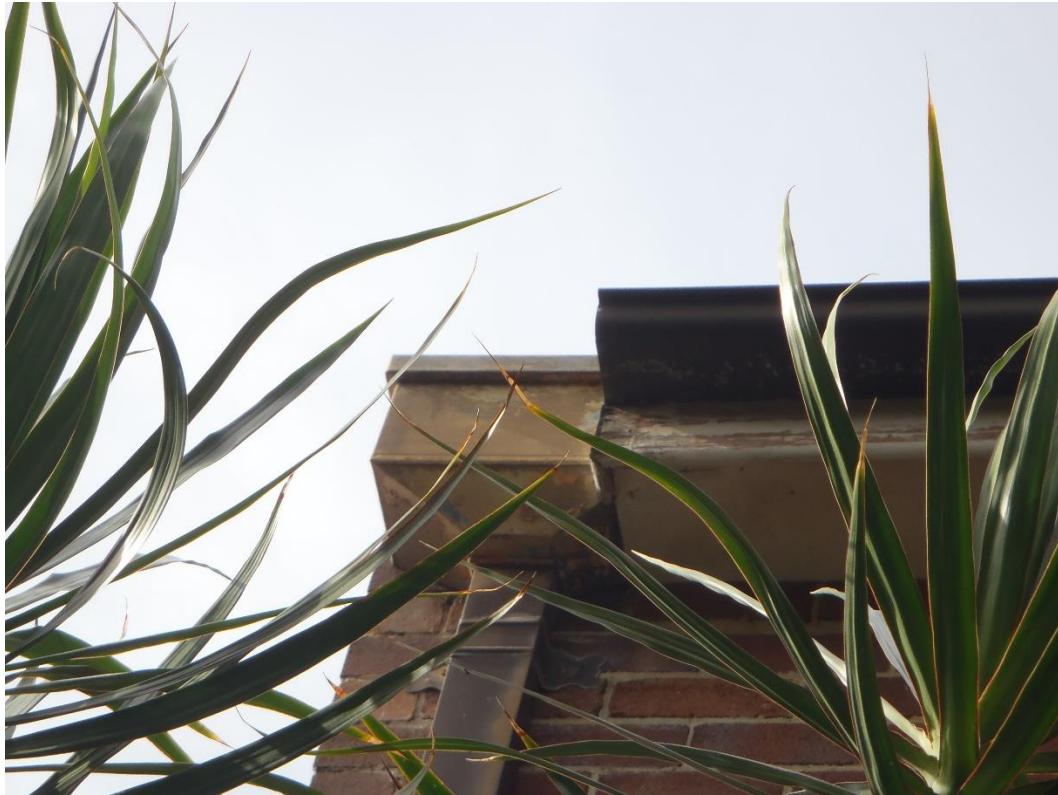
We noted deterioration and rusting to the rear third storey downpipe and collector in the north-eastern corner. **[Photograph 3]**

Photograph 3 shows deterioration and rusting to the rear downpipe and collector in the north eastern corner.

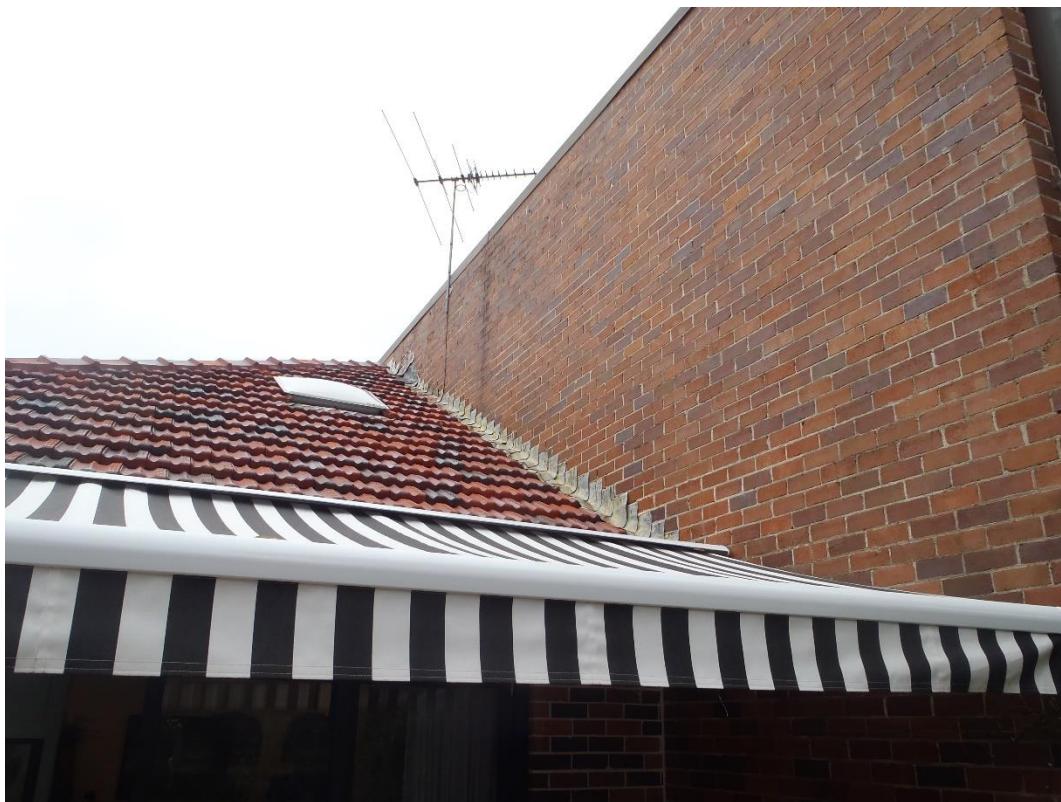
We also noted that the side flashing between the brick wall of upper floor addition and the tiled roof of the adjoining property, 102 Murrivere Road, North Bondi is generally intact and forming a weather resistant seal between the wall and the roof surface. **[Photograph 4]**

Photograph 4 shows the side flashing between the brick wall of upper floor addition and the tiled roof of the adjoining property, 102 Murriville Road, North Bondi.

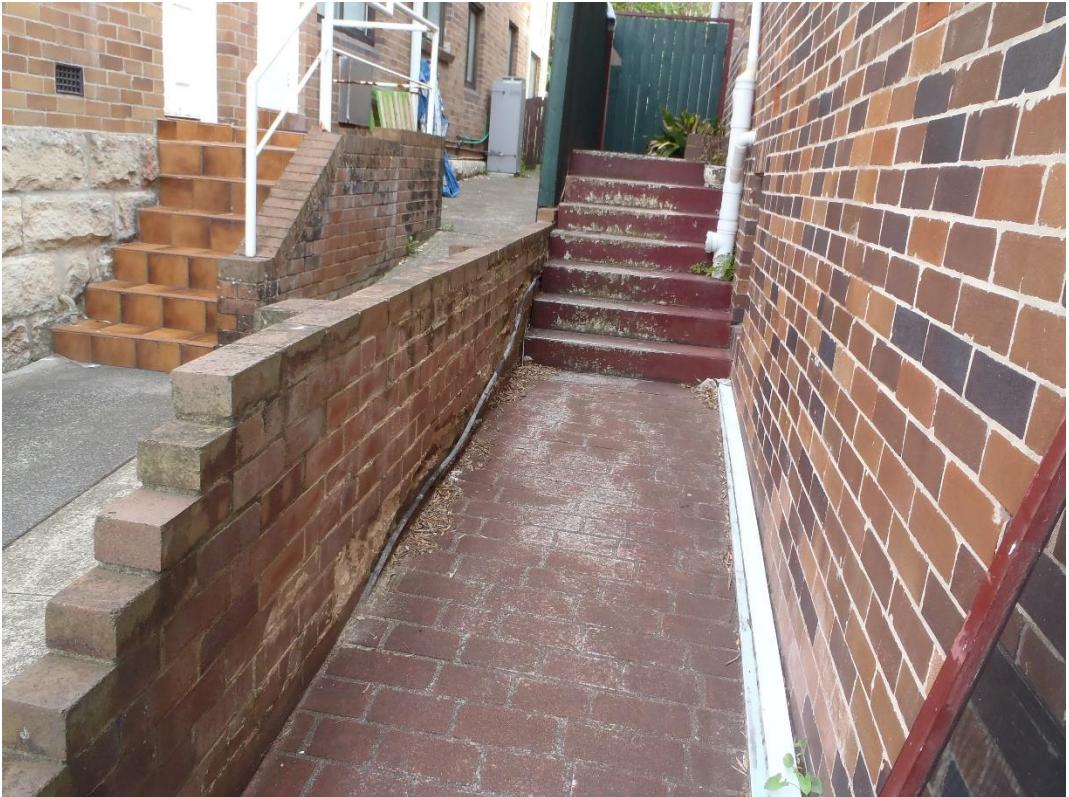
We noted damage to the brick boundary wall adjacent to the front pathway. **[Photograph 6]**

We noted deterioration to the surface coating to the stencilled concrete front side pathway and to the front entry steps. **[Photograph 6]**

Photograph 6 shows damage to the brick boundary wall adjacent to the front pathway.

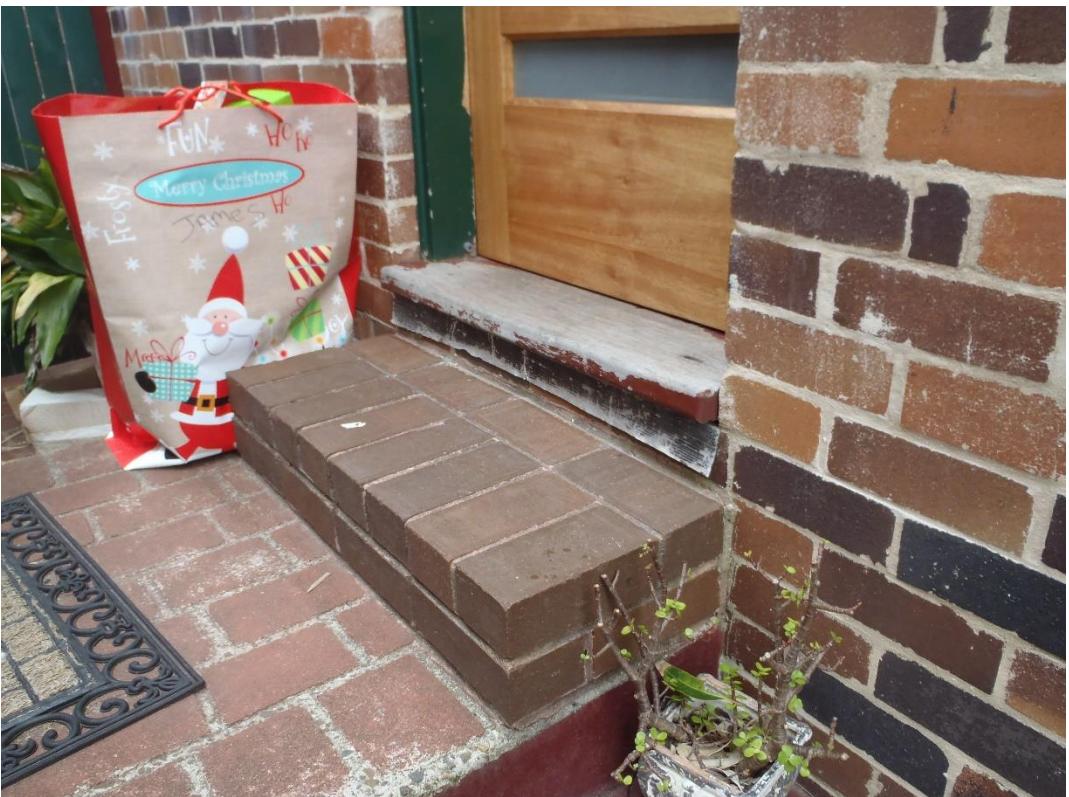
We noted deterioration to the surface coating on the front entry threshold step. **[Photograph 7]**

Photograph 7 shows deterioration to the surface coating on the front entry threshold step.

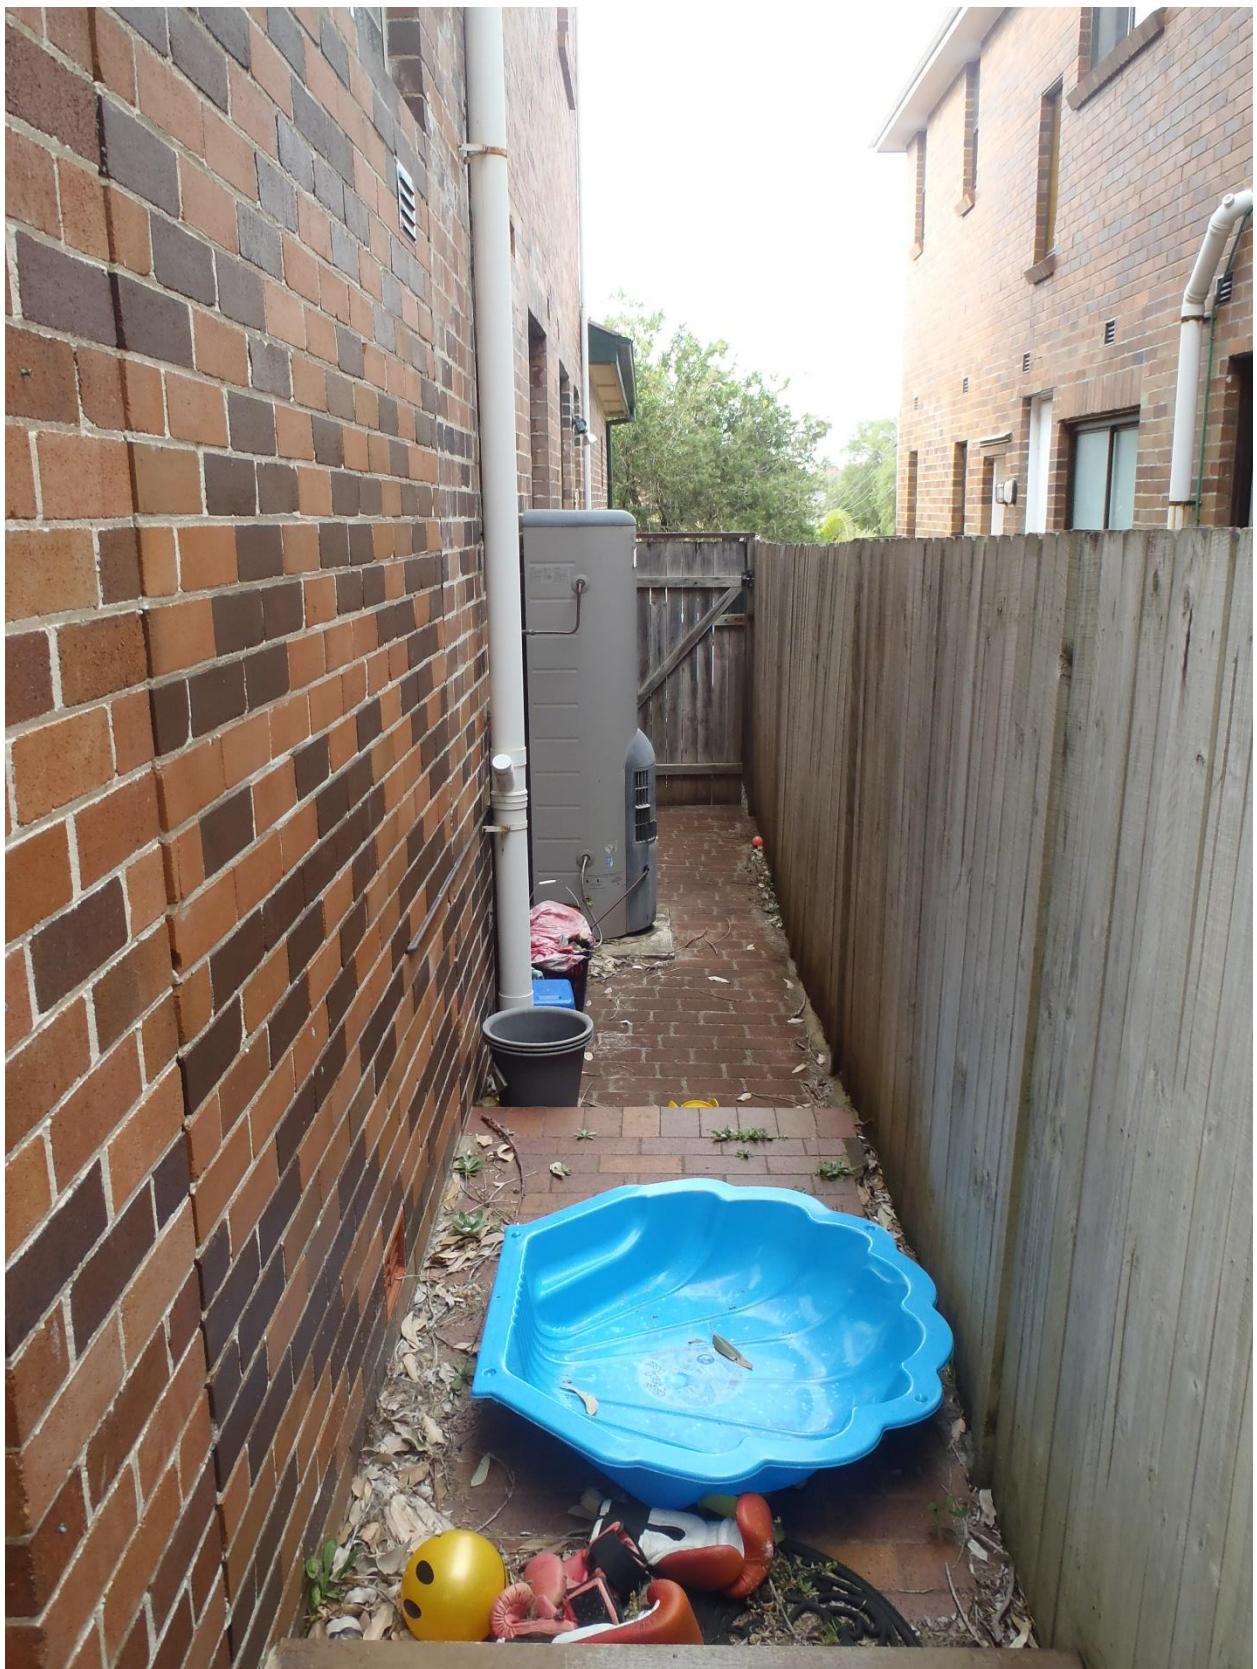
We noted that the rear side pathway was a combination of stencilled concrete and pavers. **[Photograph 8]**

Photograph 8 shows the general condition of the rear side pathway.

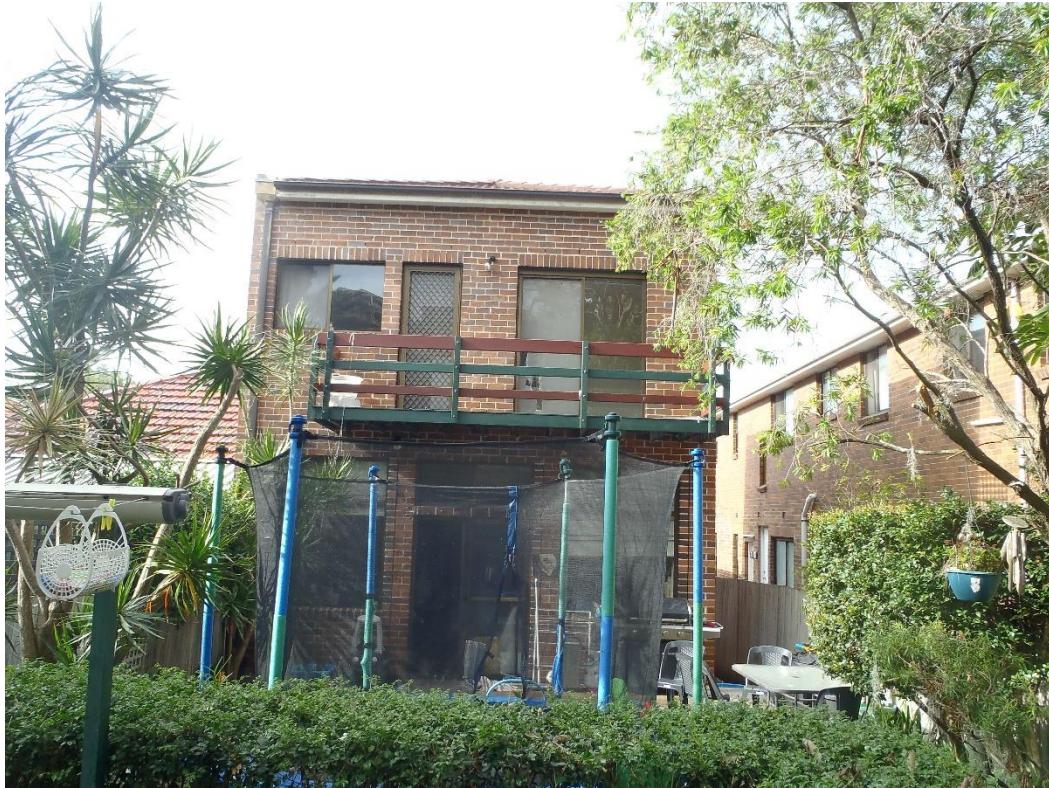
We did not observe any recent cracking to the surface coated clay masonry brickwork. **[Photograph 9]**

Photograph 9 shows the general condition of the rear elevation.

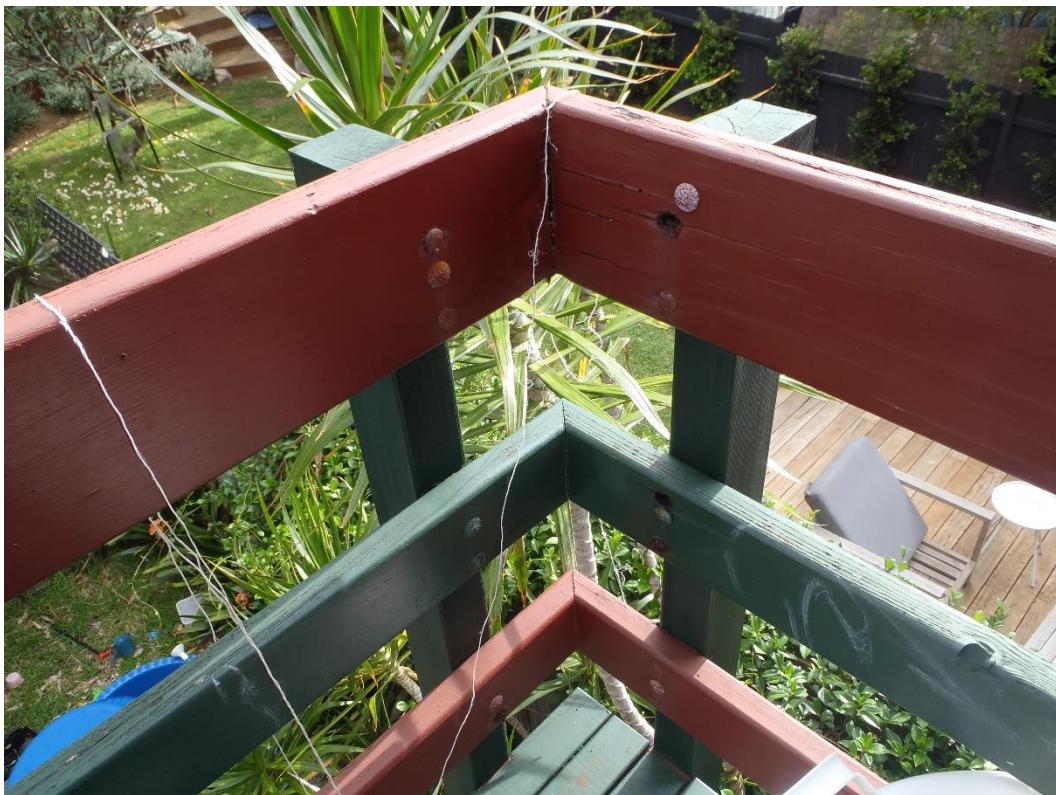
We noted that the timber cantilevered balcony structure. We further noted deterioration to the surface coating of the timber work. **[Photographs 10, 11 & 12]**

Photograph 10 shows deterioration to the surface coating of the balcony handrail.

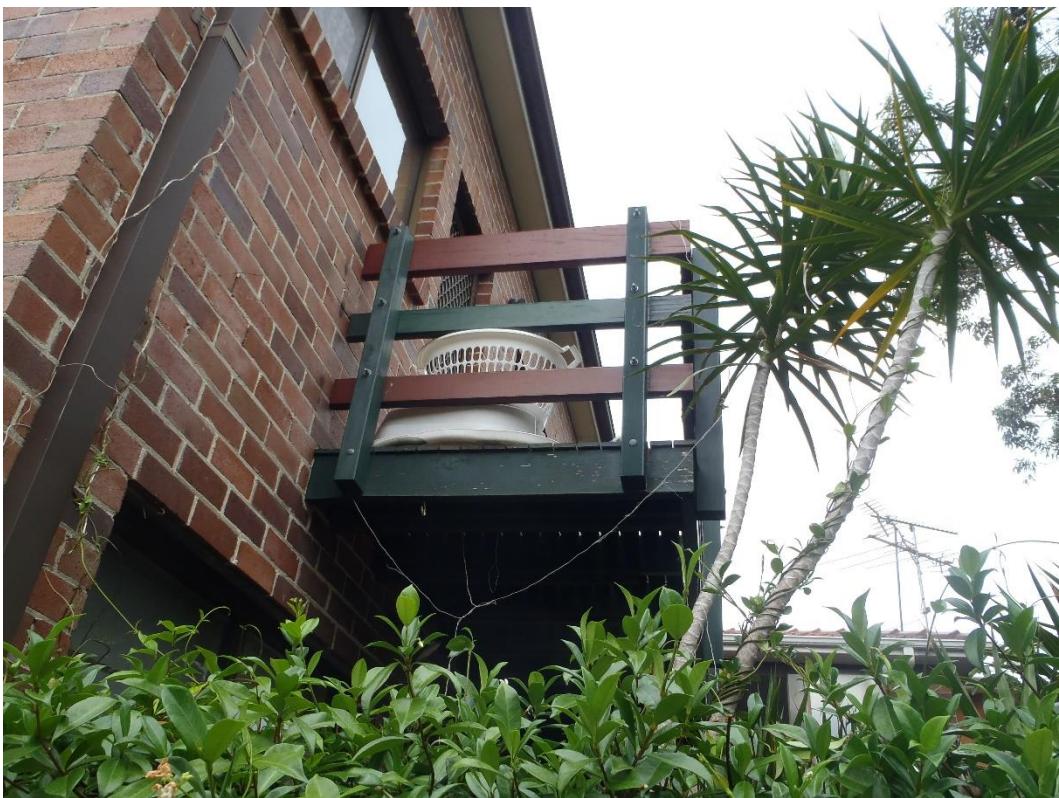
Photograph 12 shows deterioration to the surface coating of the balcony timberwork.

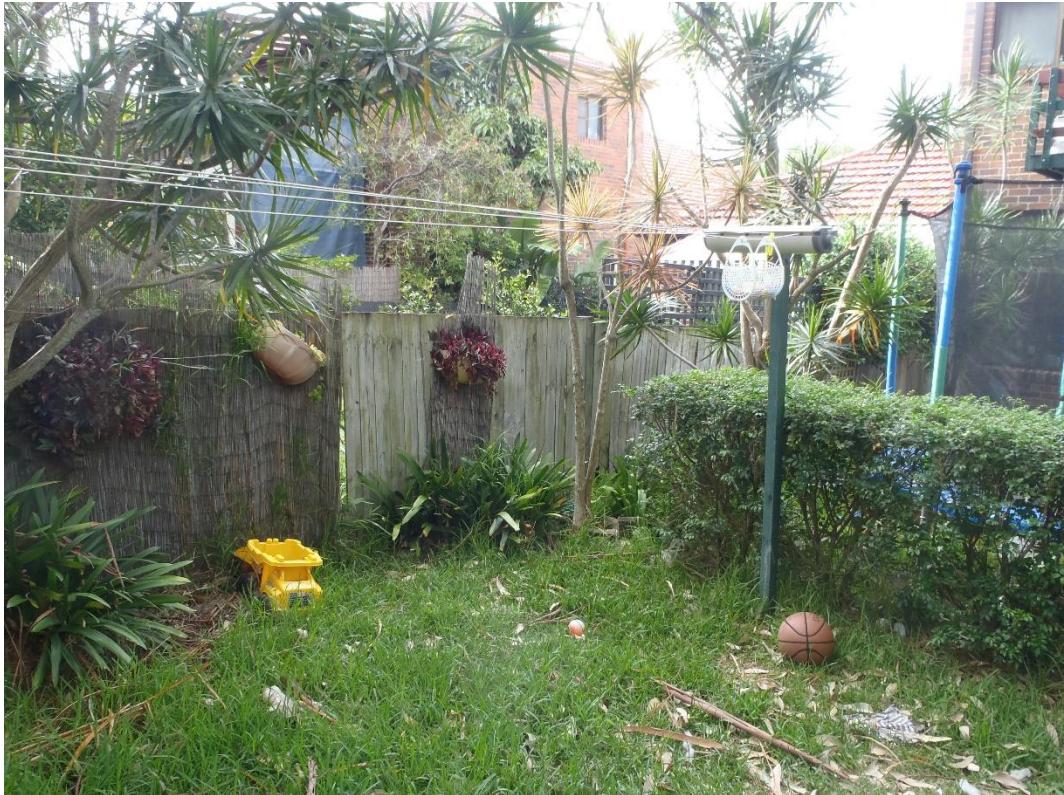
We noted that the rear common boundary fence is of timber post and rail construction. **[Photograph 14]**

Photograph 14 shows the general condition of the rear common boundary fence.

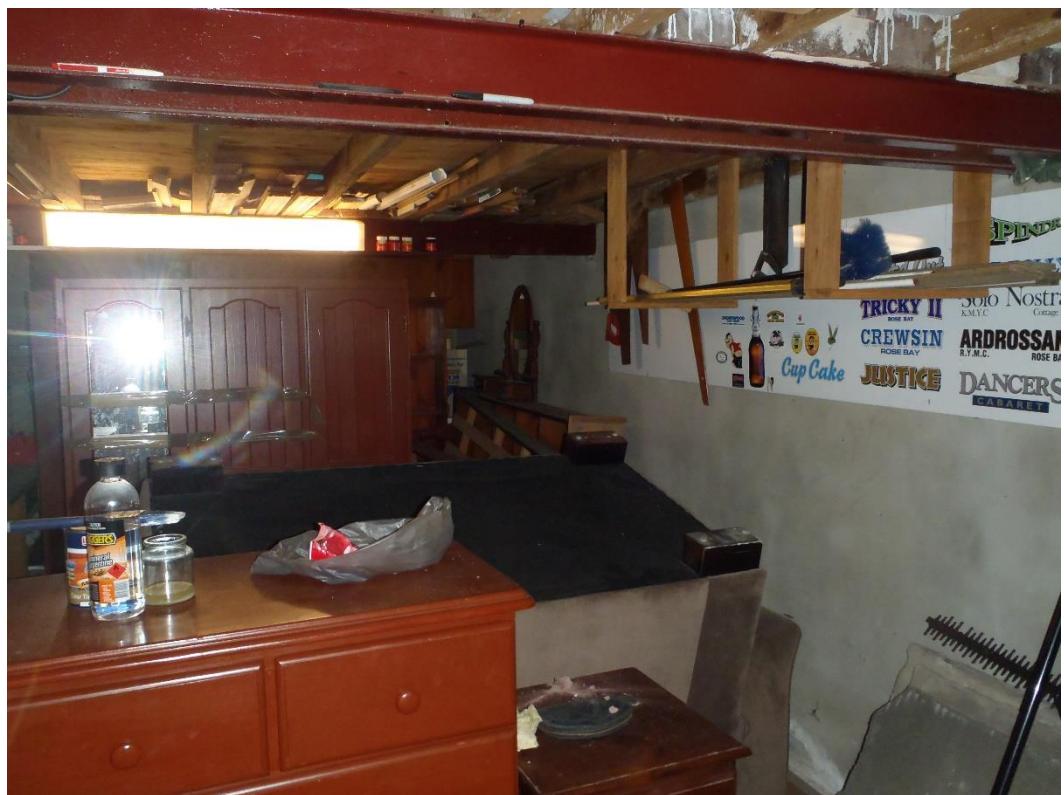
We did not observe any cracking to the *common party / separation wall* with the adjoining property, 102A Murrivie Road, North Bondi. **[Photograph 15]**

Photograph 15 shows the general condition of the garage.

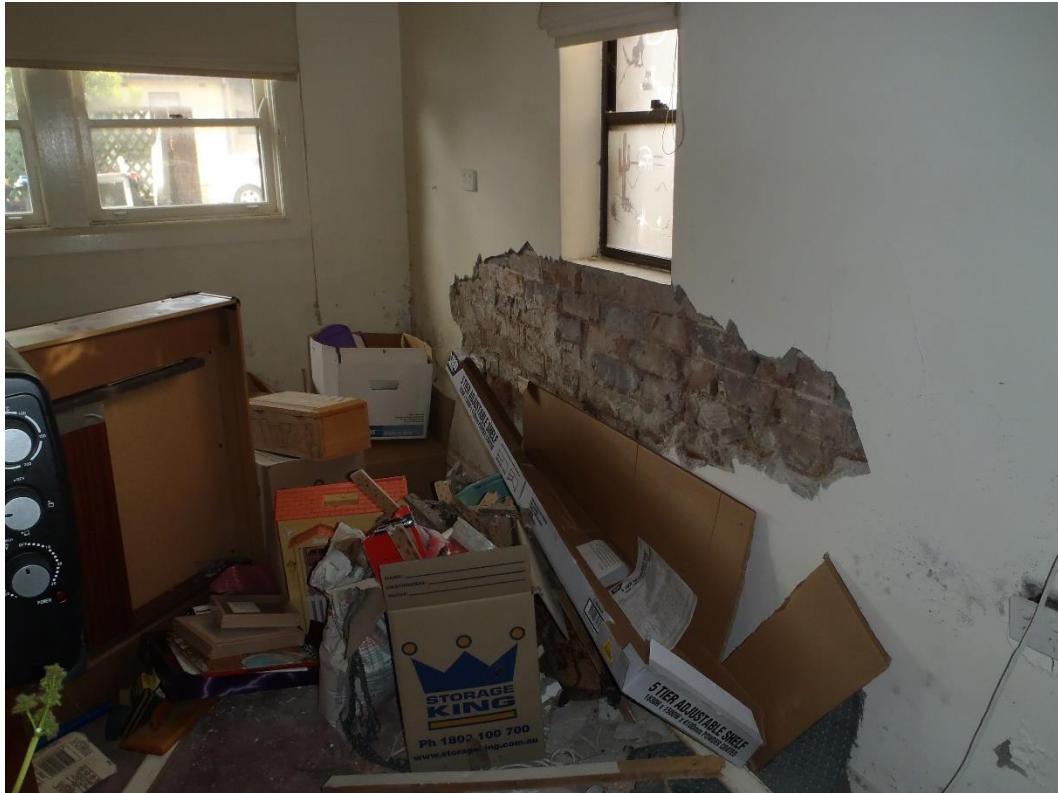
We noted displaced cement render from the external western wall under the window. **[Photograph 16]**

Photograph 16 shows displaced cement render from the external western wall under the window in the front spare room.

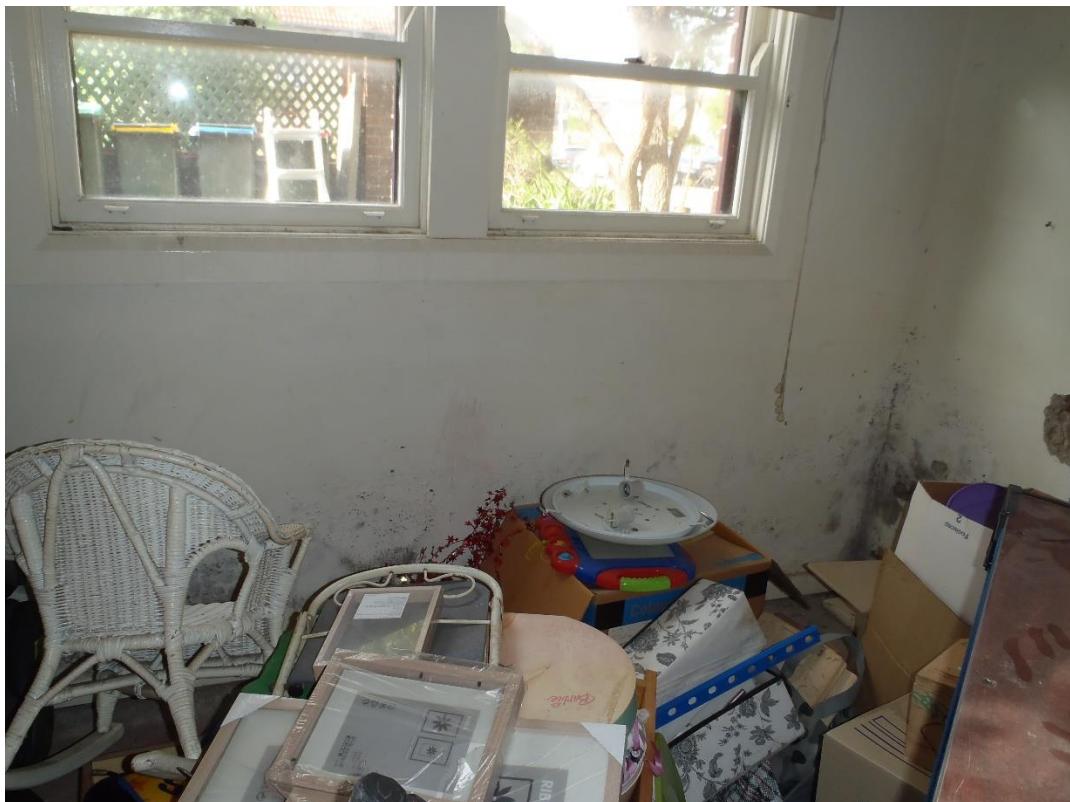
We noted areas of flaking / lifting paint to the external southern and western walls. This, in our experience, is consistent with rising damp. **[Photograph 17]**

Photograph 17 shows flaking / lifting paint to the external southern and western walls of the front spare room.

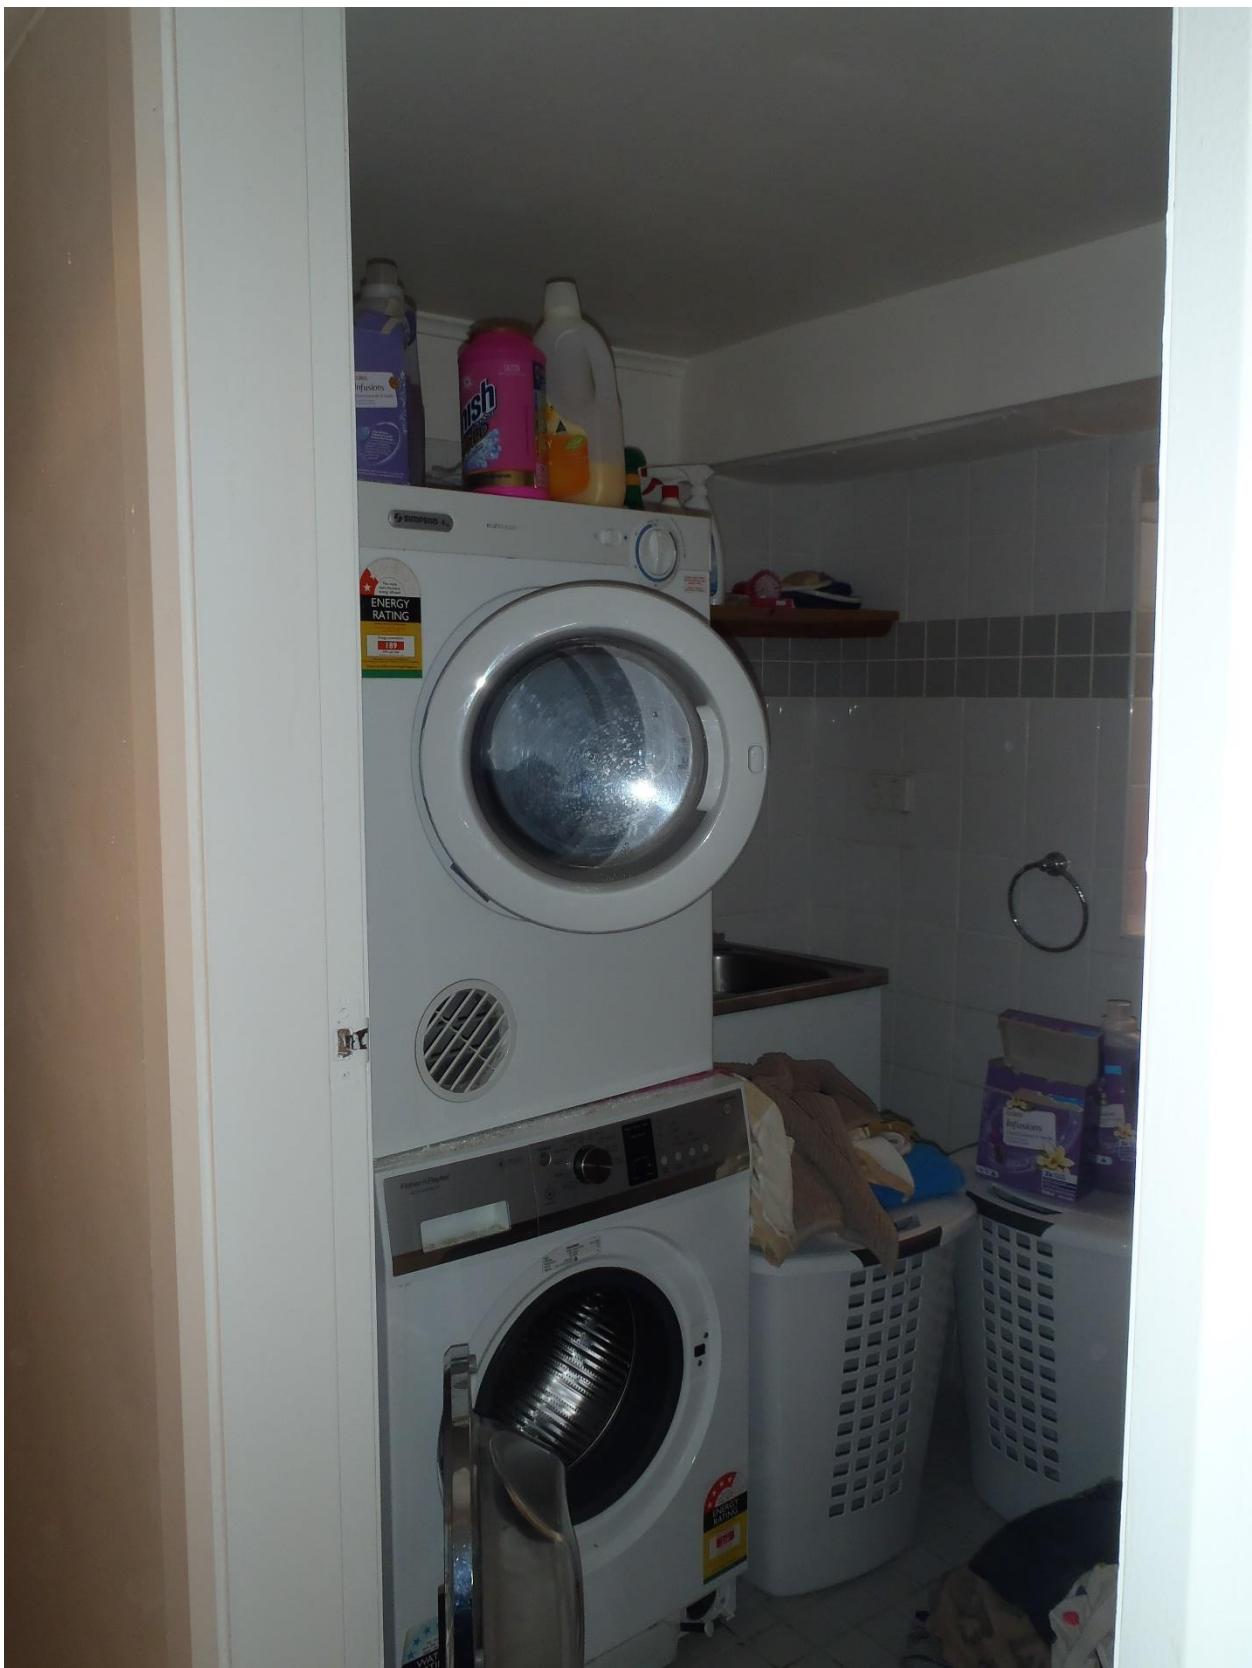
We noted that the grout to the wall and floor tiles is complete and that the wall and floor tiles when randomly "tap" tested appeared to be sound. **[Photograph 18]**

Photograph 18 shows the general condition of the Laundry.

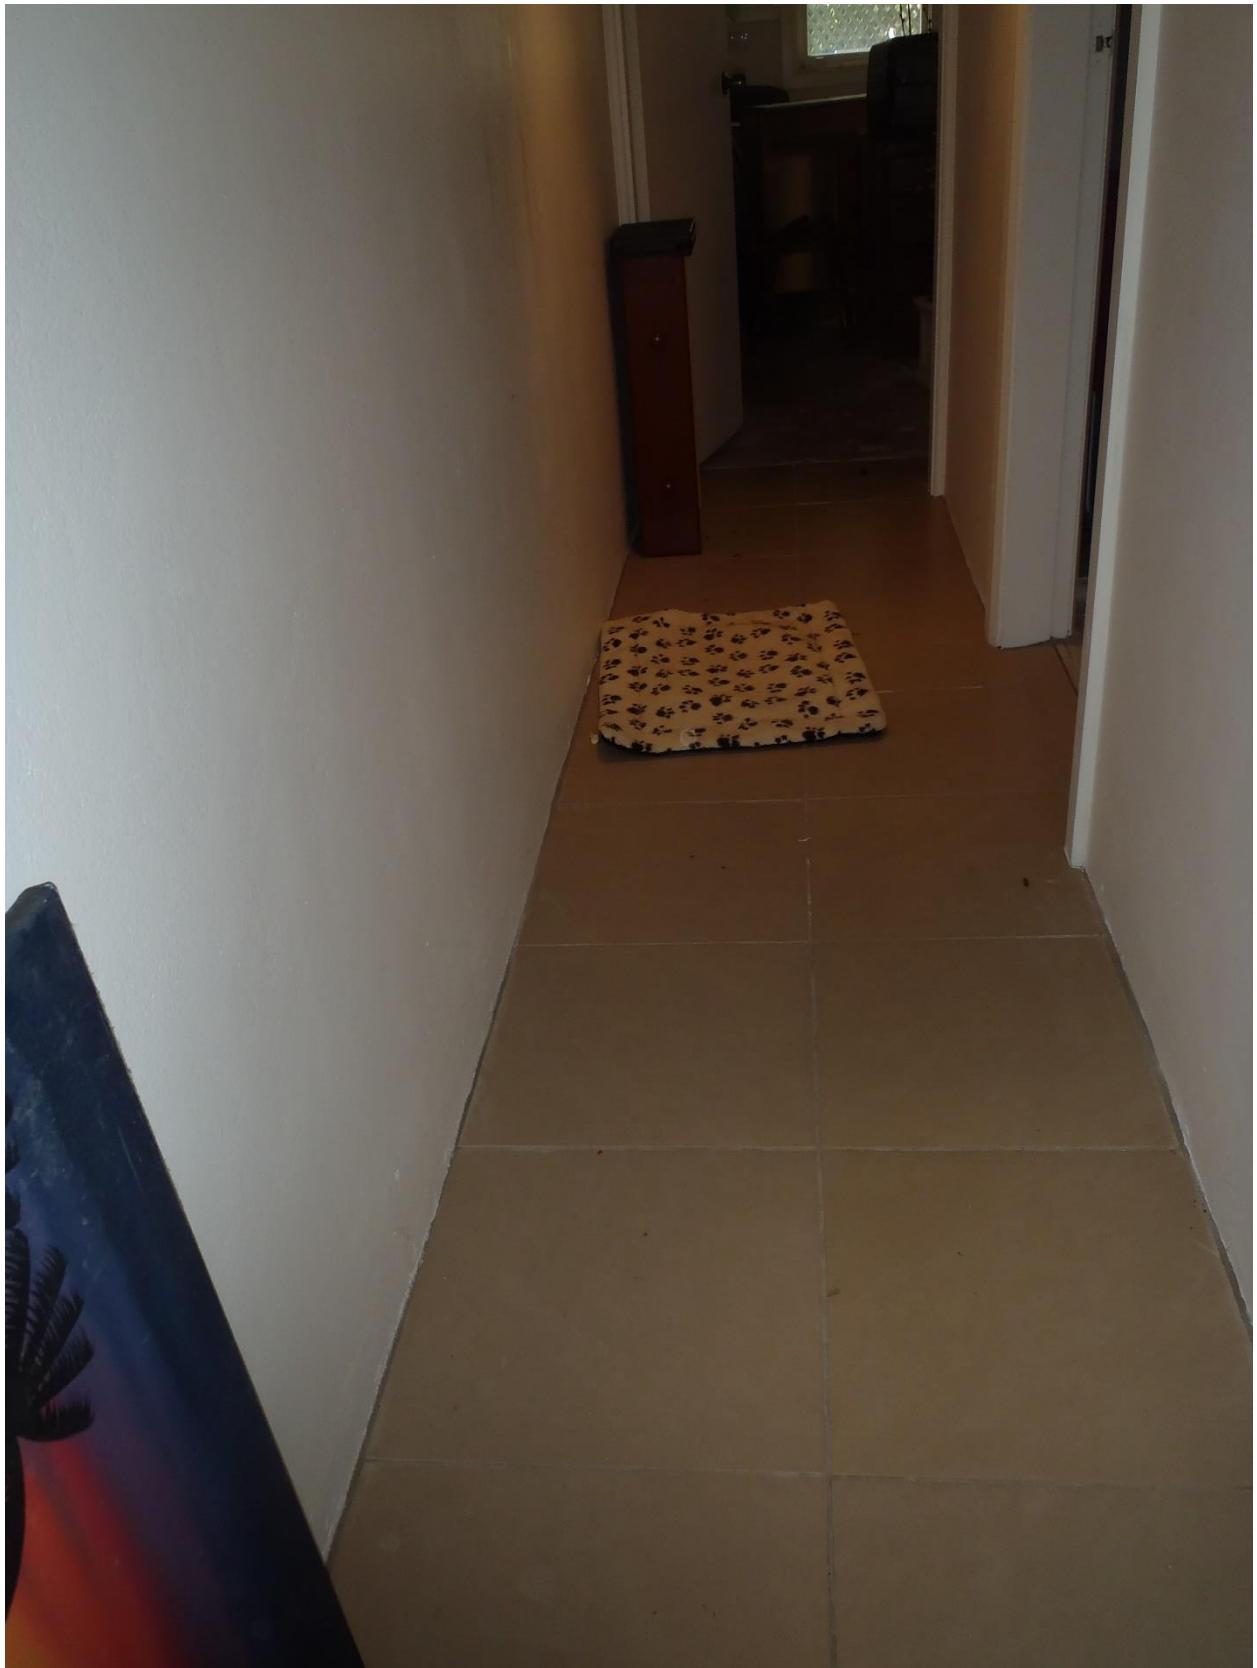
We noted that the grout to the floor tiles is complete and that the floor tiles when randomly "tap" tested appeared to be sound. **[Photograph 19]**

Photograph 19 shows the general condition of the hallway tiles.

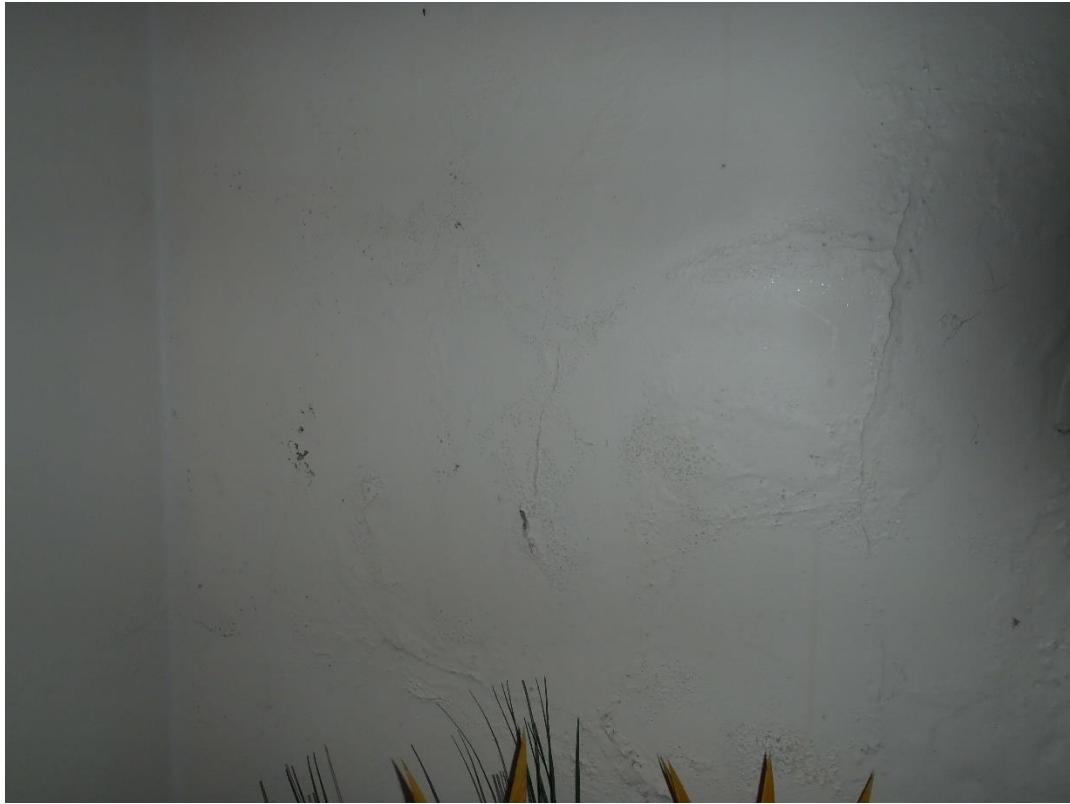
We noted radial cracking [<1mm] along the western cement rendered wall. **[Photograph 20]**

Photograph 20 shows radial cracking along the western cement rendered wall in the stairwell.

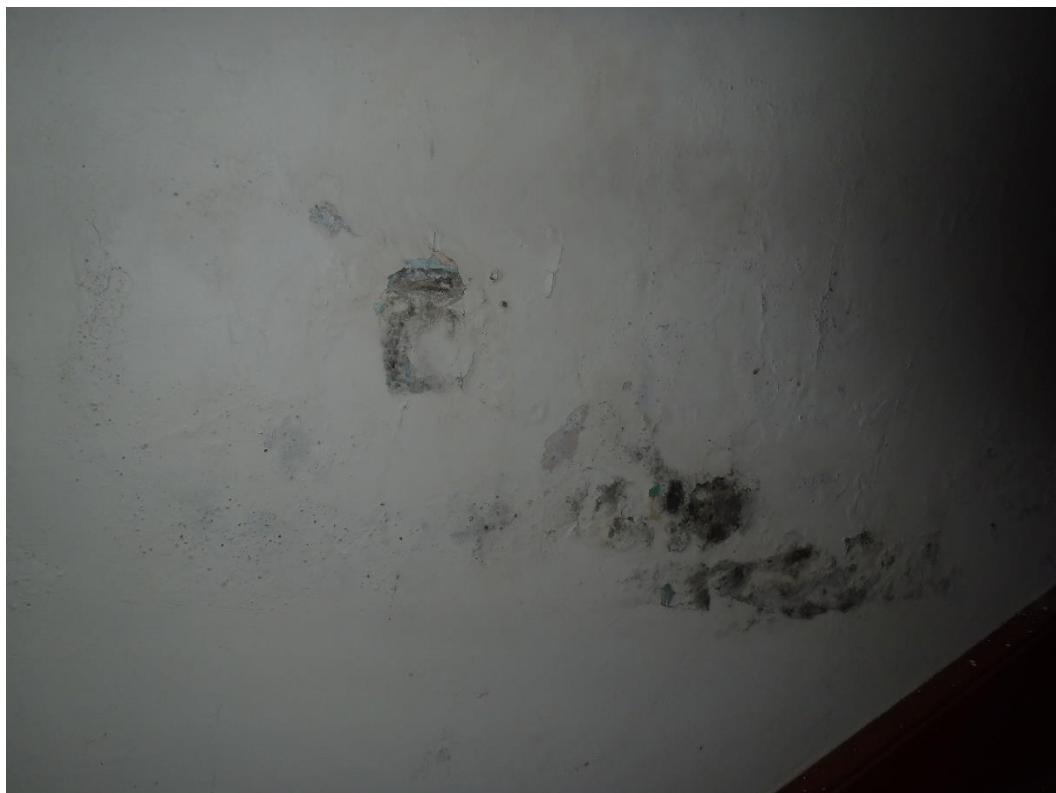
We noted areas of flaking / lifting paint and mould growth to the external western wall. This, in our experience, is consistent with rising damp. **[Photograph 21]**

Photograph 21 shows flaking / lifting paint and mould growth to the external western wall in the stairwell.

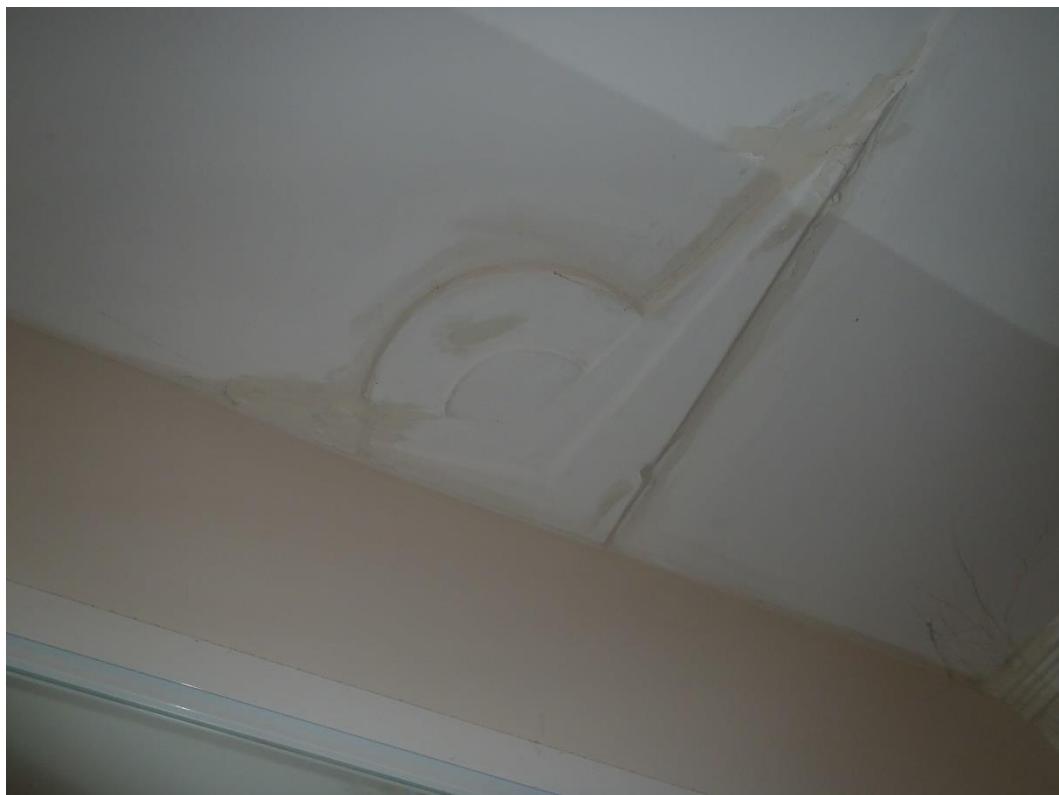
We noted previous repairs and flaking paint to the fibrous plaster ceiling in the north-eastern corner. **[Photograph 22]**

Photograph 22 shows previous repairs and flaking paint to the fibrous plaster ceiling in the north eastern corner of Bedroom 1
