Dilapidation Assessment Report

Job address: No. 102 Murrivierie Rd, North Bondi.

Date of assessment: 20th January 2017

Re: Dilapidation Report – No. 102 Murriverie Road, North Bondi.

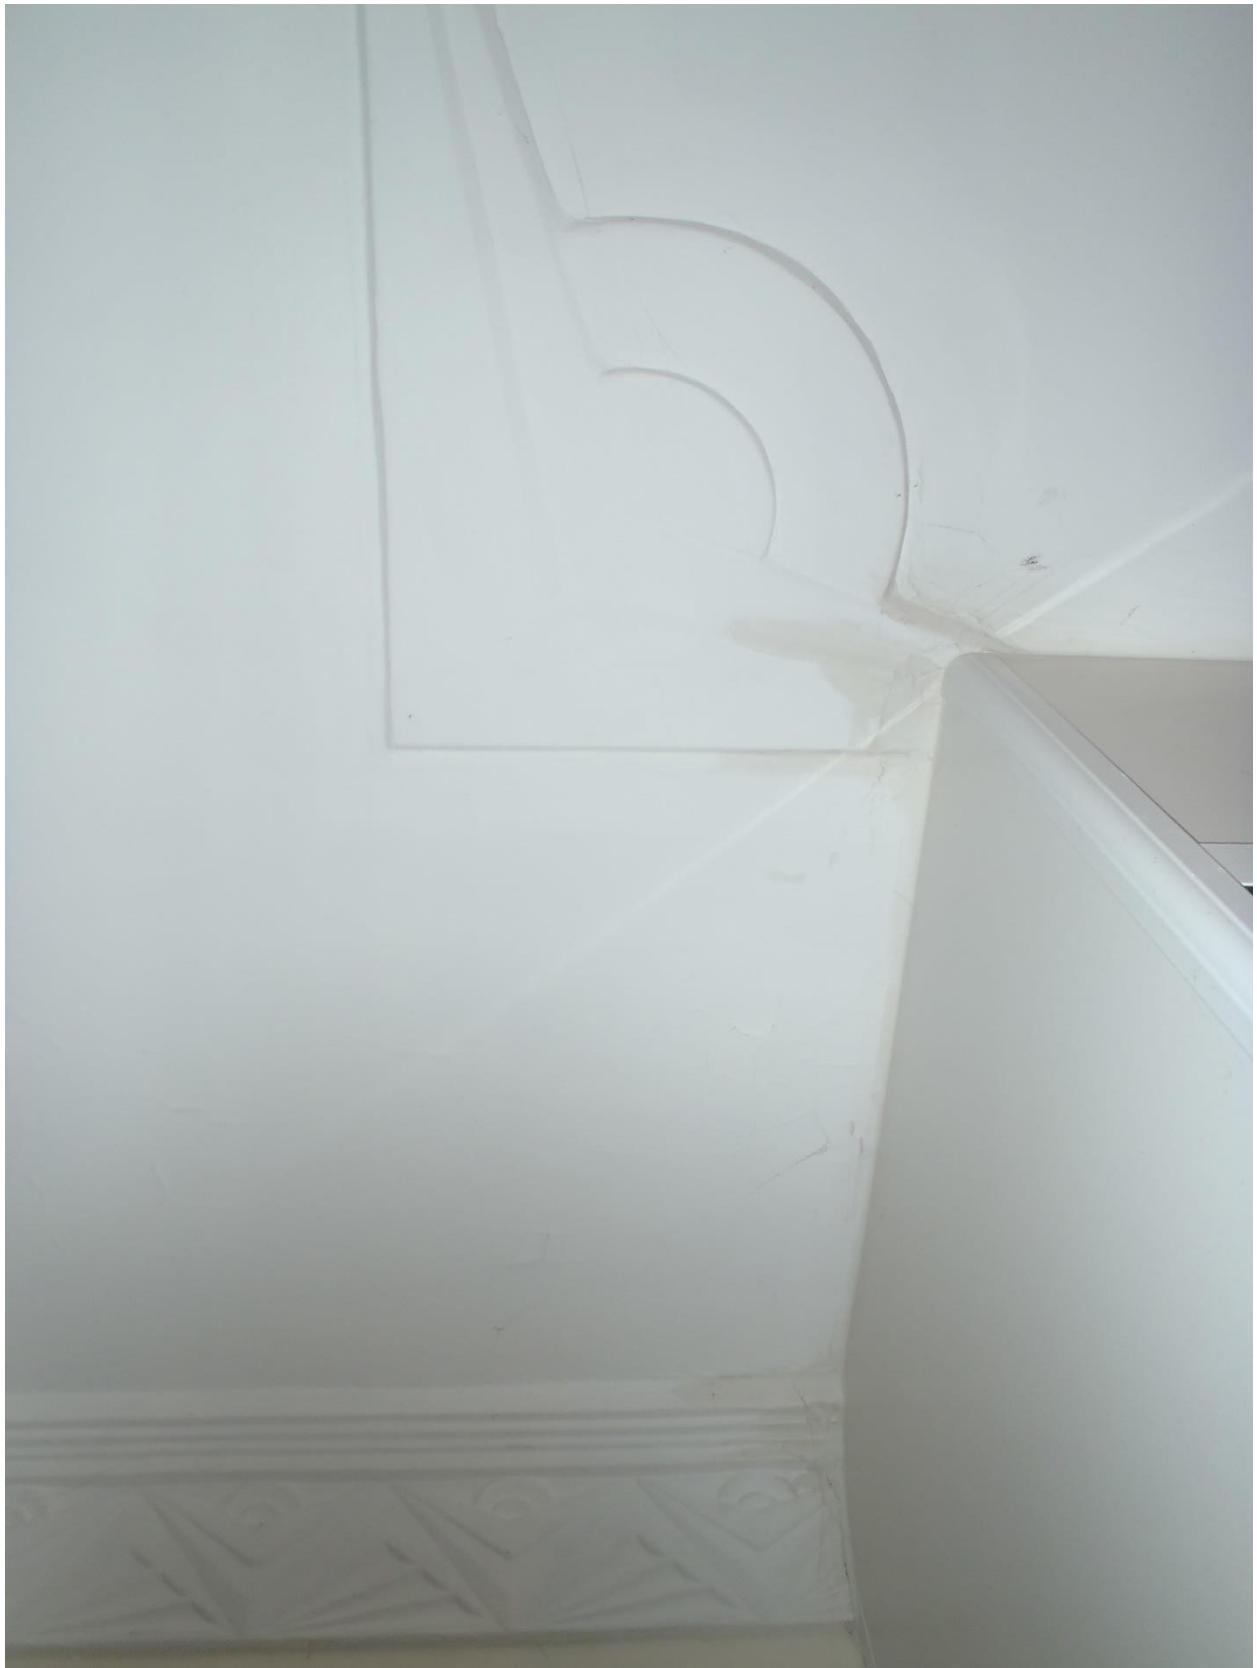
We noted previous repairs to the fibrous plaster ceiling in the north-western corner. We further noted staining to the ceiling and decorative cornice adjacent to the wardrobe. **[Photograph 23]**

Photograph 23 shows previous repairs and staining to the fibrous plaster ceiling in the north-western corner of Bedroom 1

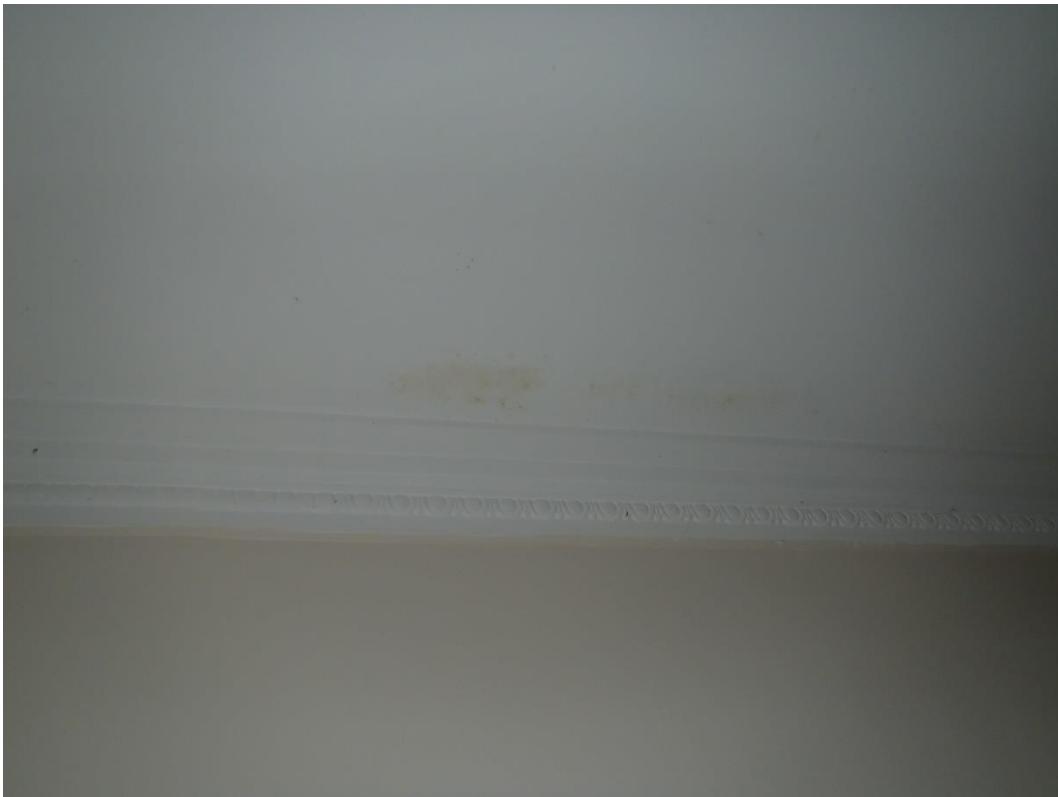
We noted staining to the fibrous plaster ceiling lining in the south-western and north western corner. **[Photographs 24 & 25]**

Photograph 25 shows staining to the fibrous plaster ceiling lining in the north western corner of Bedroom 2.

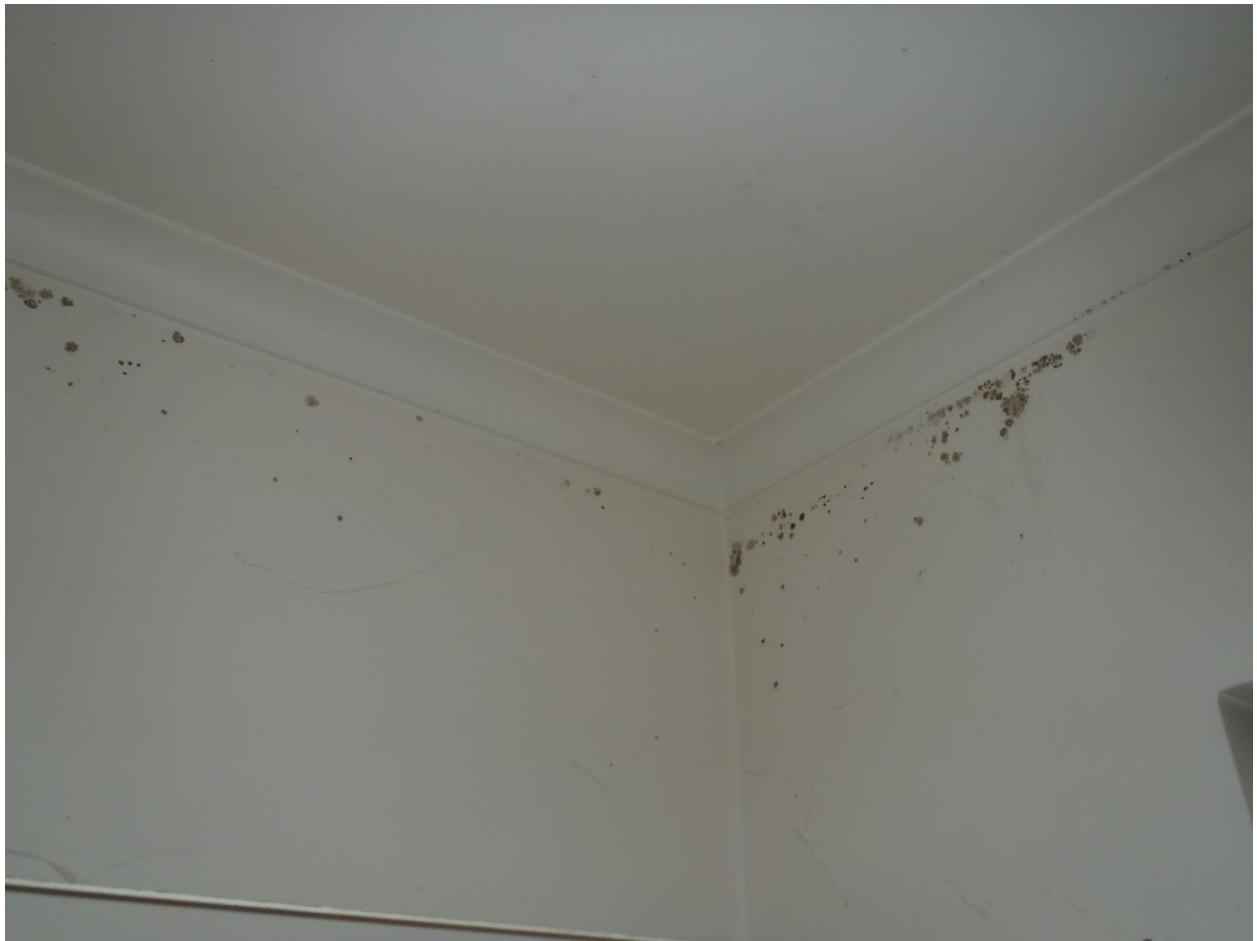
We noted mould growth to the painted cement rendered wall and the plaster ceiling in the south west corner. **[Photograph 26]**

Photograph 26 shows mould growth to the painted cement rendered wall and the plaster ceiling in the south west corner of the Bathroom.

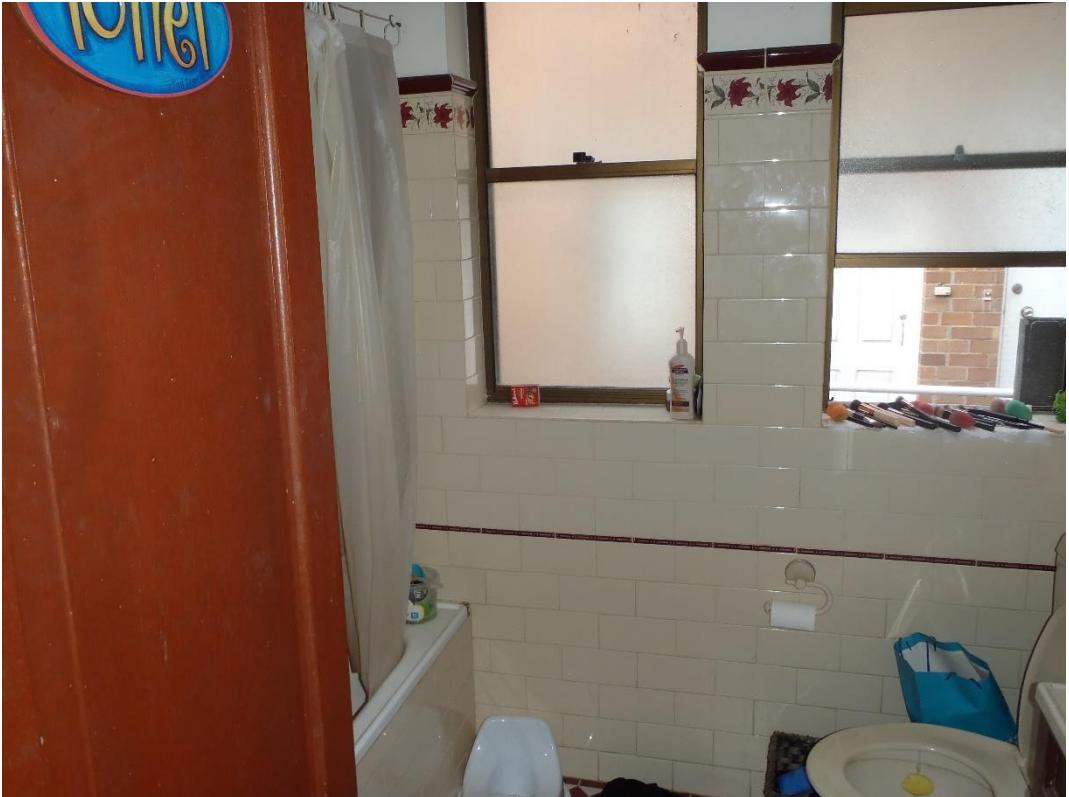
We noted that the grout to the wall and floor tiles is complete and that the wall and floor tiles when randomly "tap" tested appeared to be sound. We did not observe any recent cracking to the tile grout at the wall / wall, wall / floor junctions. **[Photograph 27]**

Photograph 27 shows the general condition of the Bathroom.

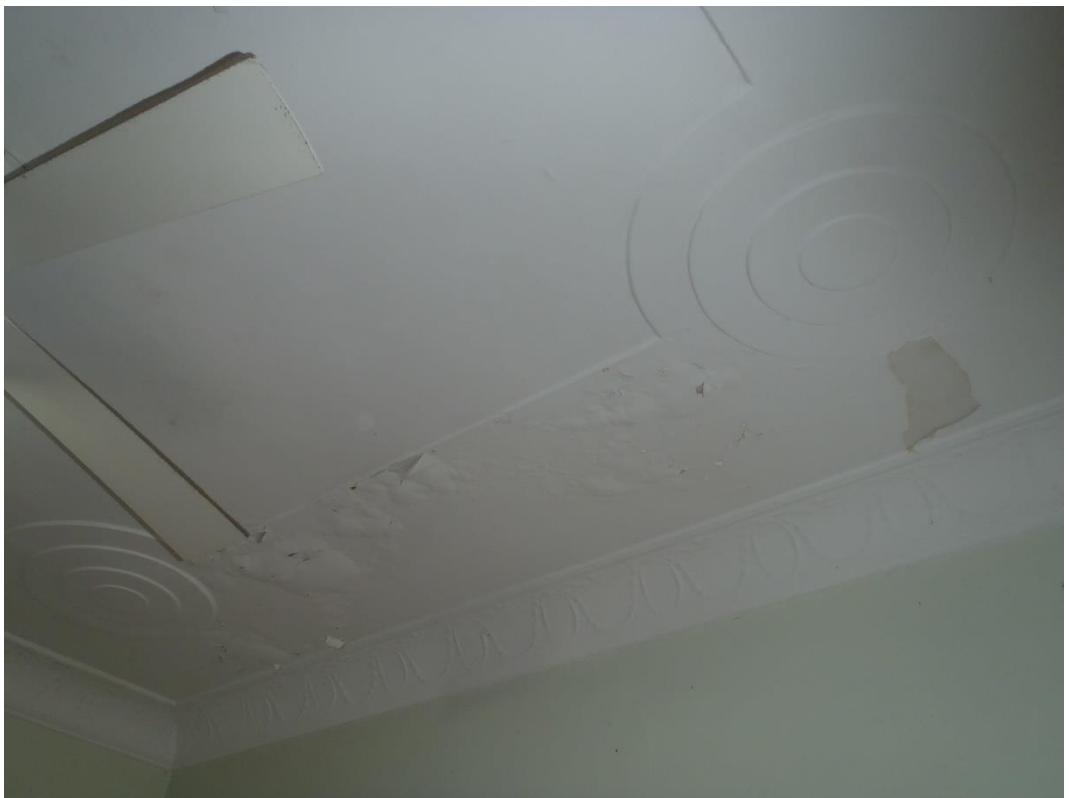
We noted flaking paint to the fibrous plaster ceiling in the north-western corner. **[Photograph 28]**

Photograph 28 shows flaking paint to the fibrous plaster ceiling in the north-western corner in Bedroom 3.

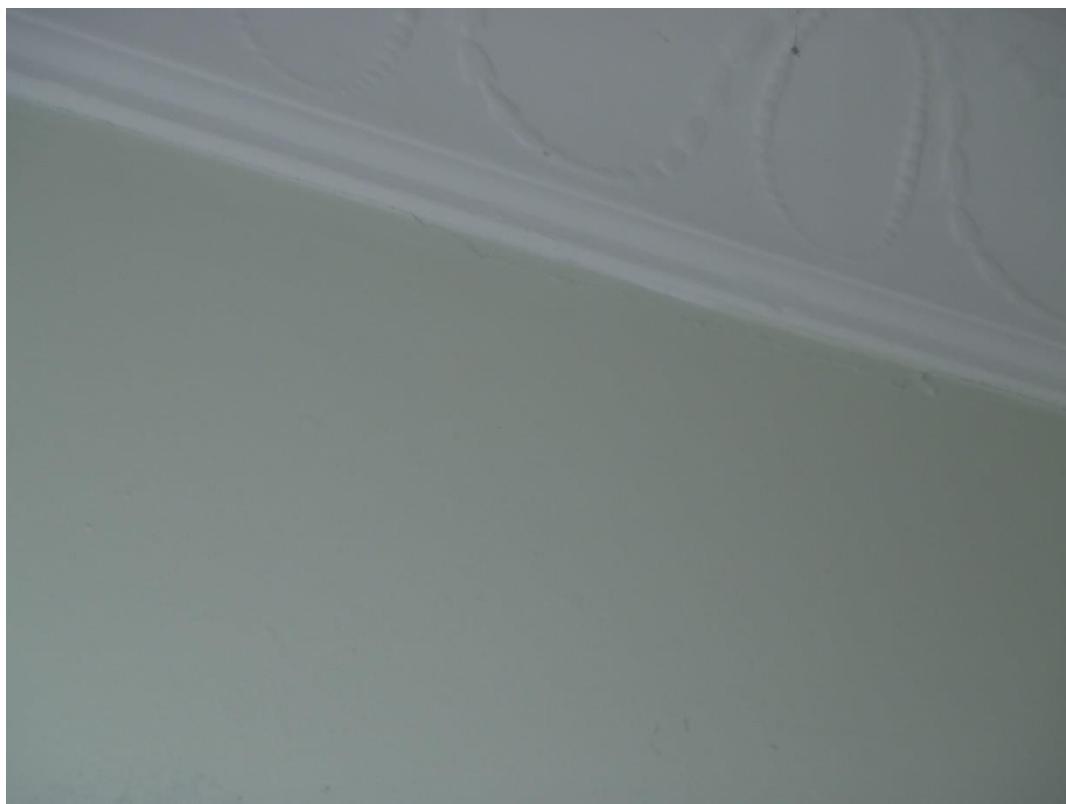
We noted separation cracking [<1mm] extending underneath the decorative cornice along the northern wall. **[Photograph 30]**

Photograph 30 shows separation cracking extending underneath the decorative cornice along the northern wall in Bedroom 3.

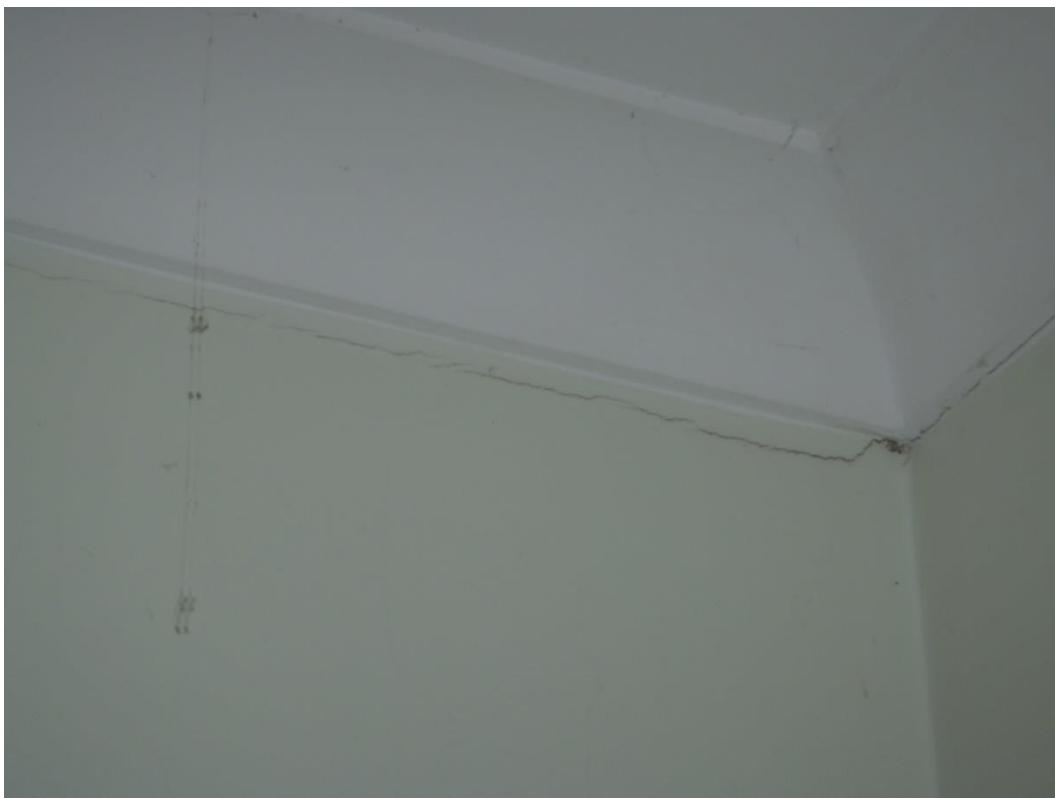
We noted horizontal cracking [1mm-3mm] extending underneath the cove profiled cornice in the south-eastern corner. **Note:** the eastern wall is the *common party / separation wall* with the adjoining property, 102A Murrivierie Road, North Bondi. **[Photograph 31]**

Photograph 31 shows horizontal cracking extending underneath the cove profiled cornice in the south-eastern corner of the Playroom.

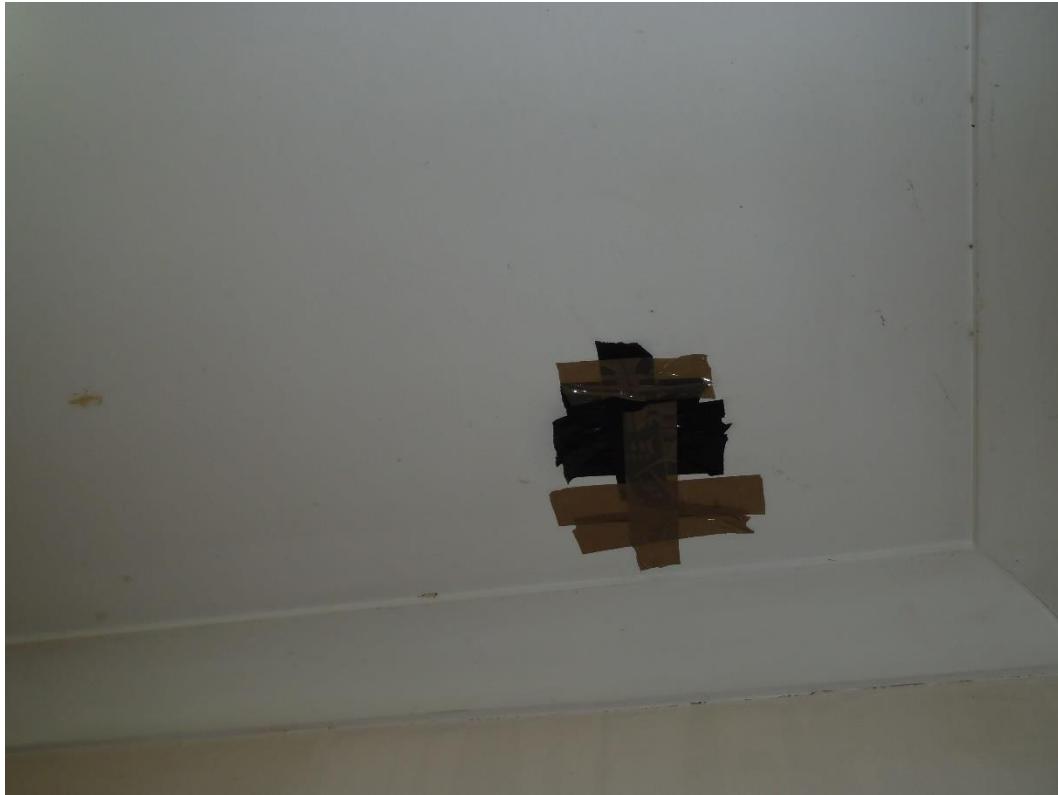
We noted a repair to the plaster ceiling in the south-western corner. **[Photograph 33]**

Photograph 33 shows a repair to the plaster ceiling in the south-western corner in the Kitchen.

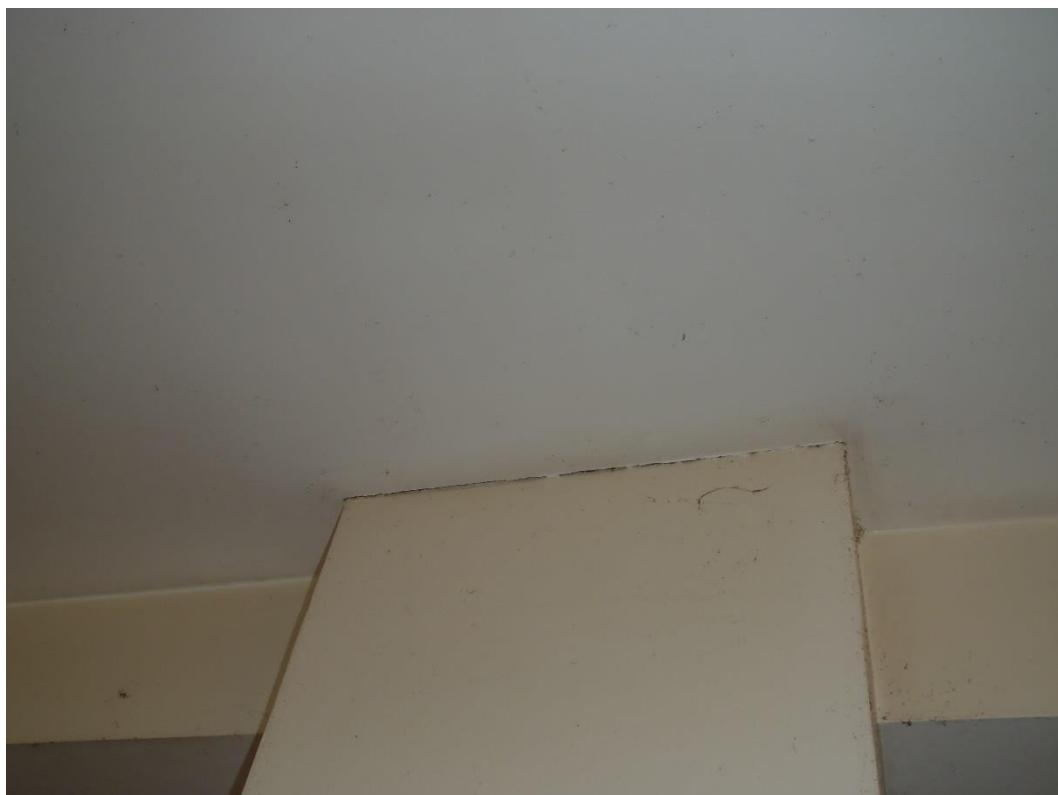
We noted separation cracking [1mm-3mm] extending along the square set junction of the painted cement rendered brick pier and the ceiling lining in the south-eastern corner. **[Photograph 34]**

Photograph 34 shows separation cracking [1mm-3mm] extending along the square set junction of the painted cement rendered brick pier and the ceiling lining in the south-eastern corner of the Kitchen.

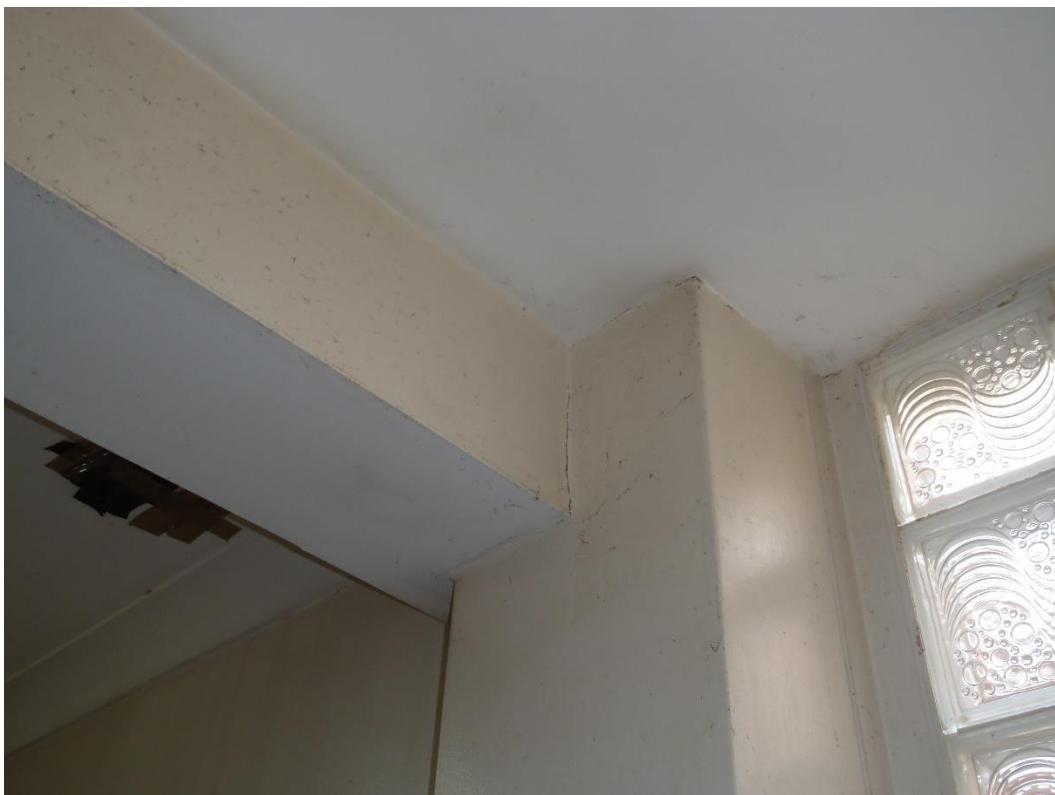
We noted vertical cracking [1mm-3mm] extending along the square set junction of the painted cement rendered brick pier and the ceiling bulkhead in the south-western corner. **[Photograph 35]**

Photograph 35 shows vertical cracking extending along the square set junction of the painted cement rendered brick pier and the ceiling bulkhead in the south-western corner of the Kitchen.

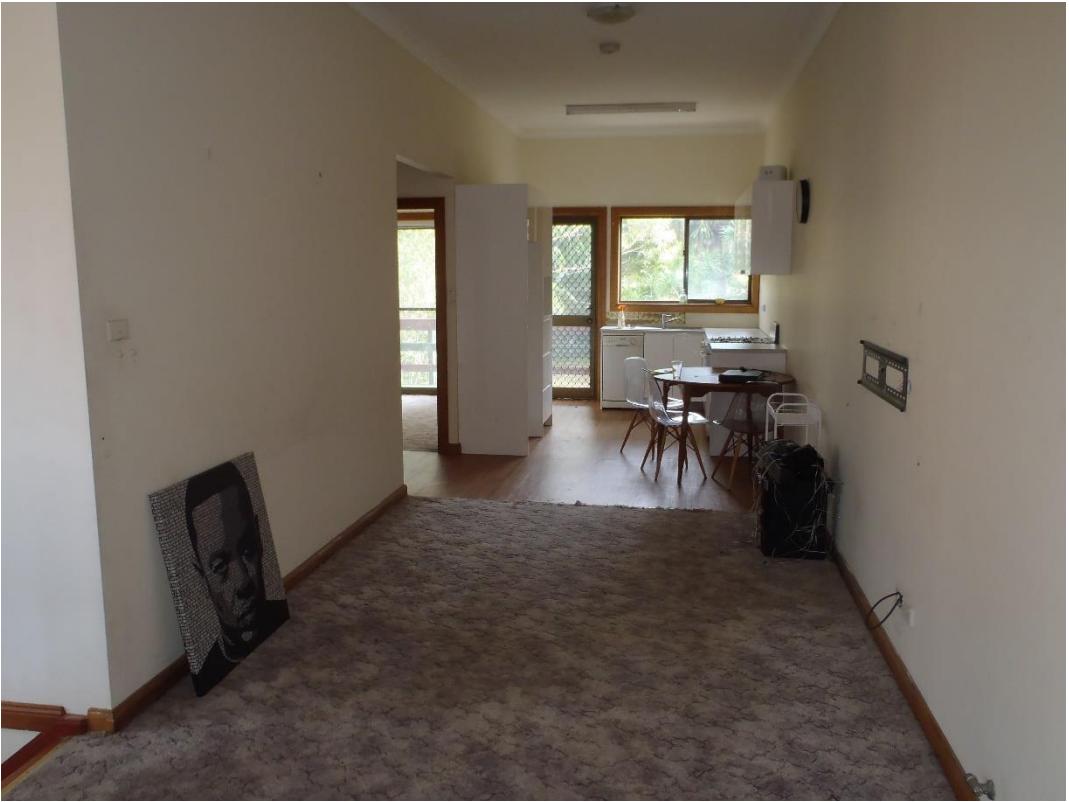
We did not observe any cracking to the plasterboard lined wall (*common party / separation wall* with the adjoining property, 102A Murrivierie Road, North Bondi), plasterboard ceiling or to the mitred joints in the cove profiled plaster cornice. **[Photograph 37]**

Photograph 37 shows the general condition of the Lounge and Stairwell landing.

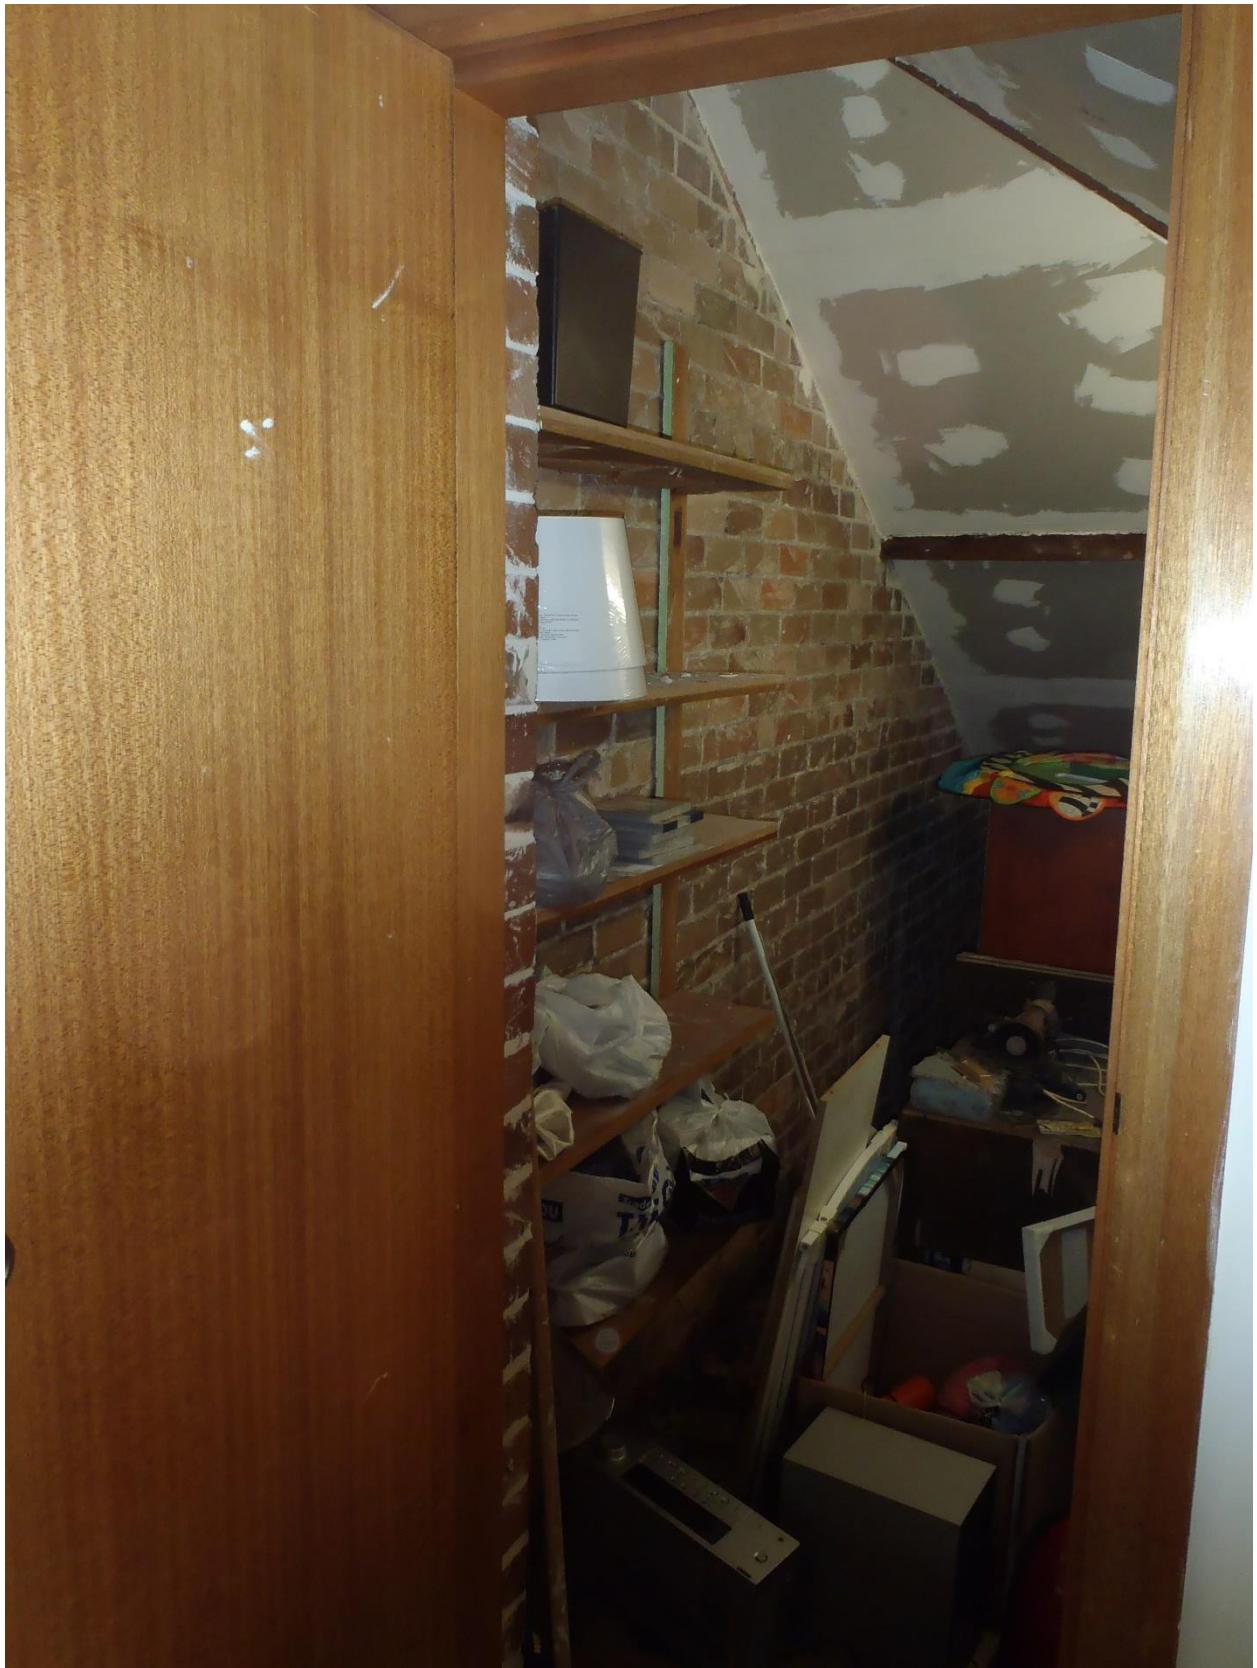
We did not observe any cracking to the clay masonry brick wall (*common party / separation wall* with the adjoining property, 102A Murrivierie Road, North Bondi). **[Photograph 38]**

We did not observe any cracking to the plasterboard ceiling lining or the western plasterboard wall. We further noted that the ceiling lining and the wall were not painted. **[Photograph 38]**

Photograph 38 shows the general condition of the attic store room.

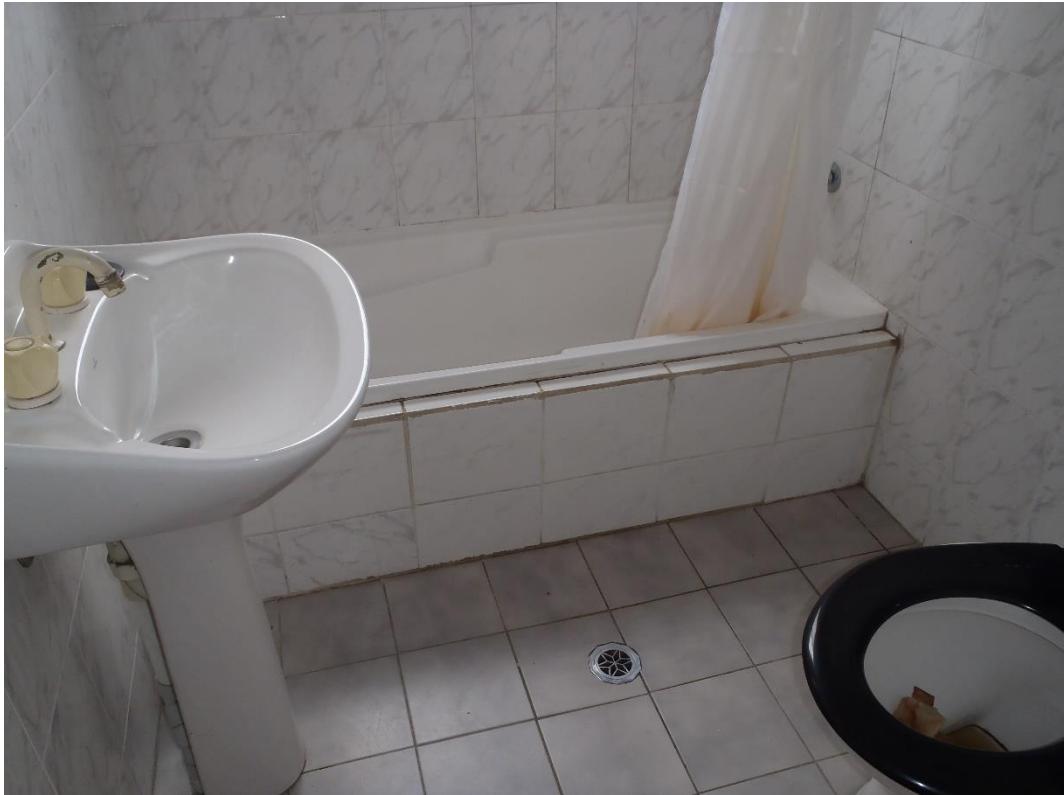
We found displaced grout and mould growth to the tiles on the bath plinth. **[Photograph 39]**

Photograph 39 shows displaced grout and mould growth to the tiles on the bath plinth wall in the Bathroom.

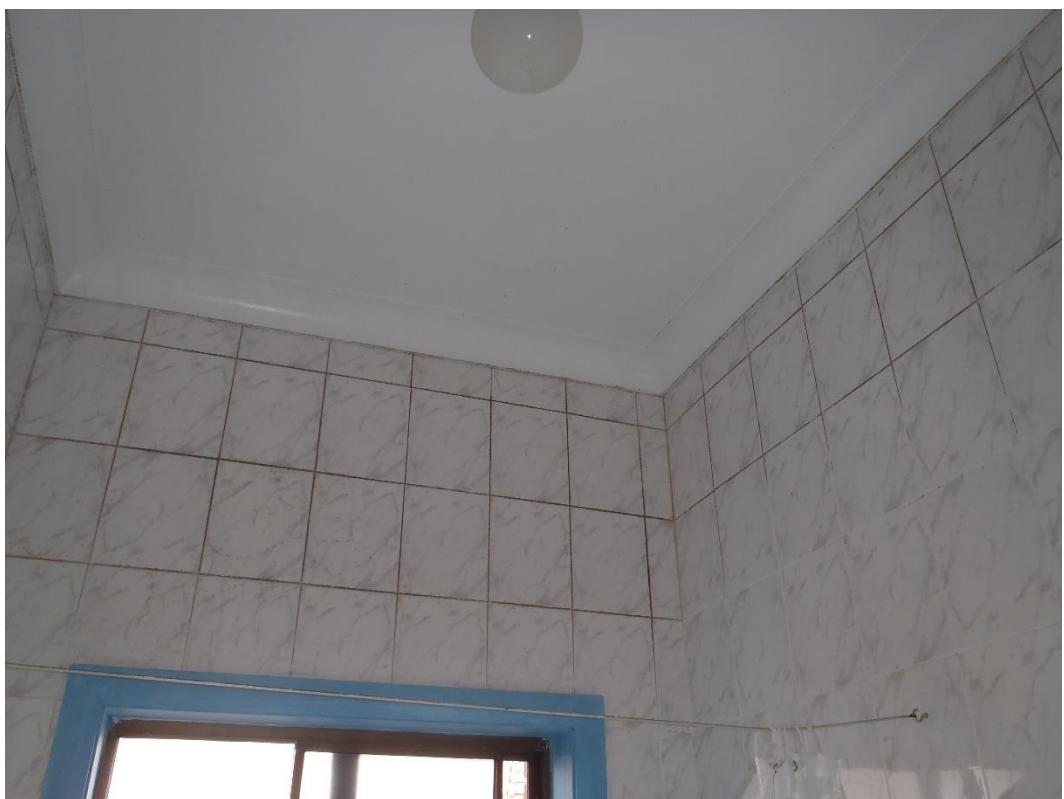
We found general staining / mould growth to the grout of the ceramic wall tiles. **[Photograph 40]**

Photograph 40 shows general staining / mould growth to the grout of the ceramic wall tiles in the Bathroom.

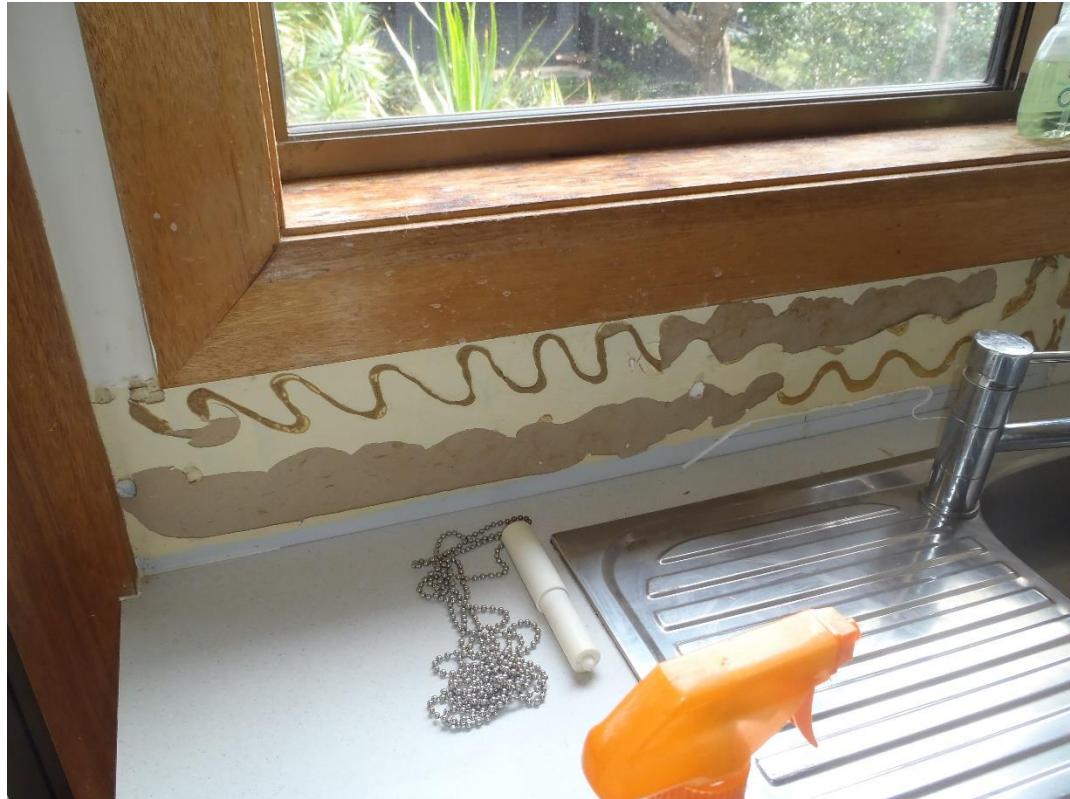
We noted that the splashback tiles to the sink are displaced. **[Photograph 42]**

Photograph 42 shows the splashback tiles to the sink are displaced in the Kitchenette.
