Dilapidation Assessment Report

Prepared for: Cape Cod Australia Pty. Limited

Job address: No. 258 Willoughby Road, Naremburn.

Date of assessment: 17th February 2017

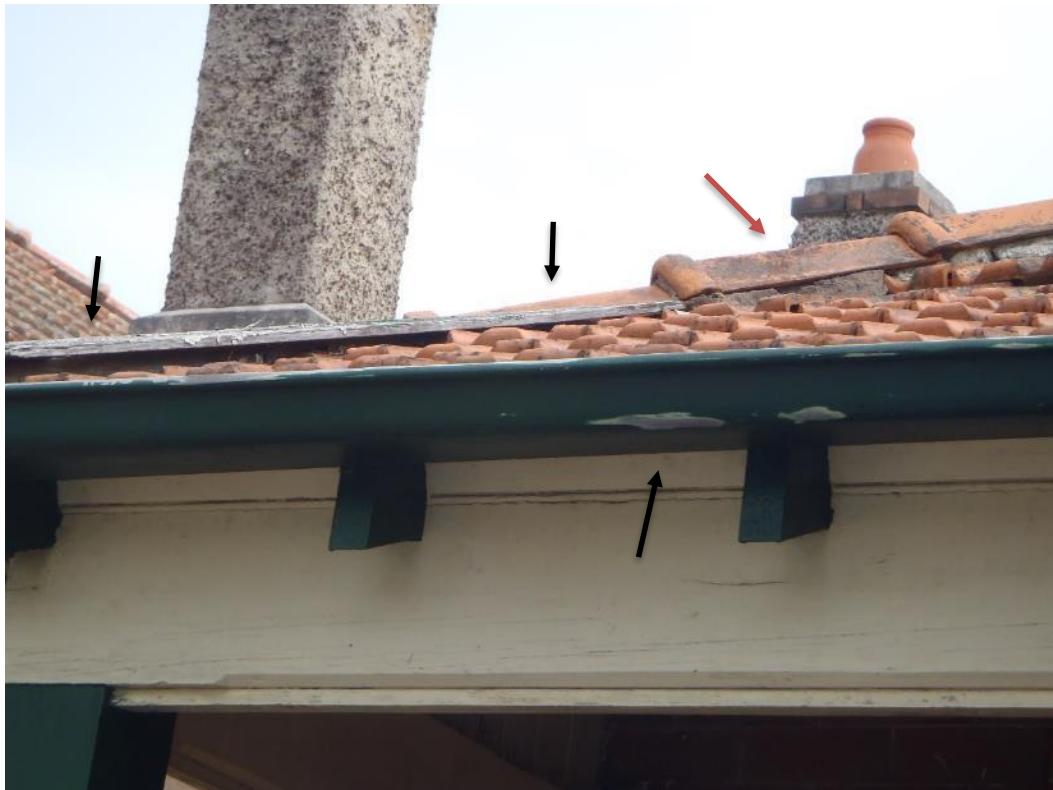
We noted re-pointing to the hip tiles over the front south-east corner of the residence.

We noted deterioration and flaking paint of the timber barge board and gutter system over the front verandah. **[Photographs 1 & 2]**

Photograph 1 shows re-pointing to the hip tiles and deterioration of the timber barge board and gutter system over the front verandah.

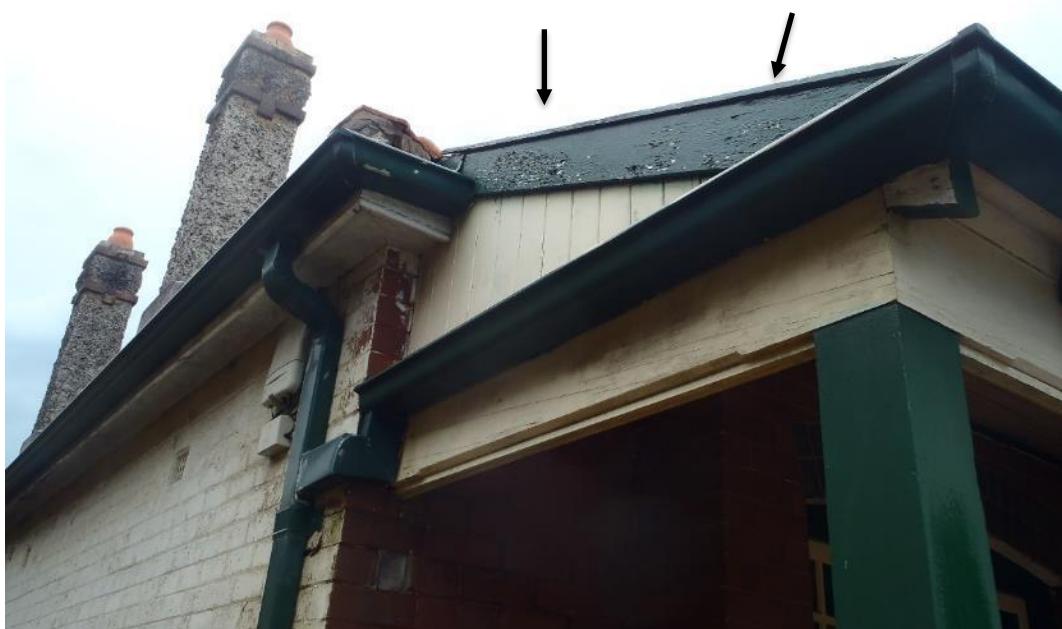
Photograph 2 shows deterioration and flaking paint of the timber barge board over the front verandah.

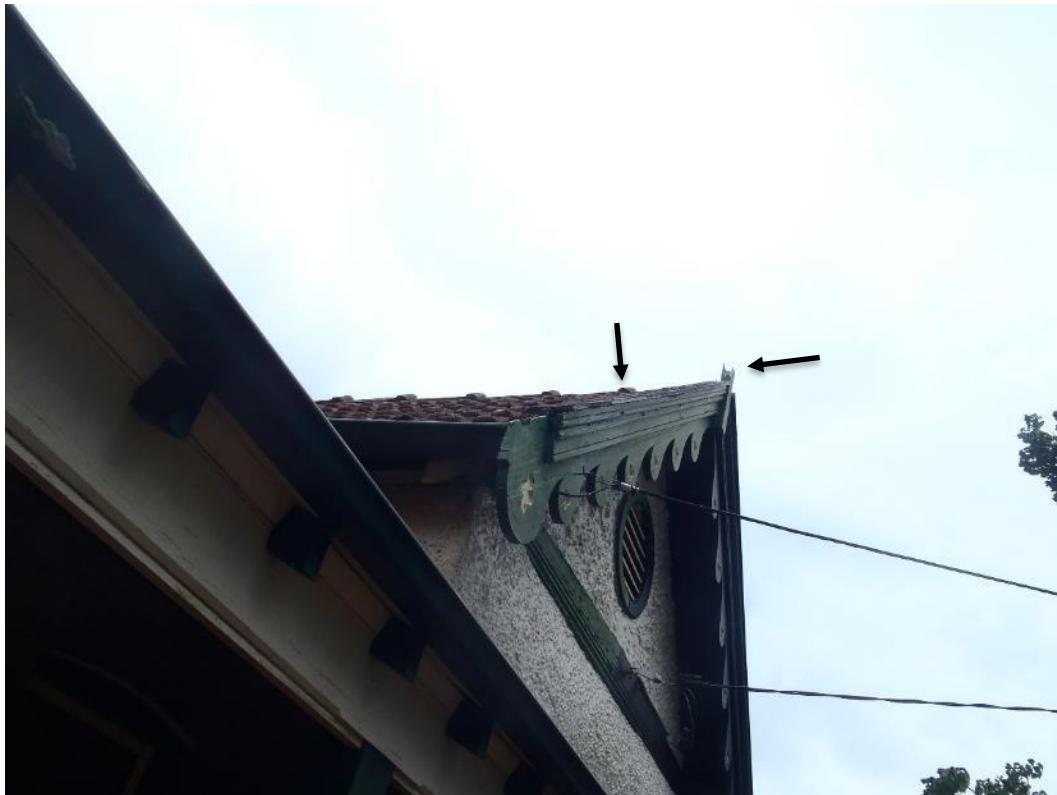
We noted a broken finial post and deterioration of the decorative barge board to the front common gable. **[Photograph 3]**

Photograph 3 shows broken finial post and deterioration of the decorative barge board to the front common gable.

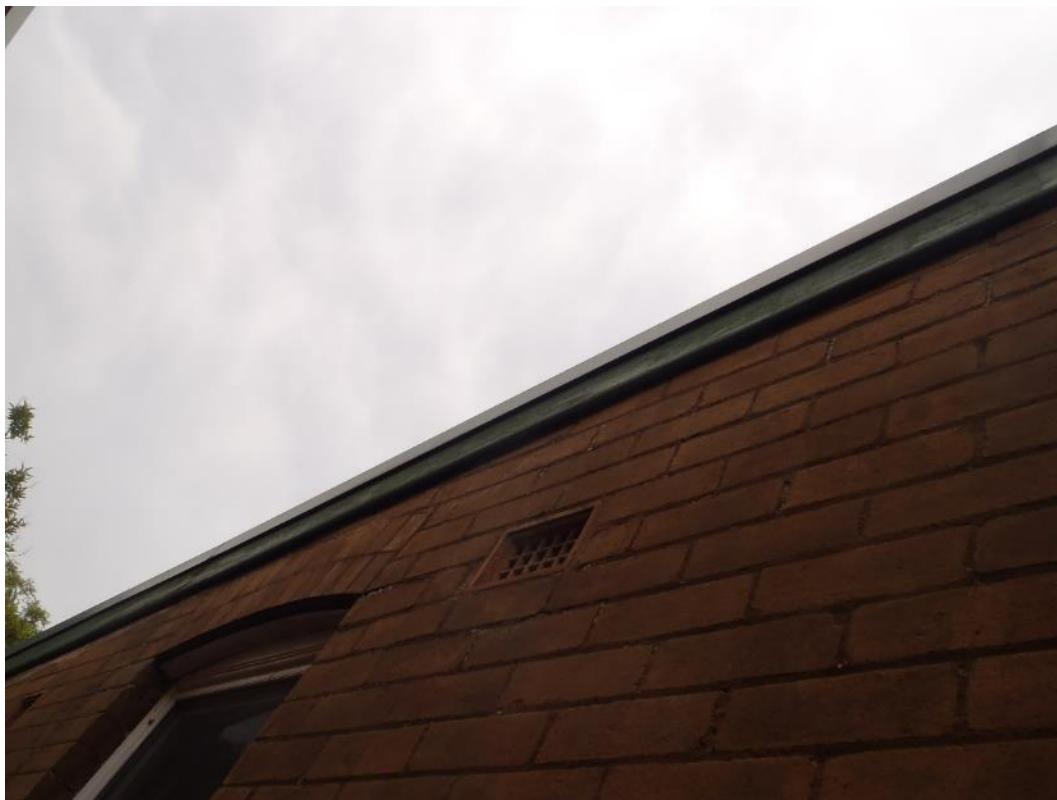
We noted deterioration and flaking paint to the timber barge board along the southern elevation wall. **[Photograph 4]**

Photograph 4 shows deterioration and flaking paint to the timber barge board along the southern elevation wall.

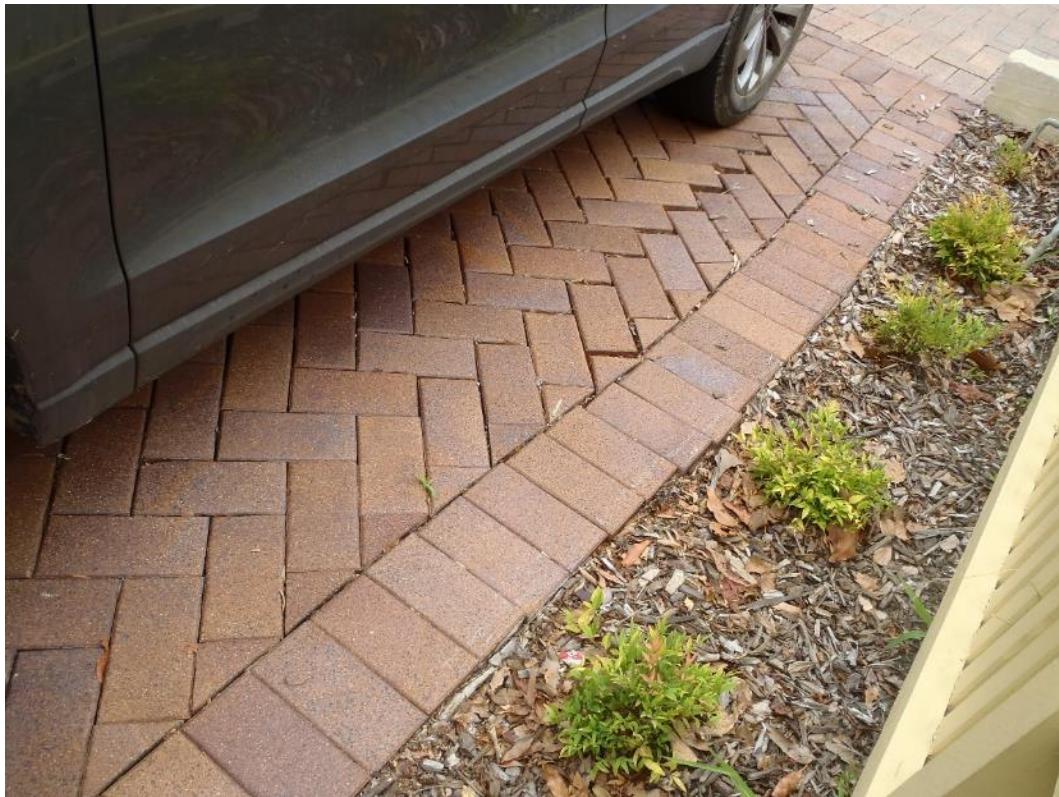
We noted displacement to the paved surface of the driveway on the southern side. **[Photograph 5]**

Photograph 5 shows displacement to the paved surface of the driveway on the southern side.

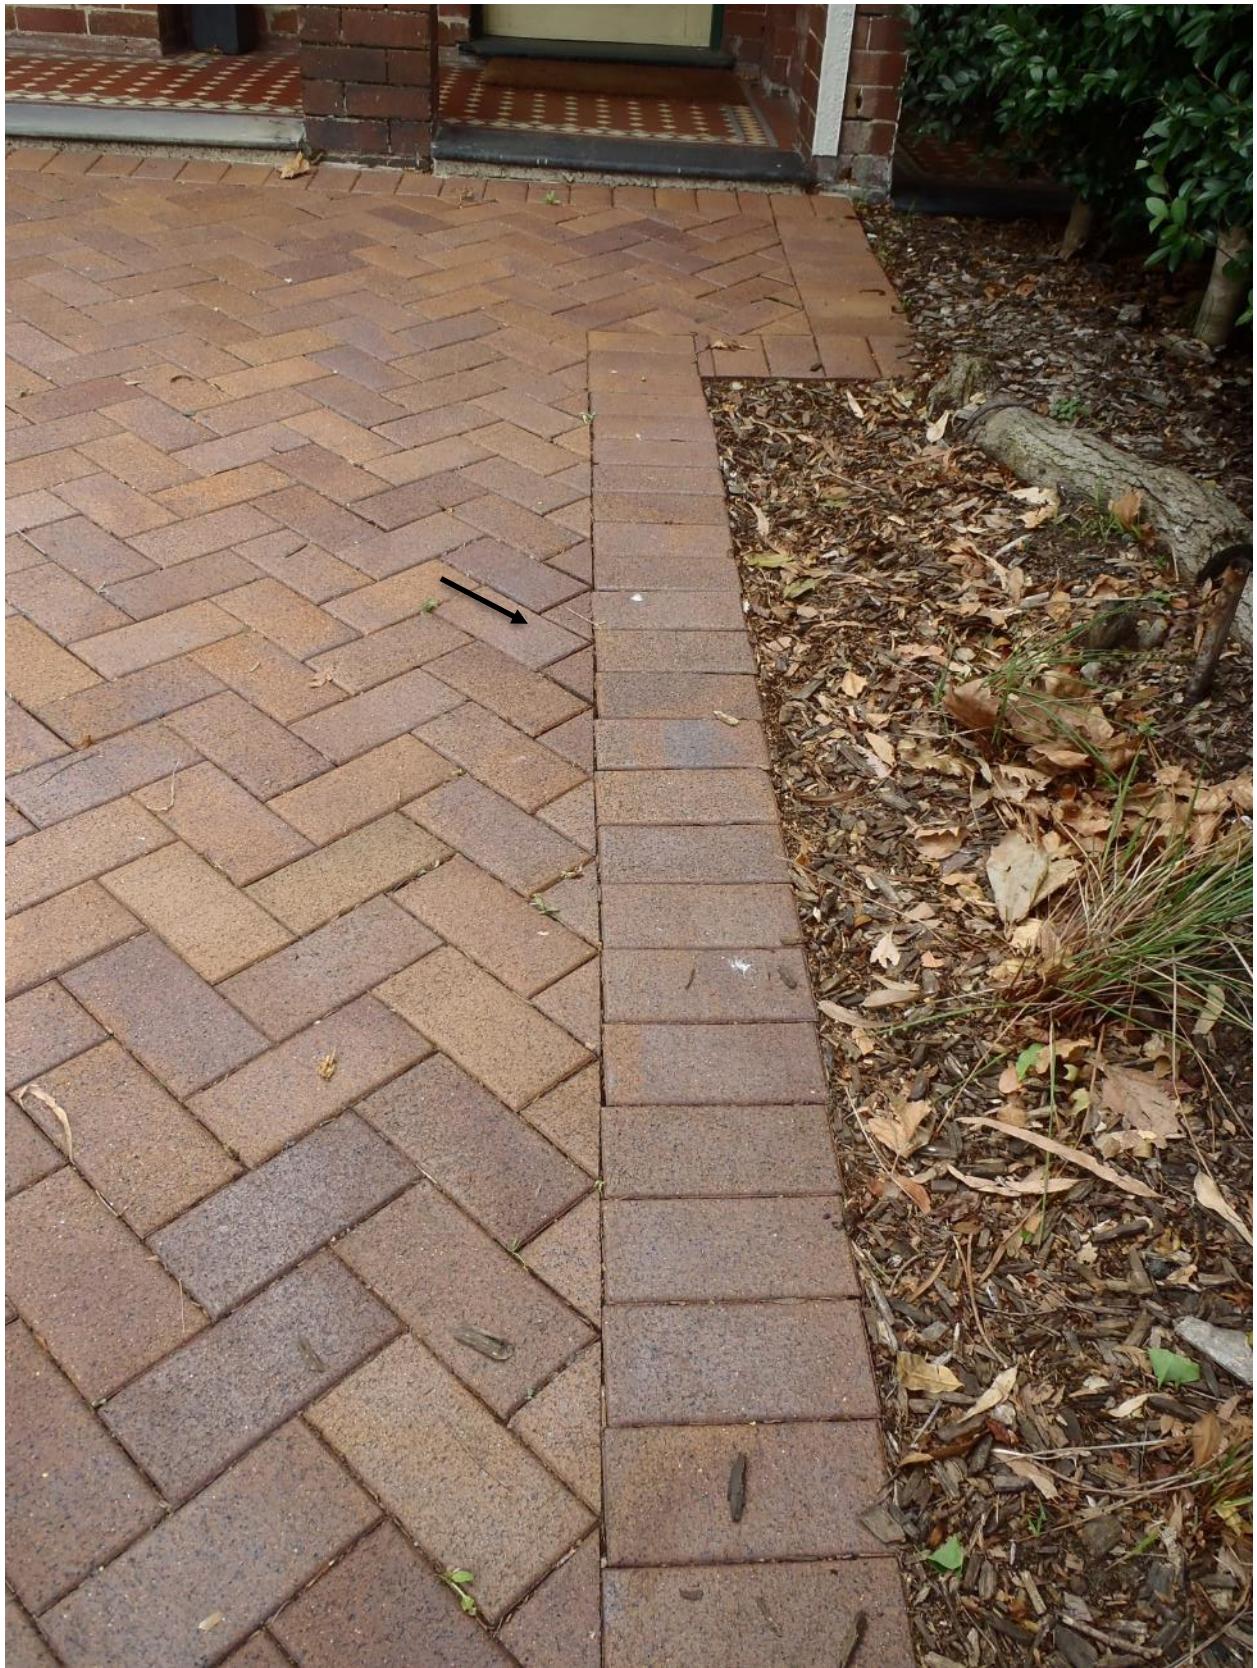
We noted displacement to the paved surface of the driveway on the northern side and some cracking to the pavers. **[Photographs 7 & 8]**

Photograph 7 shows displacement to the paved surface of the driveway on the northern side.

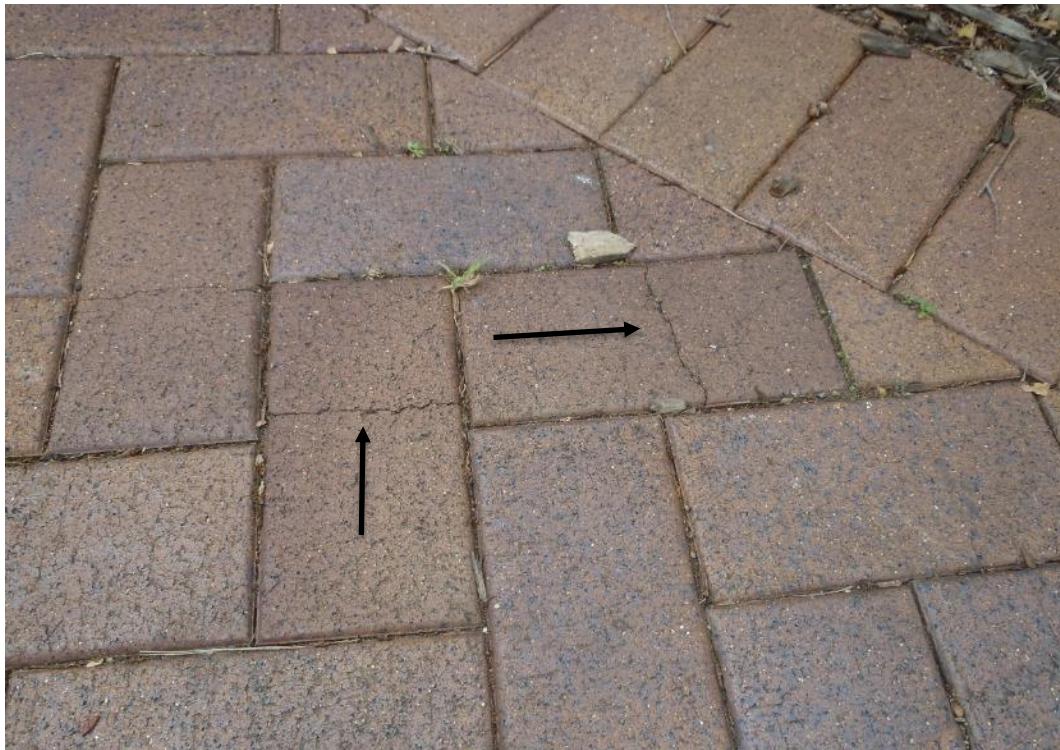
Photograph 8 shows some cracking to the driveway pavers.

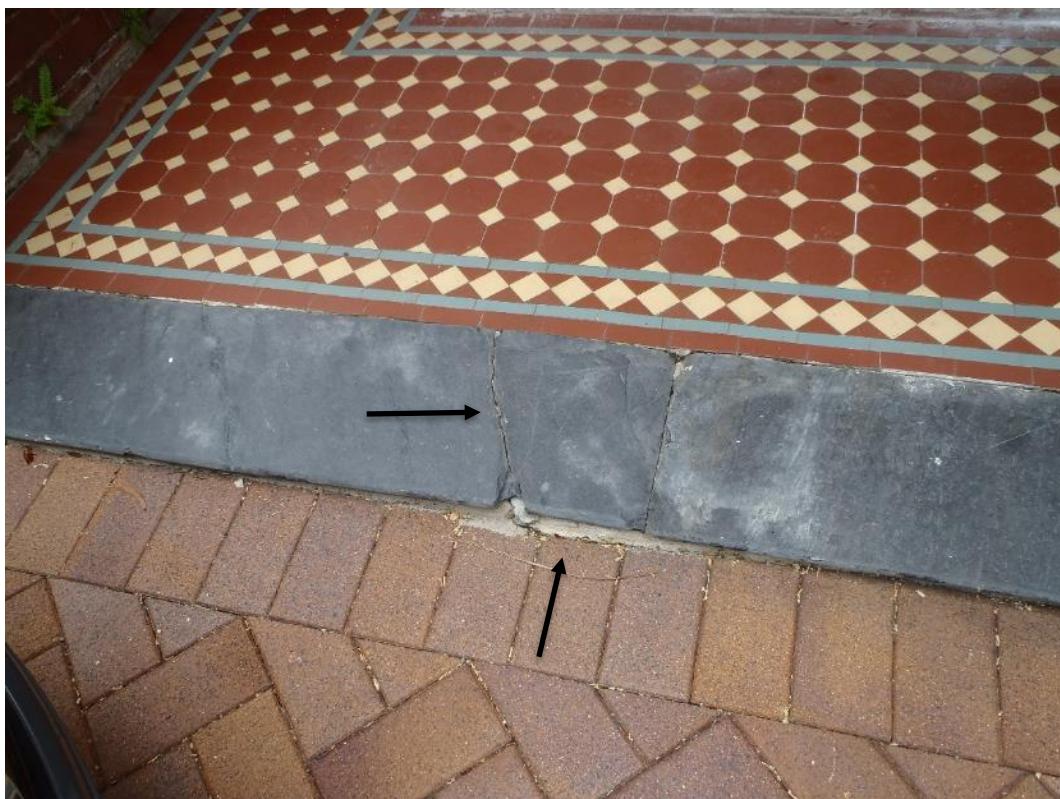
We noted cracking [1.0mm – 3.0mm] and damage to the stone edging step on the front verandah. We further noted evidence of previous repairs. **[Photographs 9 & 10]**

Photograph 9 shows cracking and damage to the stone edging step on the front verandah.
Note: evidence of previous repairs.

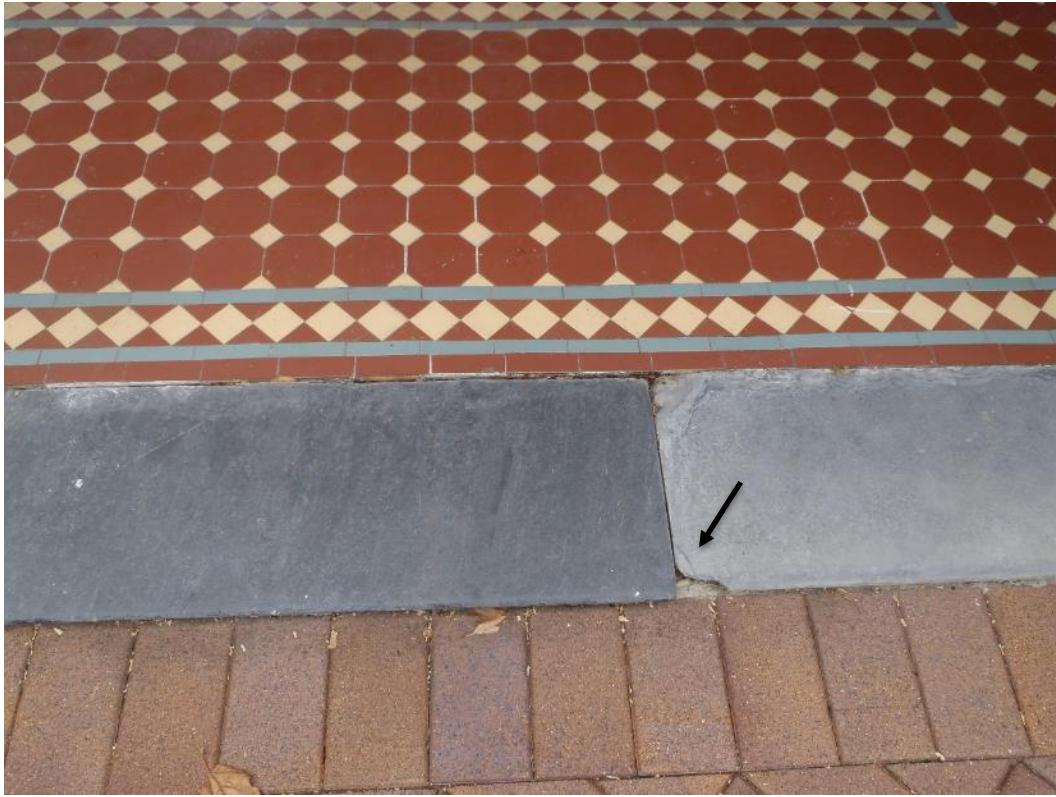
Photograph 10 shows further damage to the stone edging step on the front verandah.

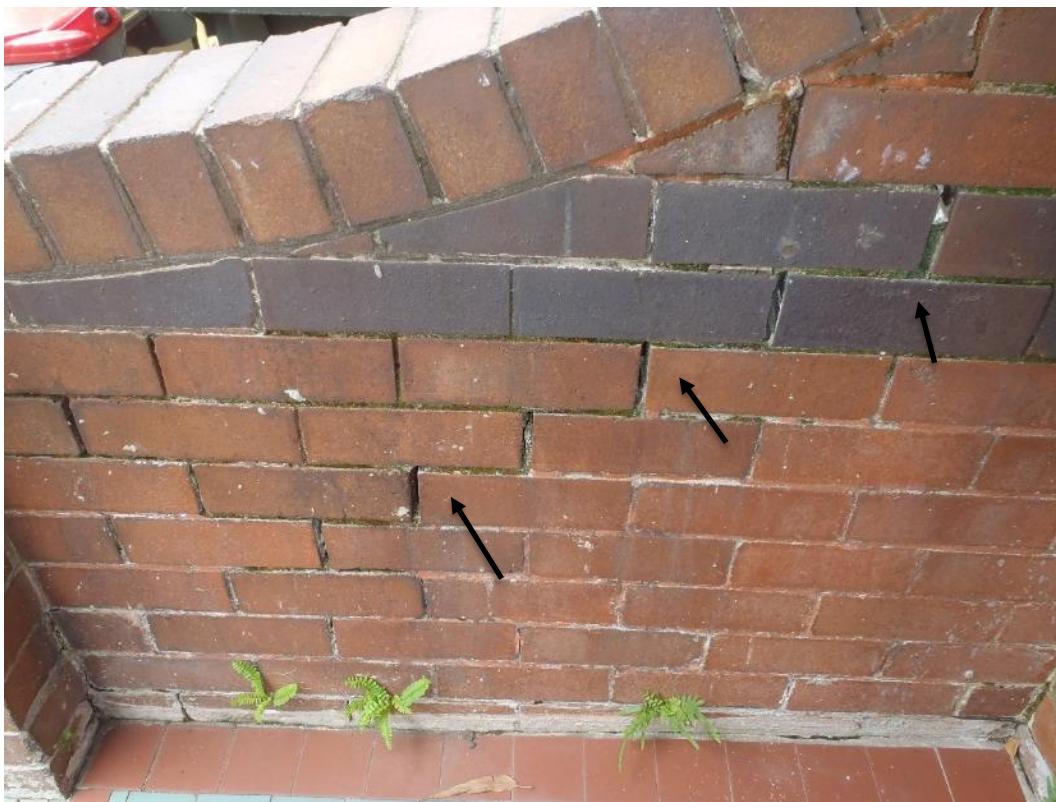
We noted step cracking and displaced mortar (fretting) to the verandah privacy wall on the southern elevation. We further noted vegetation growth through the wall. **[Photograph 11]**

Photograph 11 shows step cracking and displaced mortar (fretting) to the porch privacy wall on the southern elevation.

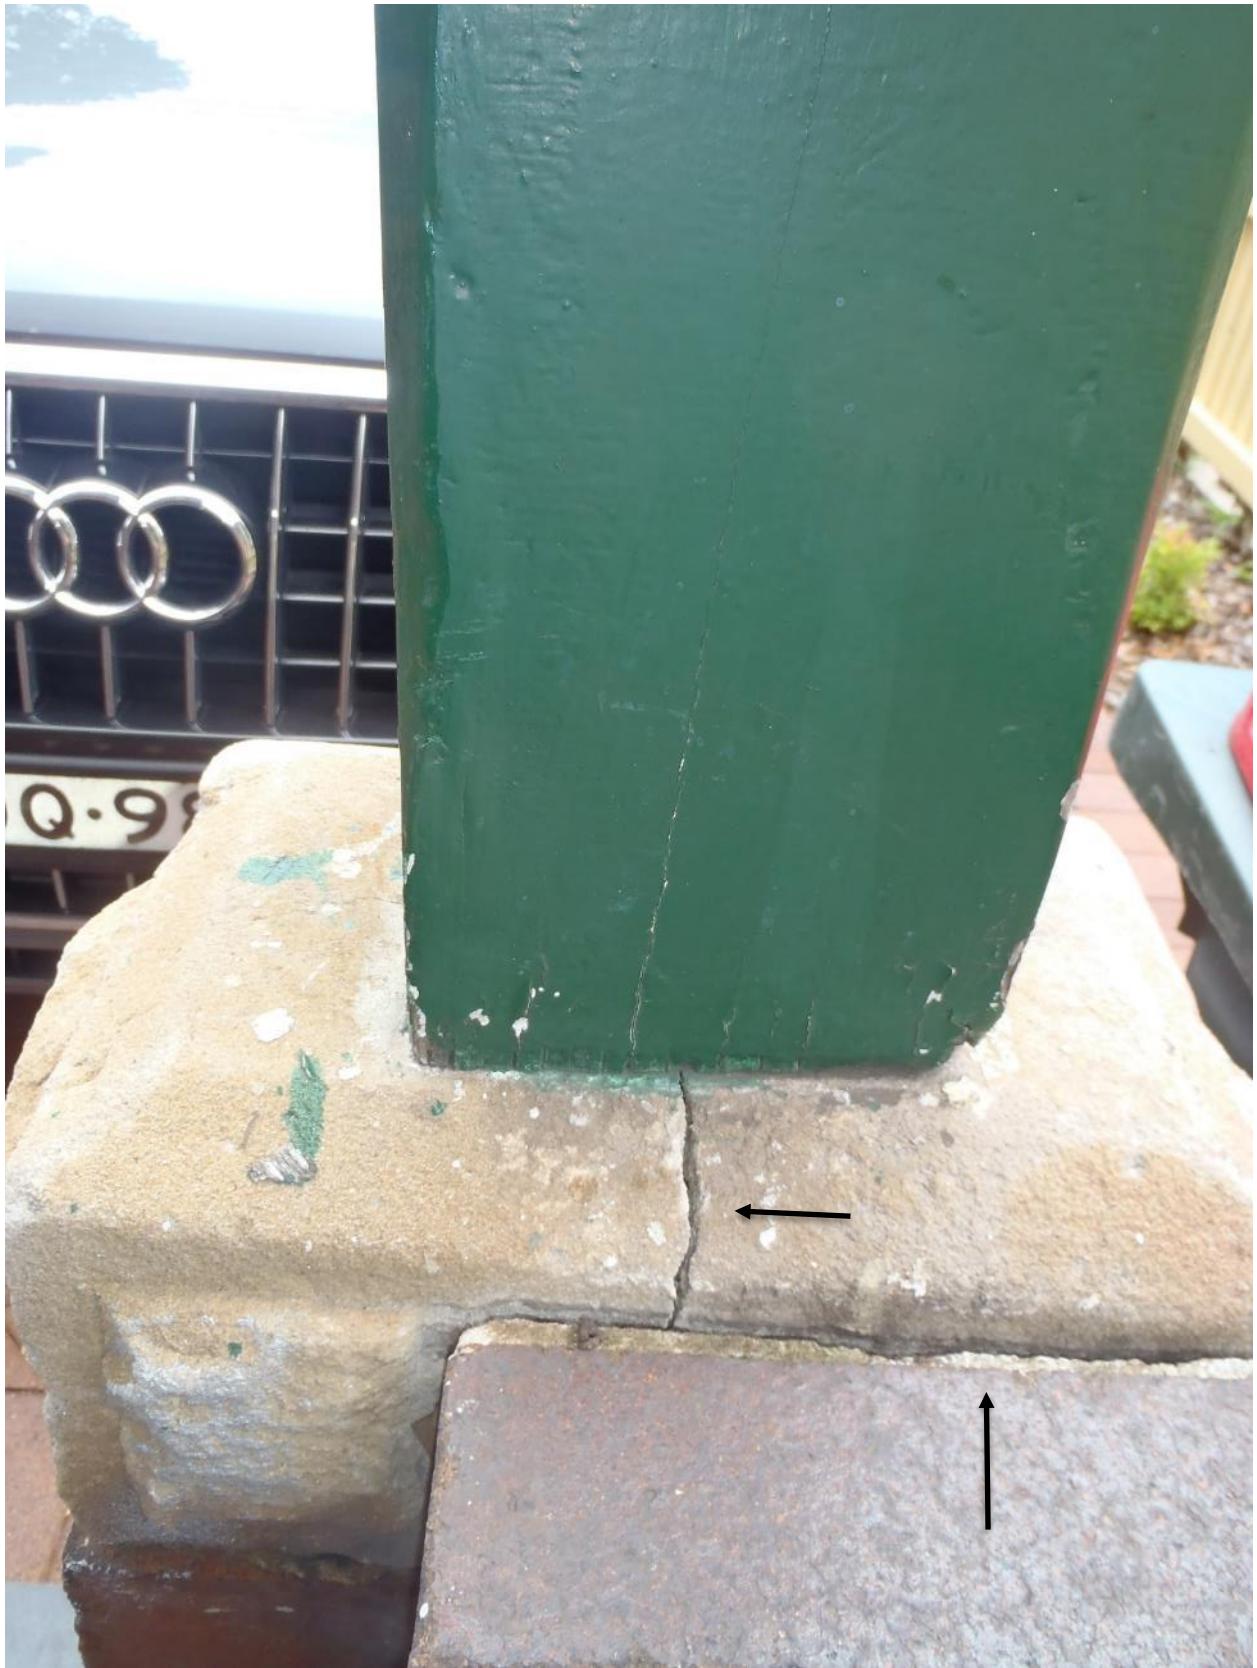
We noted cracking [1.0mm – 3.0mm] to the sandstone block verandah support base and displaced brickwork to the footings in the south-eastern corner of the front verandah. **[Photographs 12 & 13]**

Photograph 12 shows cracking to the sandstone block verandah support base.

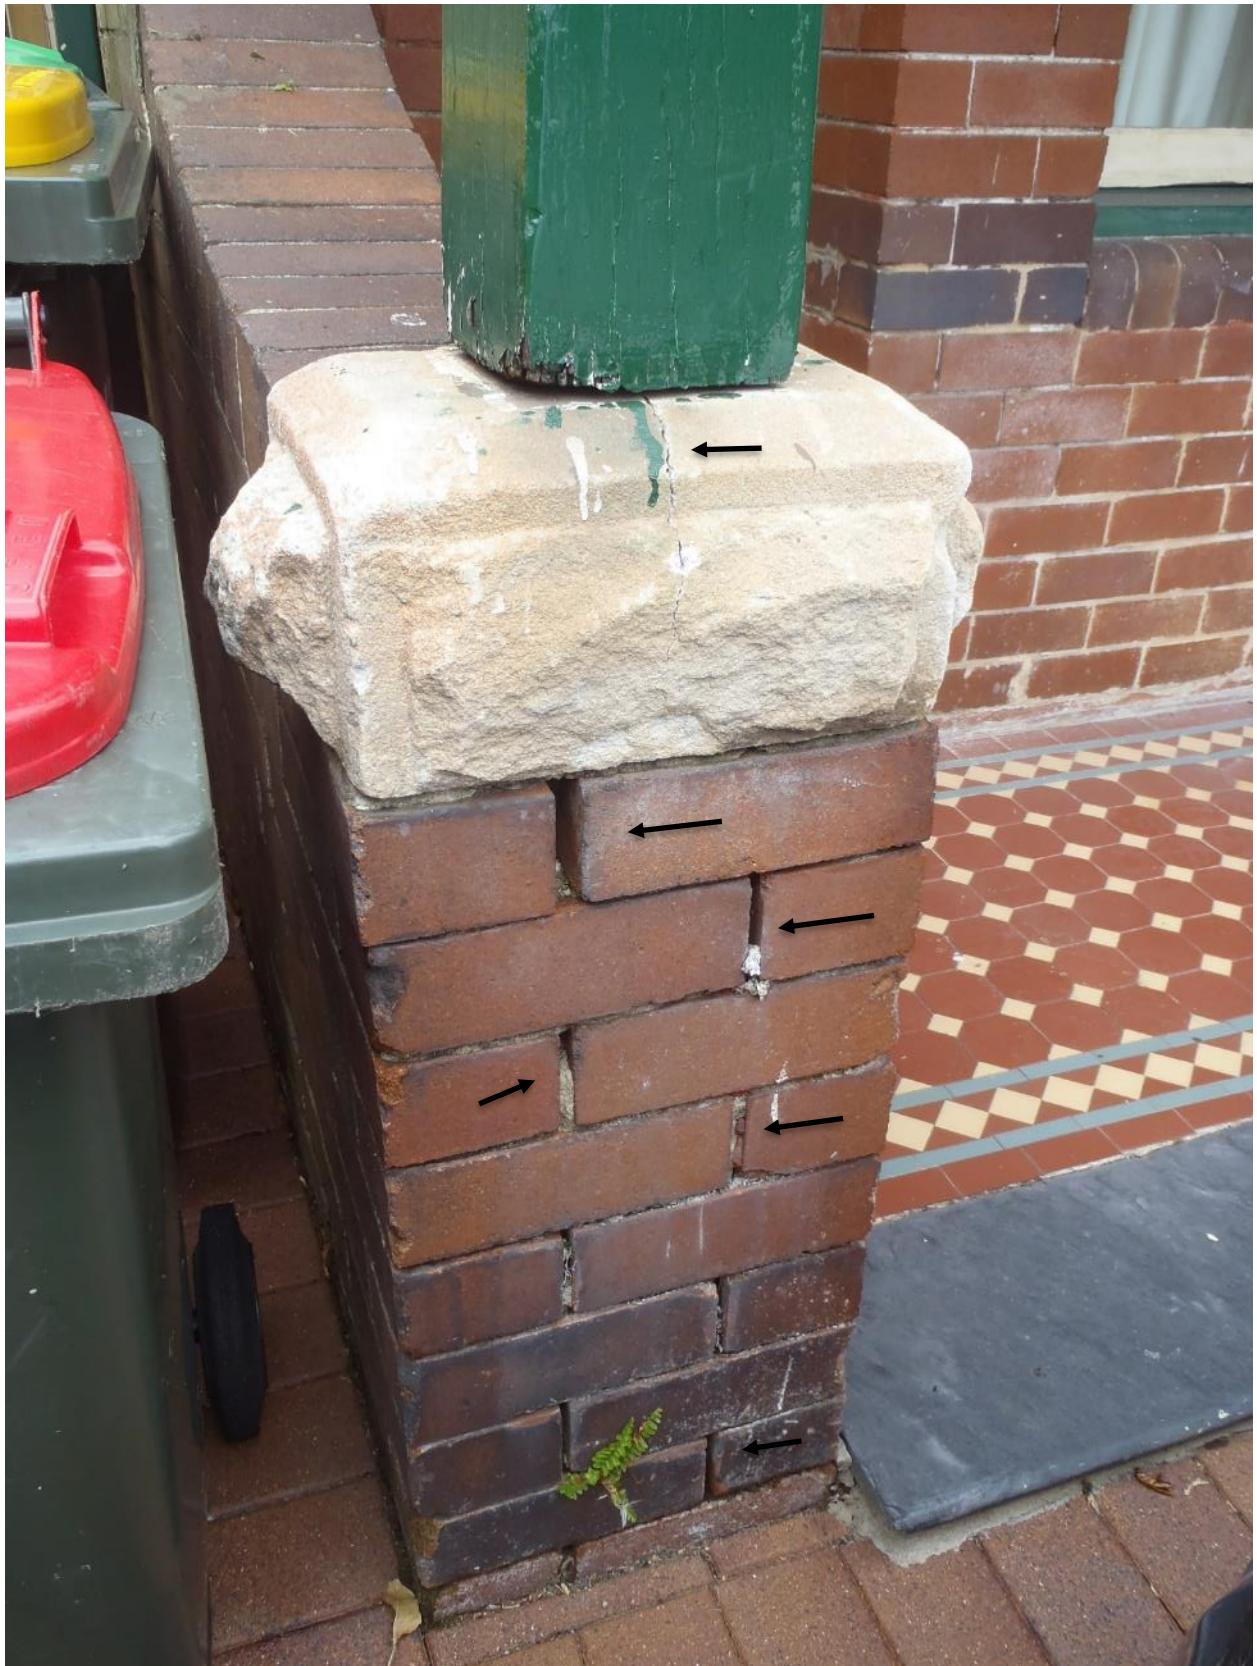
Photograph 13 shows displaced brickwork to the footings in the south-eastern corner of the front verandah.

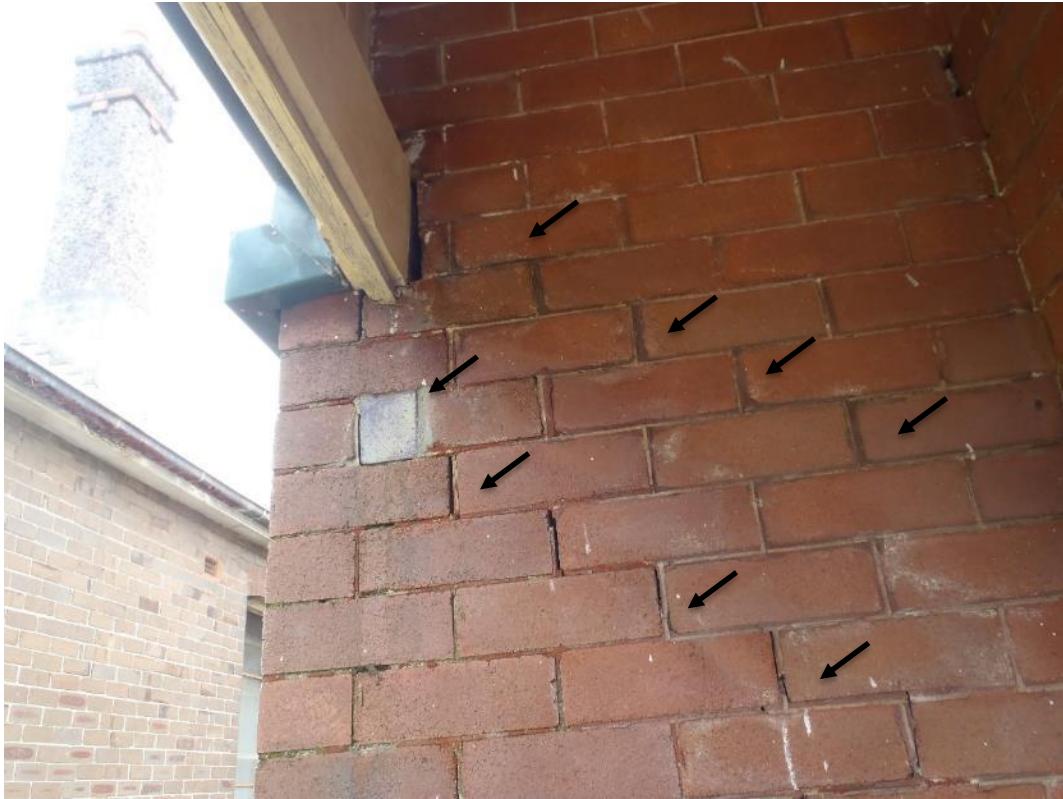
We noted step cracking [1.0mm – 3.0mm] and evidence of previous repairs to the verandah wall outside Bedroom 1. **[Photograph 14]**

Photograph 14 shows step cracking and evidence of previous repairs to the verandah wall outside Bedroom 1.

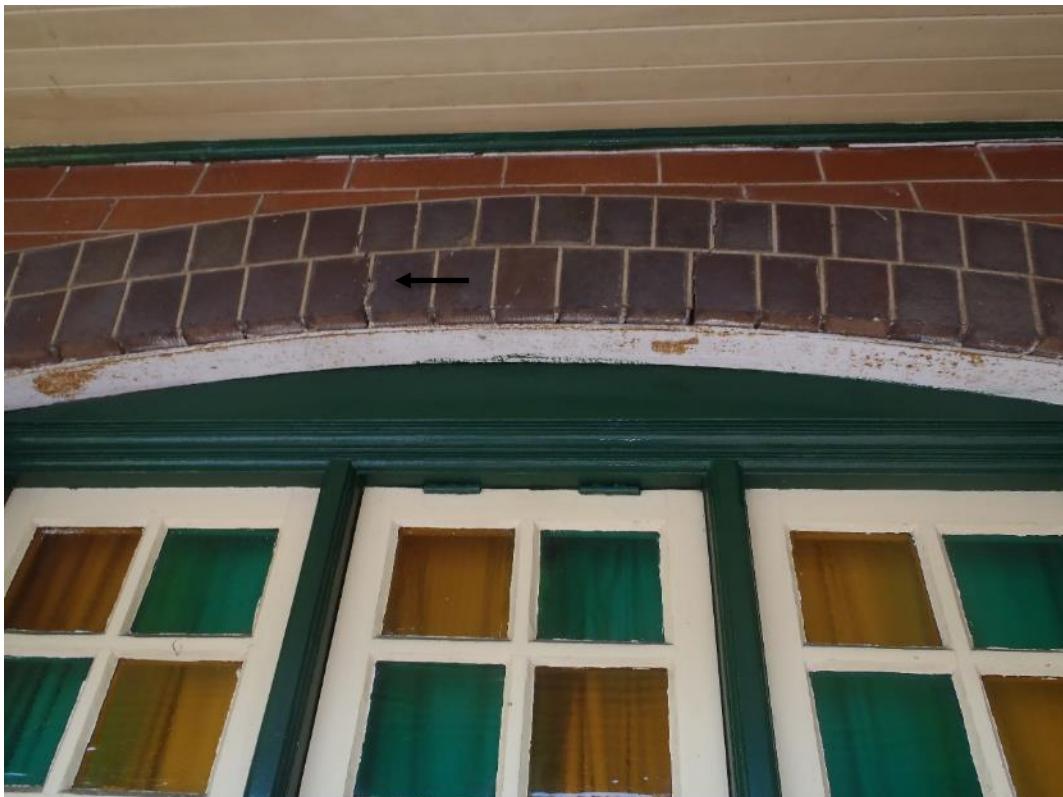
We noted rusting to the metal lintel above the Bedroom 1 window arch. We further noted cracking to the clay masonry brick arch above. **[Photograph 15]**

Photograph 15 shows rusting to the metal lintel above the Bedroom 1 window arch and cracking to the clay masonry brick arch above.

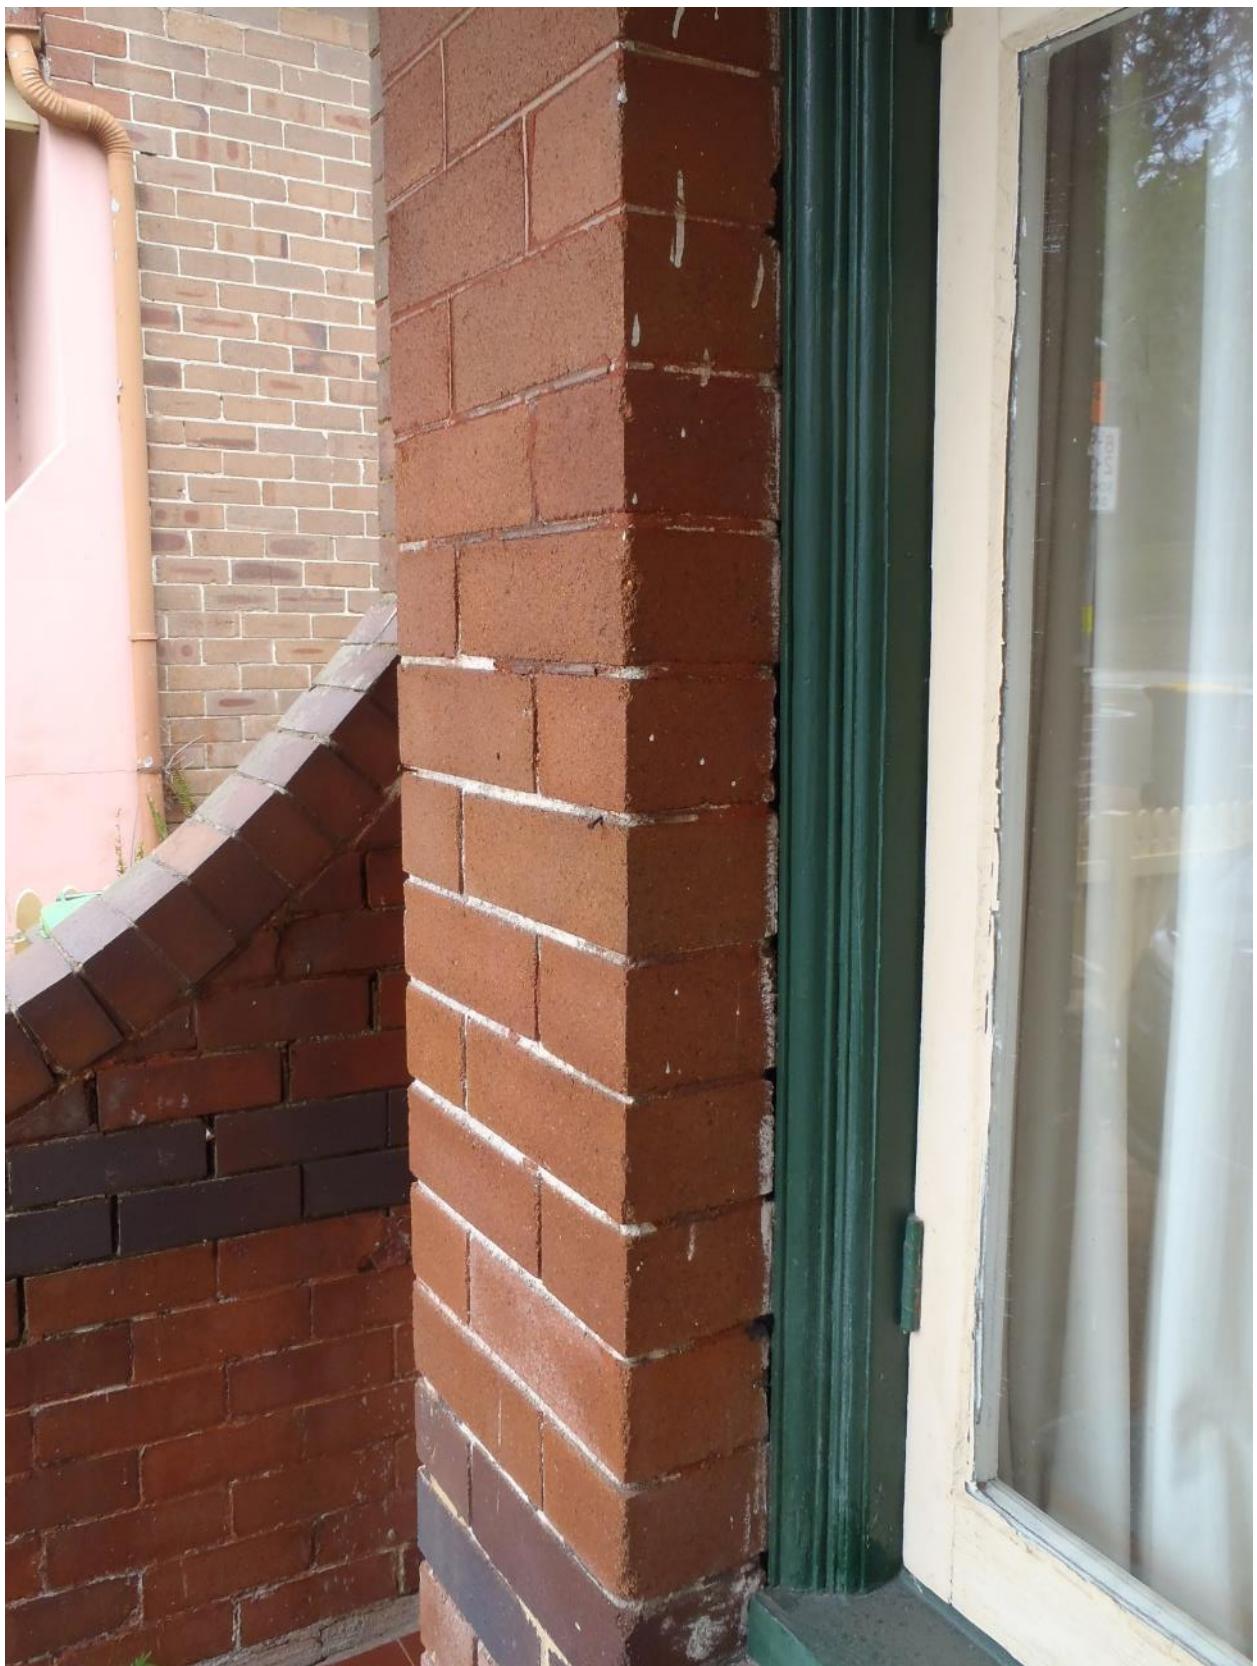
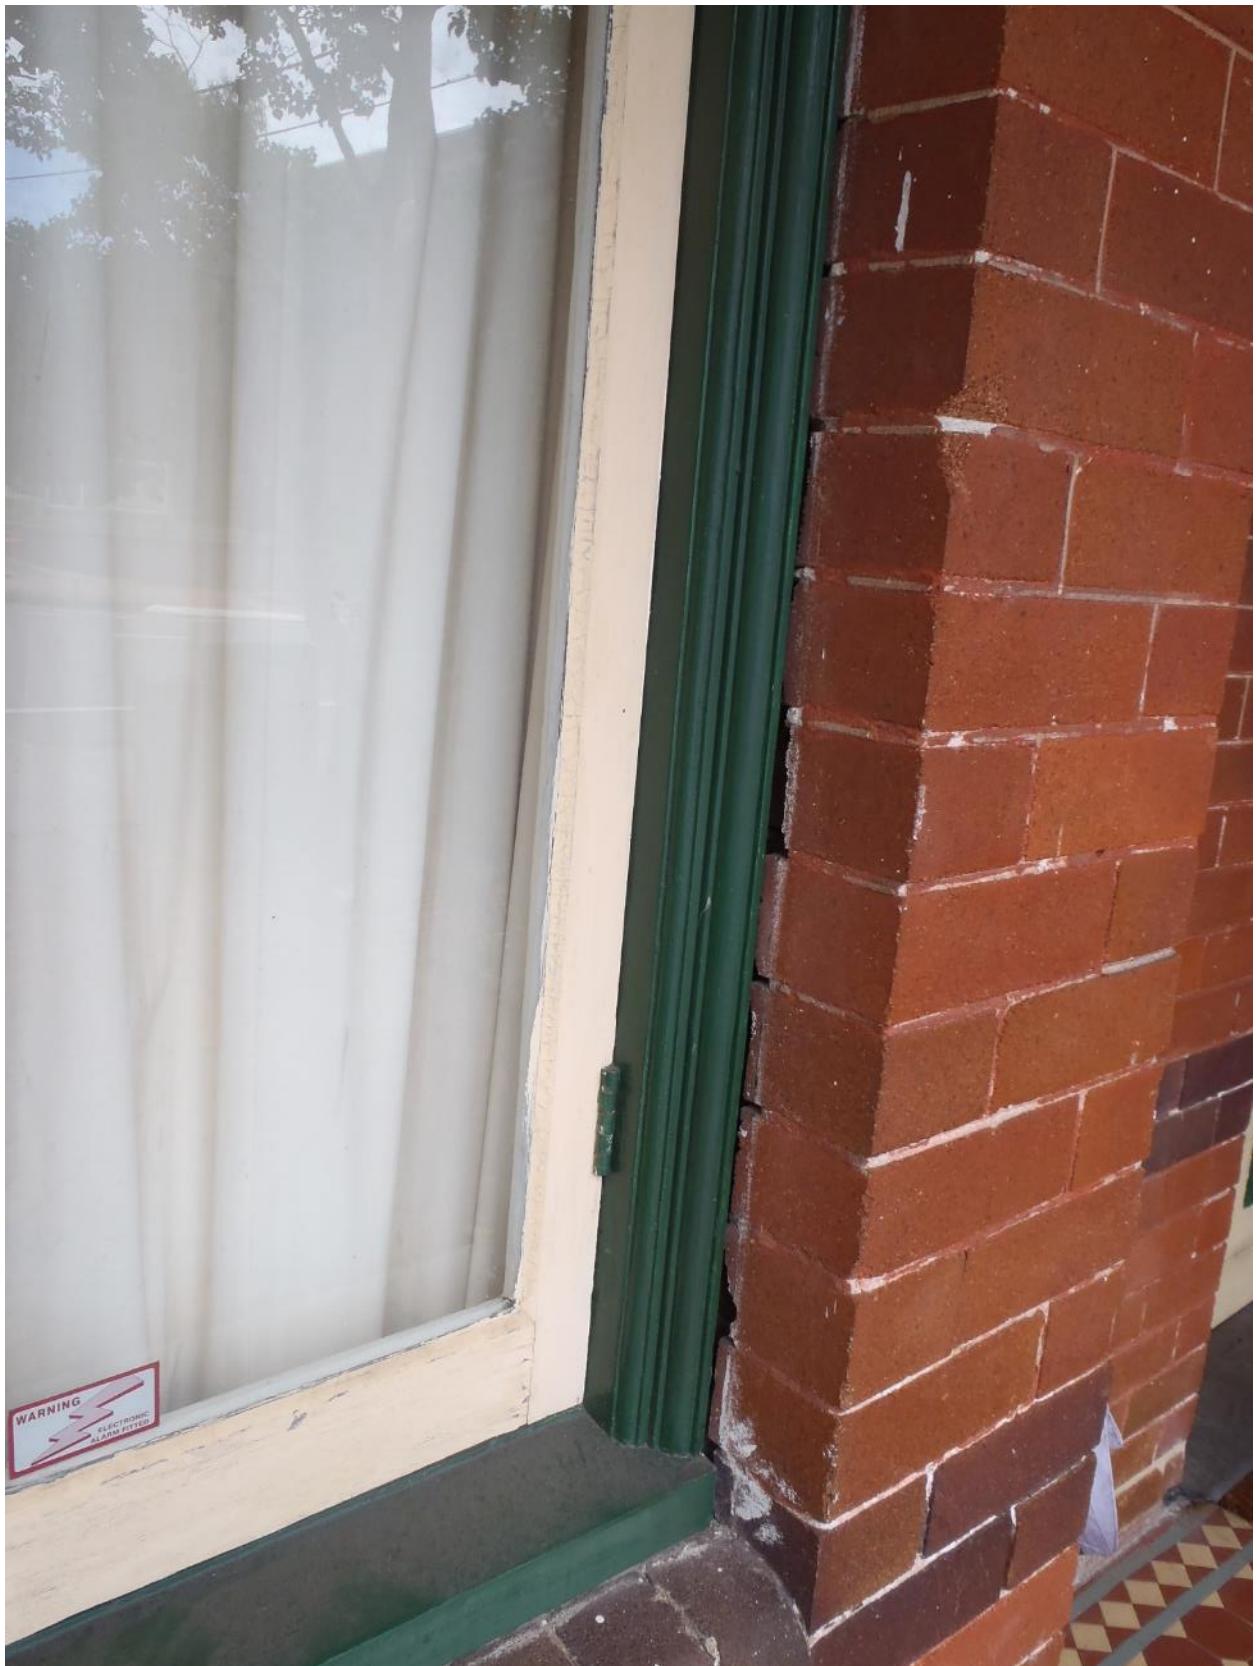
We noted gaps between the window reveal and the timber window frame outside Bedroom 1. **[Photographs 16 & 17]**

Photograph 16 shows gaps between the window reveal and the timber window frame outside Bedroom 1.

Photograph 17 shows gaps between the window reveal and the timber window frame outside Bedroom 1.

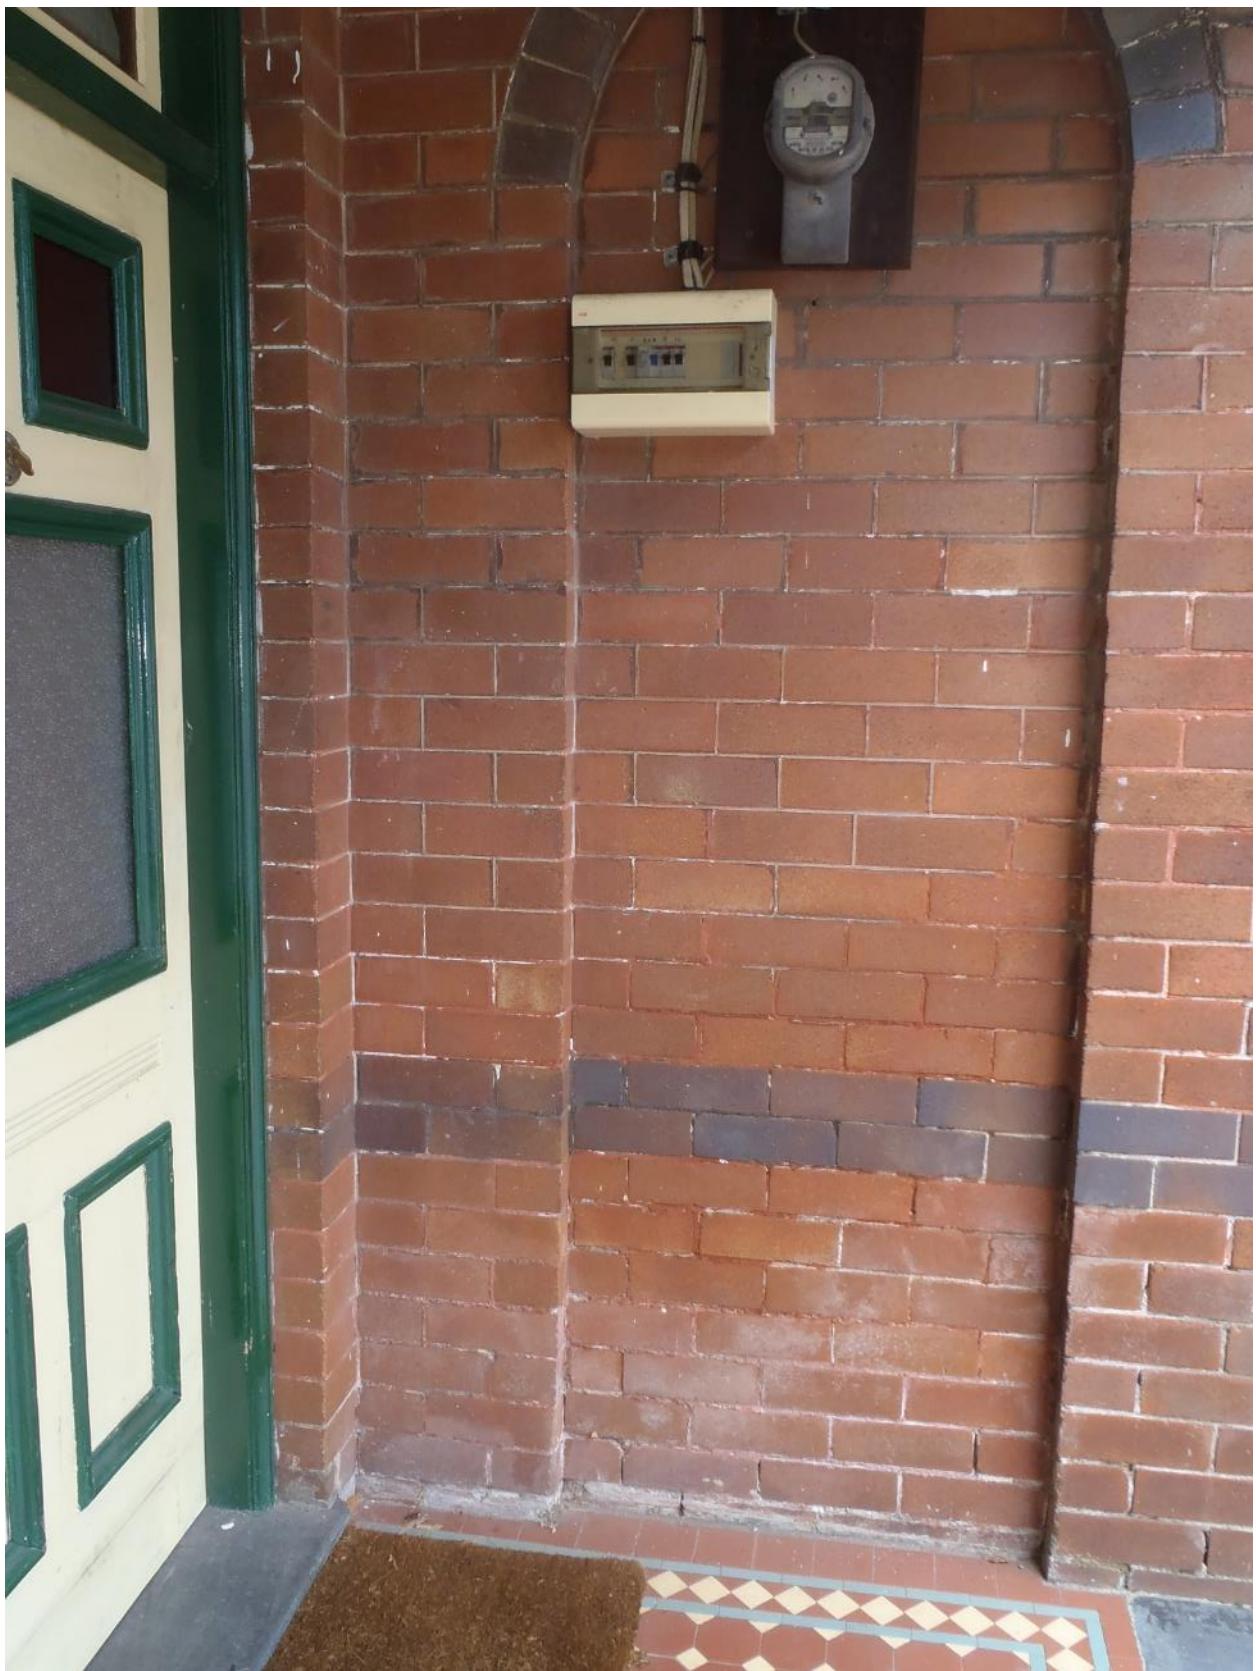
We noted evidence of previous repairs to the *common* privacy wall with the adjoining property, No. 260 Willoughby Road of the front verandah. **[Photographs 18 & 19]**

Photograph 18 shows the general condition of the *common* privacy wall with the adjoining property, No. 260 Willoughby Road of the front verandah.
