Dilapidation Assessment Report

Prepared for: Cape Cod Australia Pty. Limited

Job address: No. 258 Willoughby Road, Naremburn.

Date of assessment: 17th February 2017

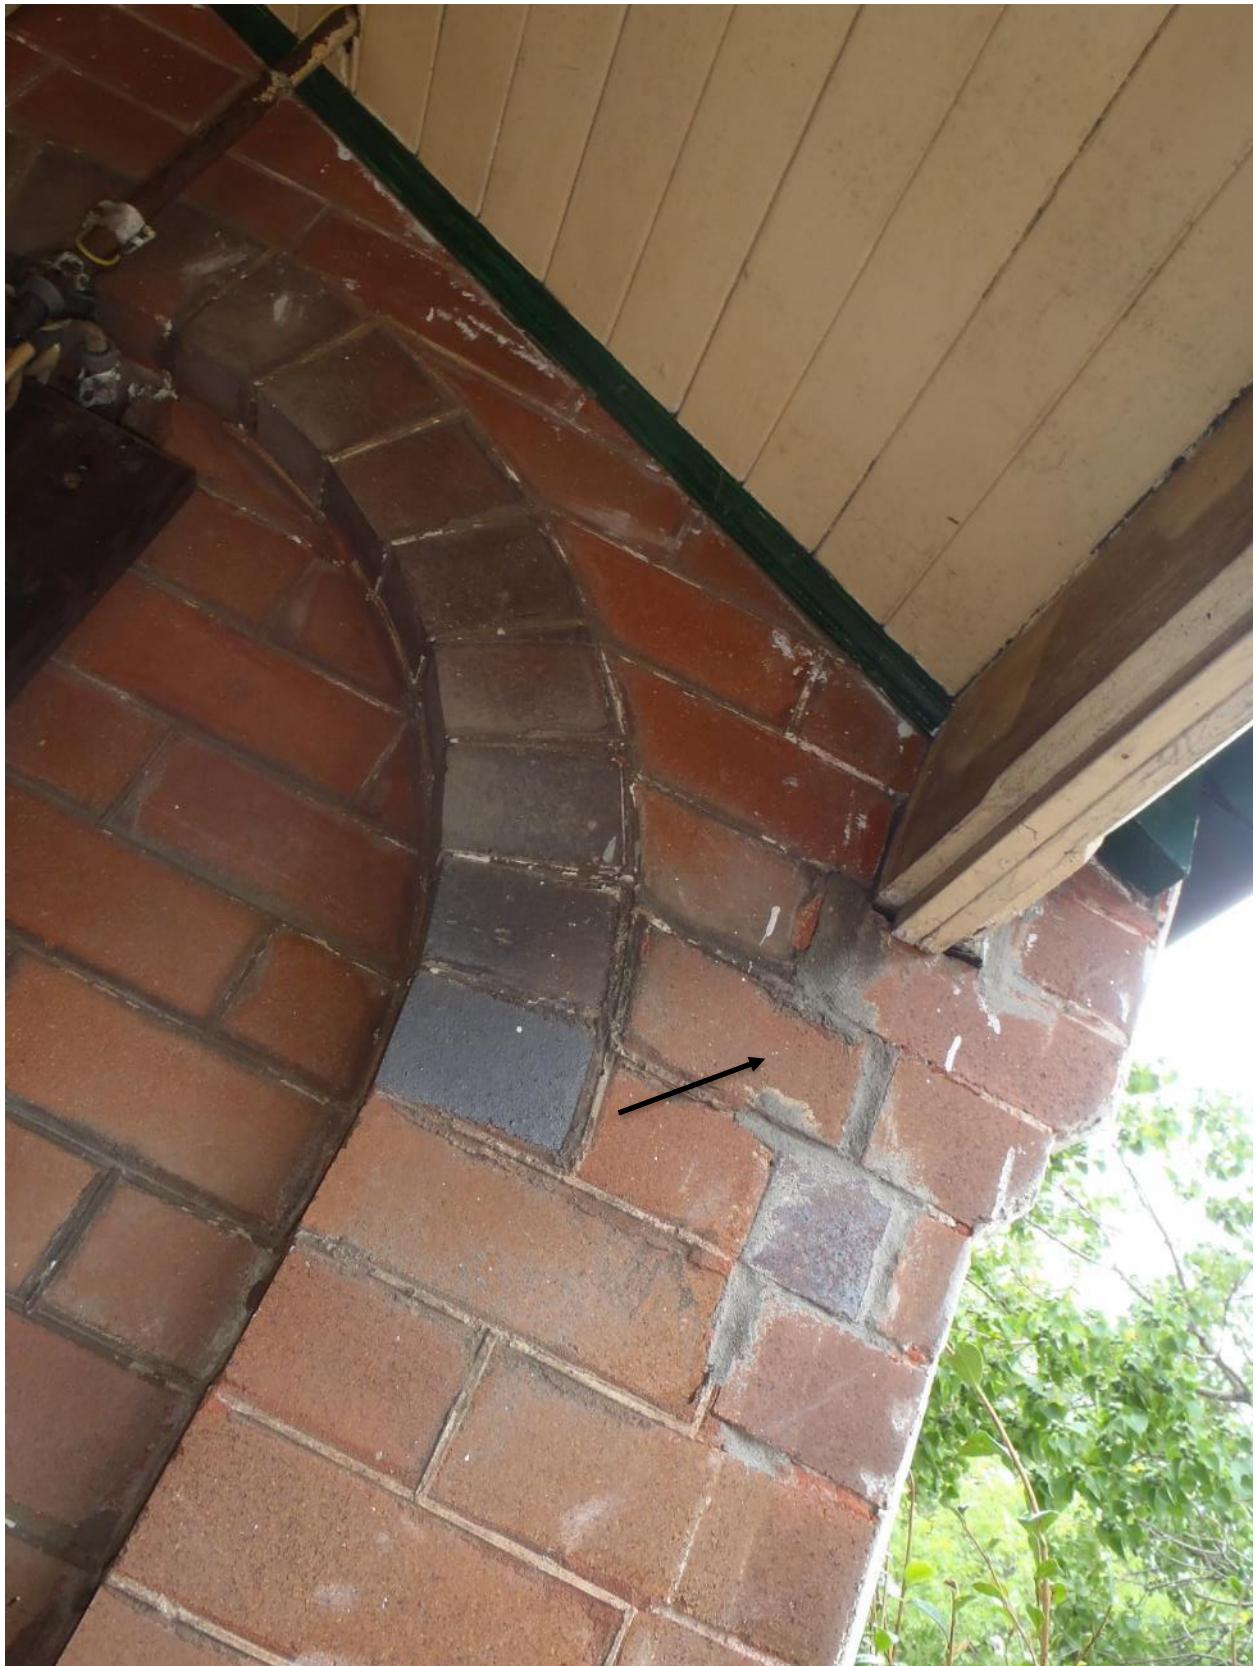
We noted evidence of previous repairs to the *common* privacy wall with the adjoining property, No. 260 Willoughby Road of the front verandah. **[Photographs 18 & 19]**

Photograph 19 shows evidence of previous repairs to the *common* privacy wall with the adjoining property, No. 260 Willoughby Road of the front verandah.

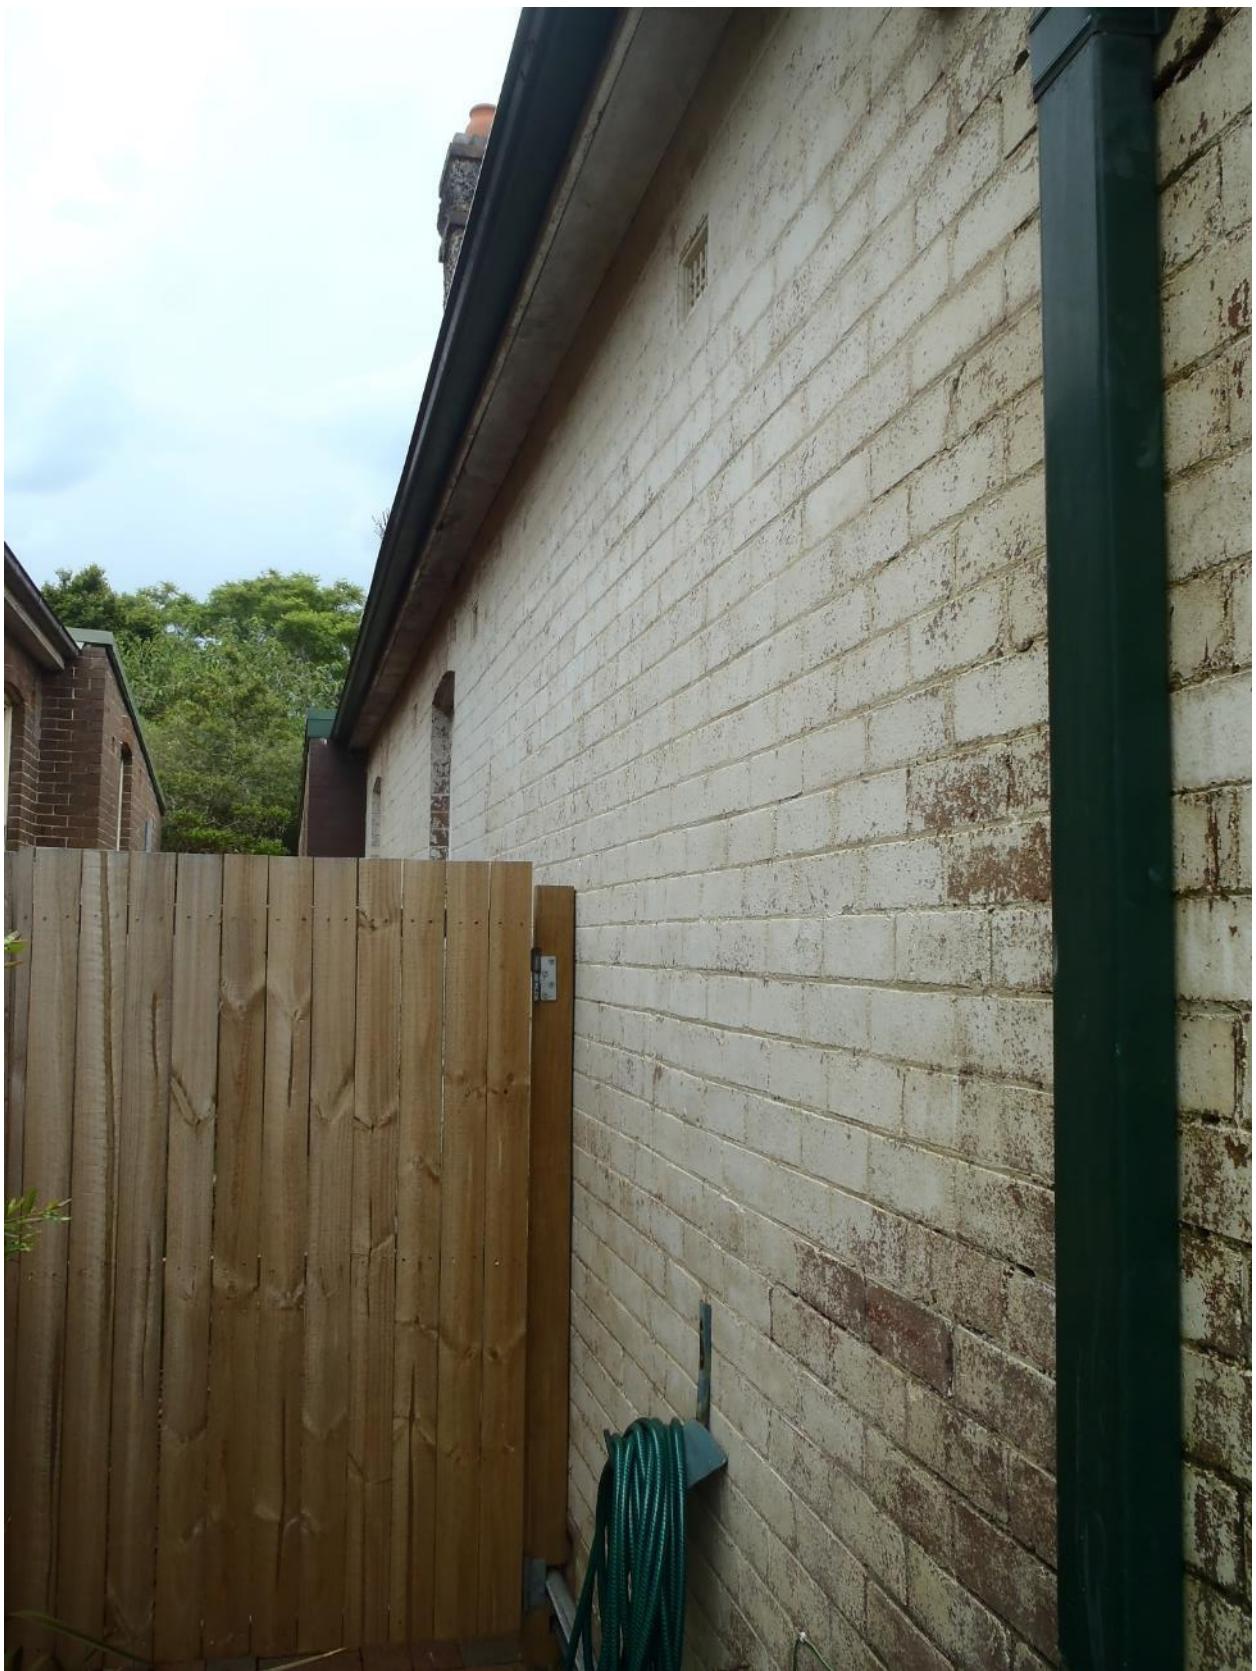
We noted deterioration of the surface coating on the brickwork. **[Photographs 20 & 21]**

Photograph 20 shows deterioration of the surface coating on the southern elevation brickwork.

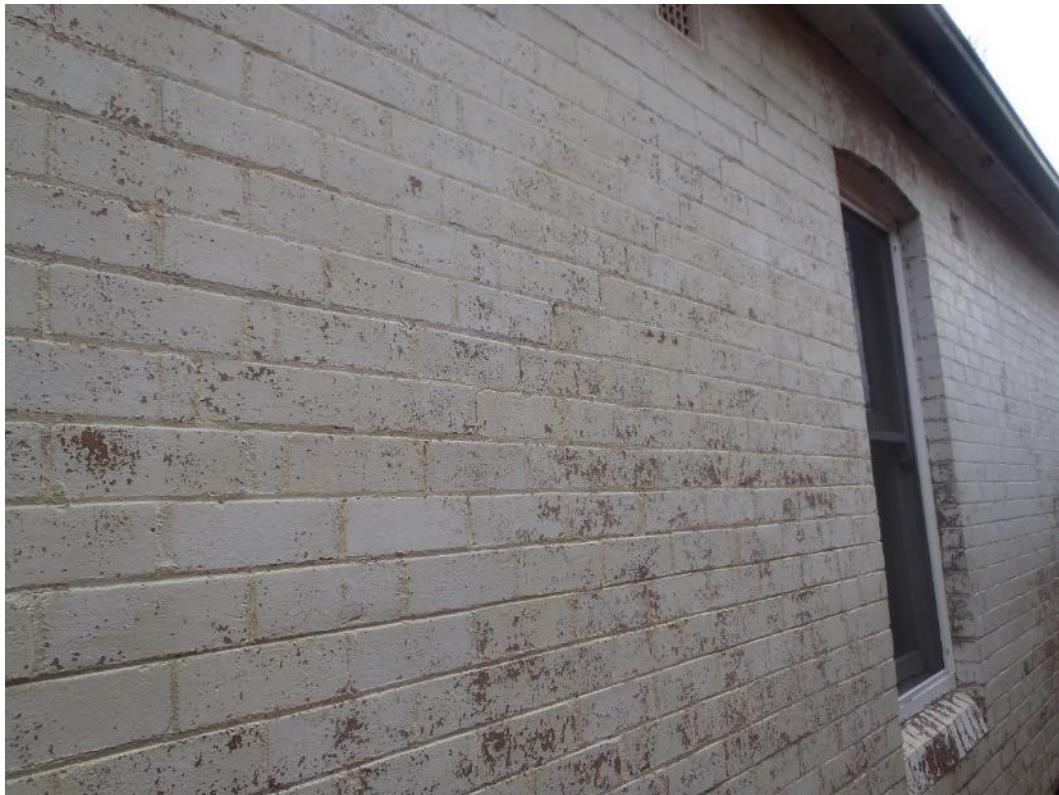
We noted step cracking [<1.0mm] extending from the western side of the Bedroom 2 window arch toward the ground. **[Photograph 21]**

Photograph 21 shows deterioration of the surface coating on the southern elevation brickwork.

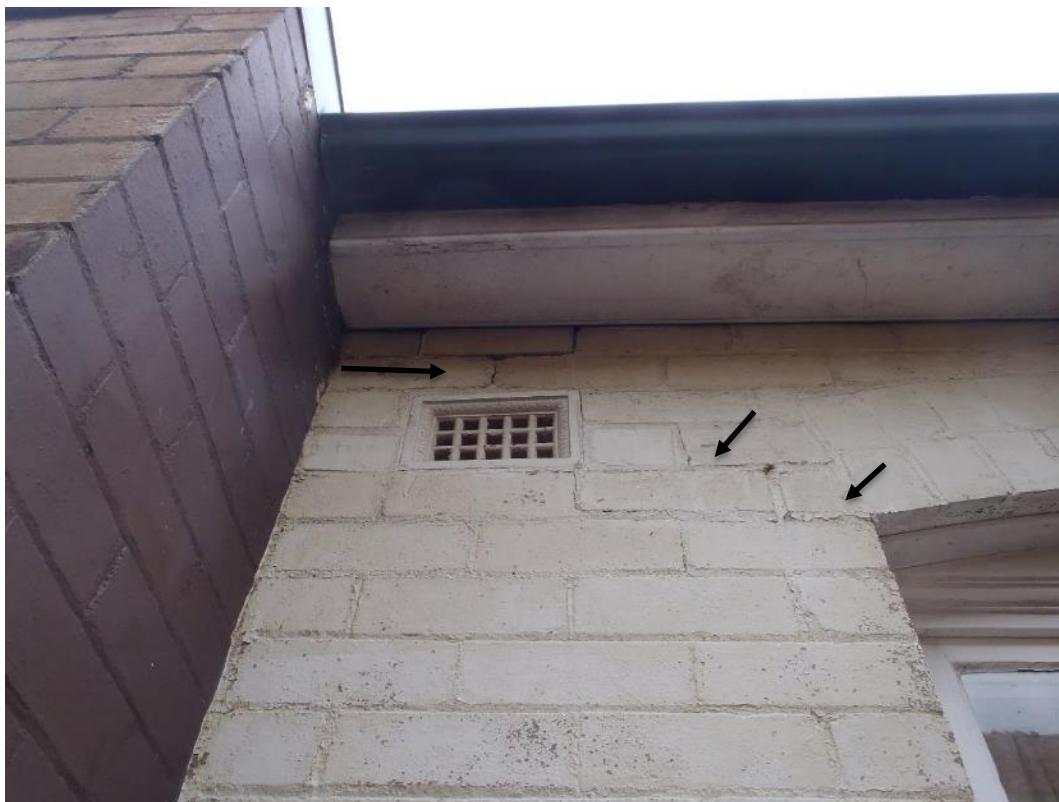
We noted step cracking [1.0mm – 3.0mm] around the wall vent extending towards the window head outside the Lounge Room. **[Photograph 22]**

Photograph 22 shows step cracking around the wall vent extending towards the window head outside the Lounge Room.

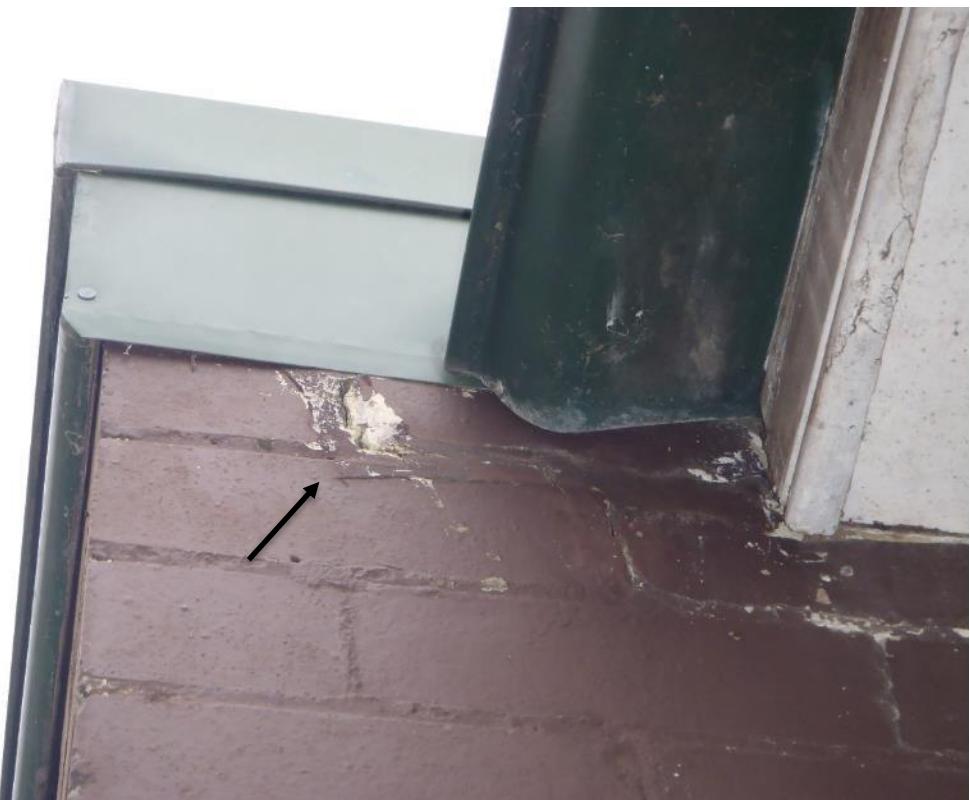
We noted evidence of a previous repair to the surface coated brickwork adjoining the barge flashing outside Bedroom 3. **[Photograph 23]**

Photograph 23 shows evidence of a previous repair to the surface coated brickwork adjoining the barge flashing outside Bedroom 3

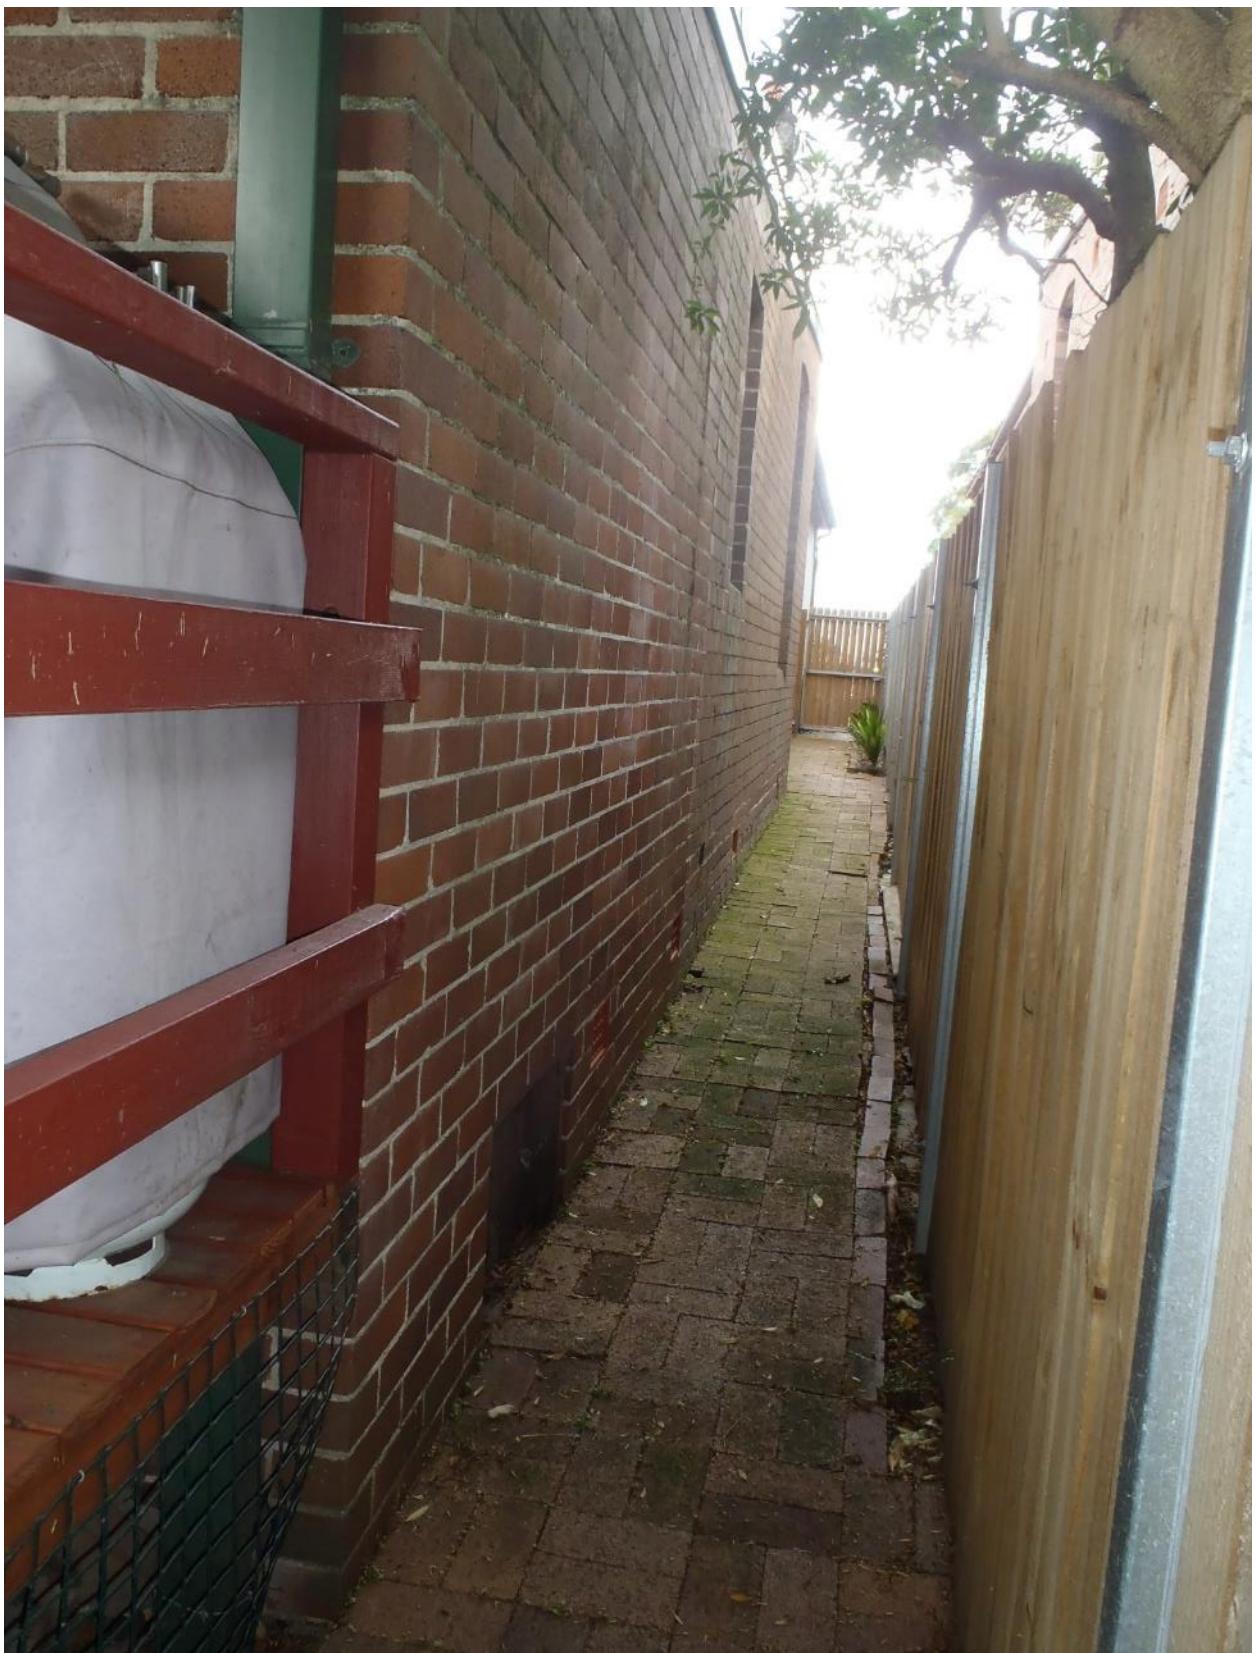
We noted displaced pavers to the side elevation pathway. We further noted dampness and lichen growth to the surface of the pavement. **[Photograph 25]**

Photograph 25 shows displaced pavers to the side elevation pathway and dampness / lichen growth to the surface of the pavement

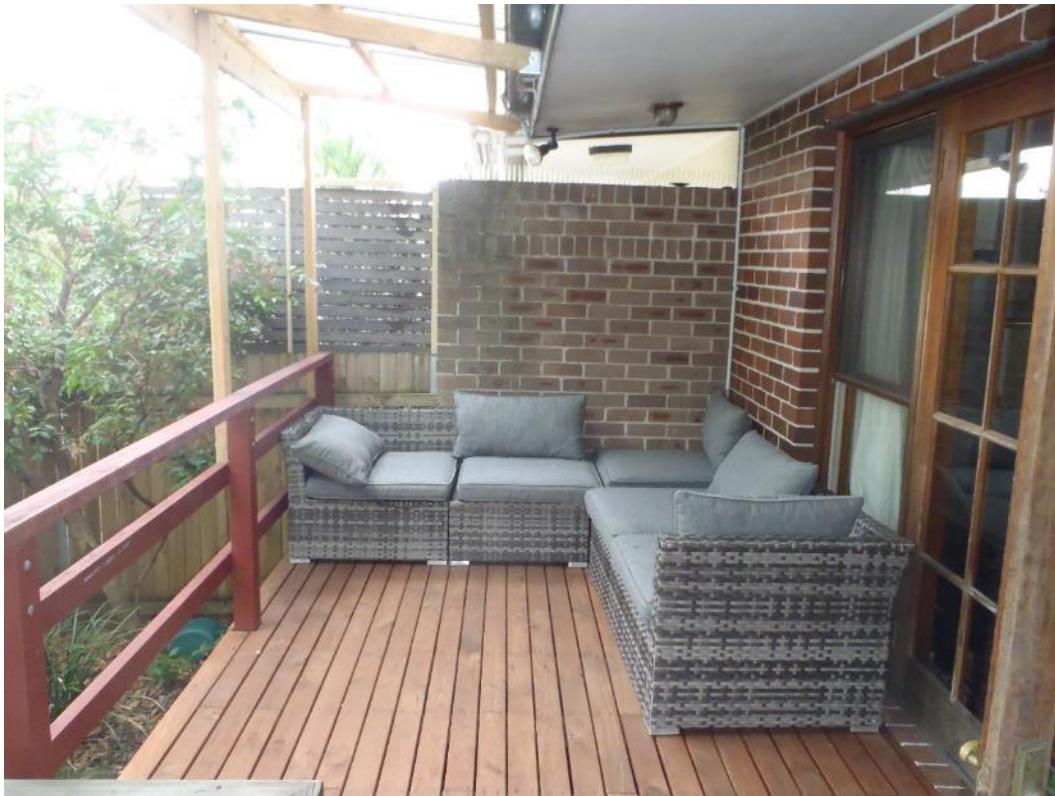
We did not observe any recent cracking to the clay masonry brickwork of the *common* privacy wall with the adjoining property, No. 260 Willoughby Road on the rear deck. **[Photograph 27]**

Photograph 27 shows the general condition of the clay masonry brickwork of the *common* privacy wall with the adjoining property, No. 260 Willoughby Road on the rear deck

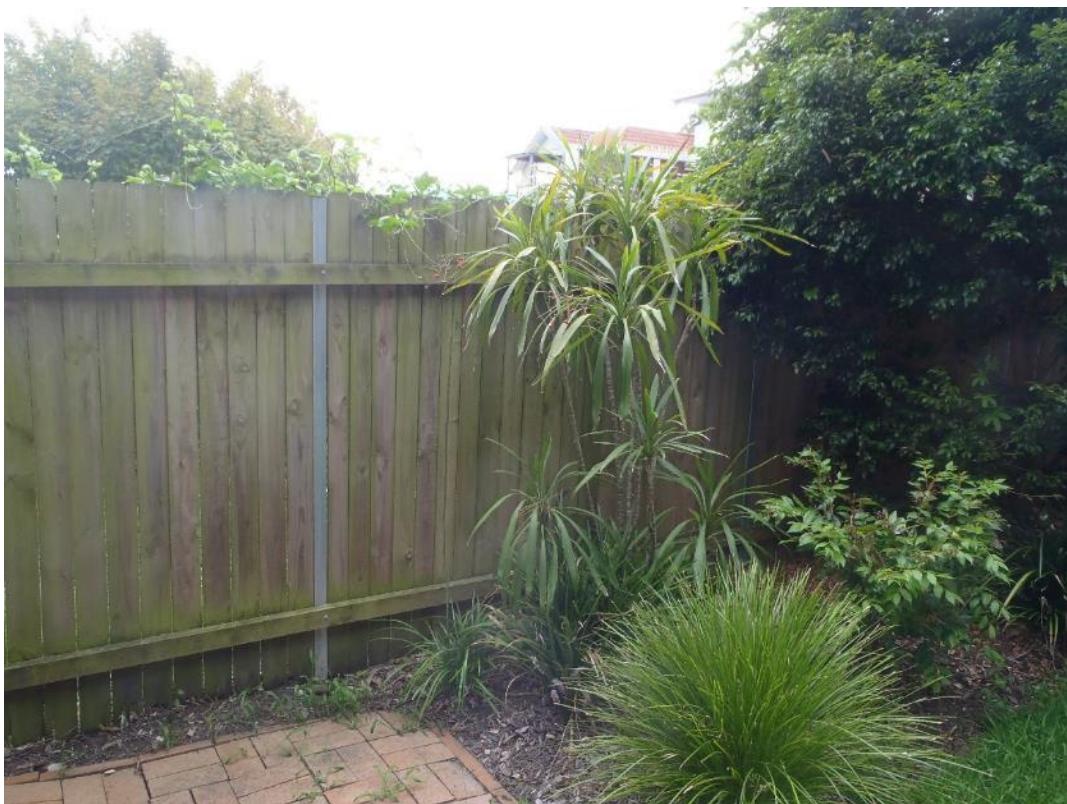
We noted that the rear common boundary fence is a timber post and rail construction. **[Photograph 28]**

Photograph 28 shows the general condition of the rear common boundary fence with the adjoining property, No. 260 Willoughby Road.

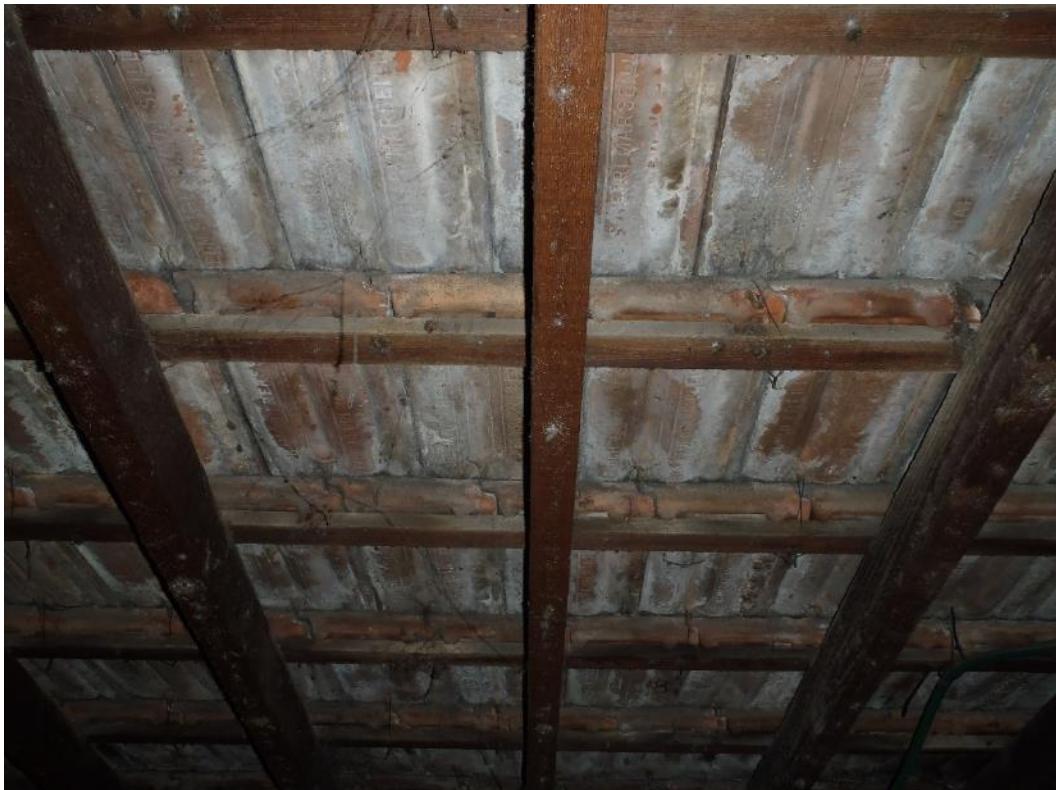
We noted that there is no sarking to the underside of the terracotta roofing tiles. We further noted deterioration of the underside of the roof tiles (efflorescence). **[Photograph 29]**

We observed that the roof and ceiling timbers that are accessible are generally in good condition. **[Photograph 29]**

Photograph 29 shows the general condition of the roofing timbers and the deterioration of the terracotta tiles.

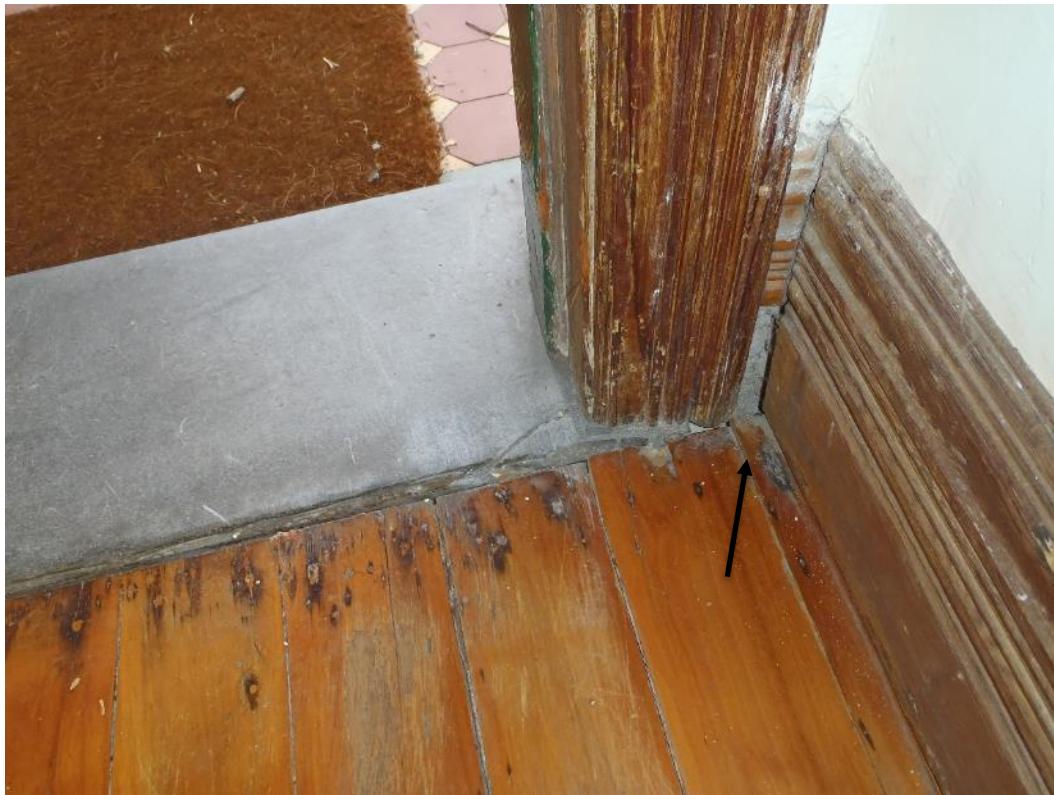
We noted a gap to the skirting board adjacent to the front entry door. We further noted a crack [<1.0mm] to the threshold step adjacent to the front door jamb. **[Photograph 30]**

Photograph 30 shows a gap to the skirting board adjacent to the front entry door and a crack to the threshold step adjacent to the front door jamb.

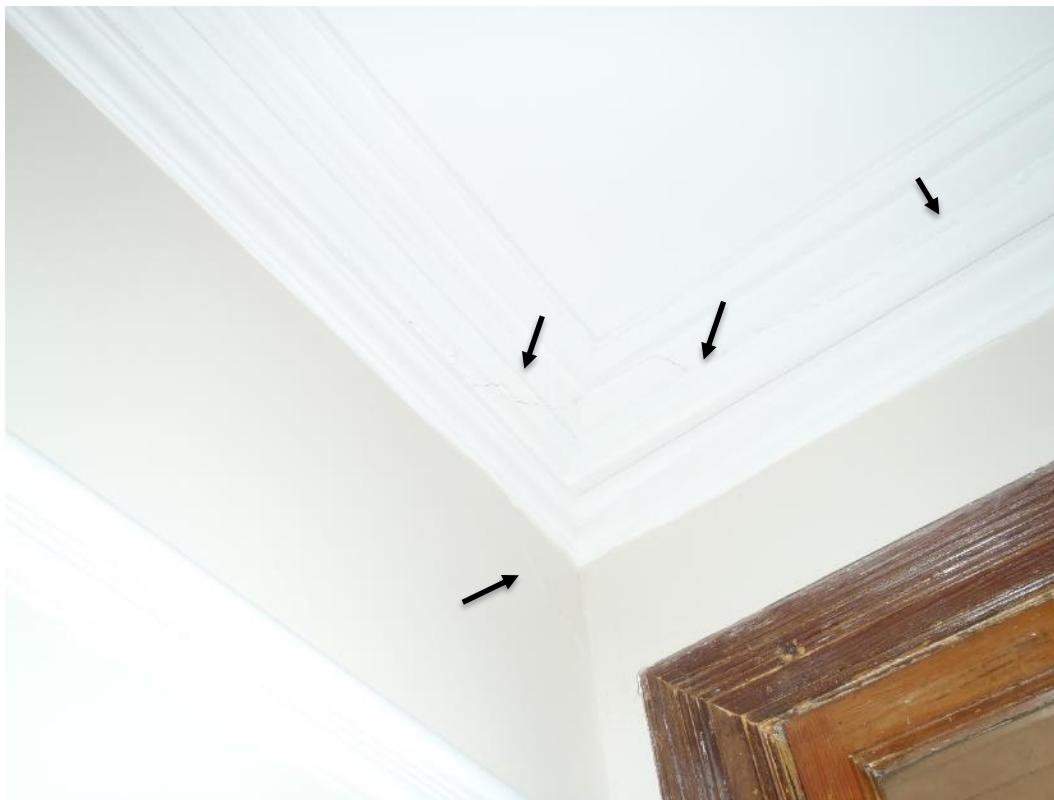
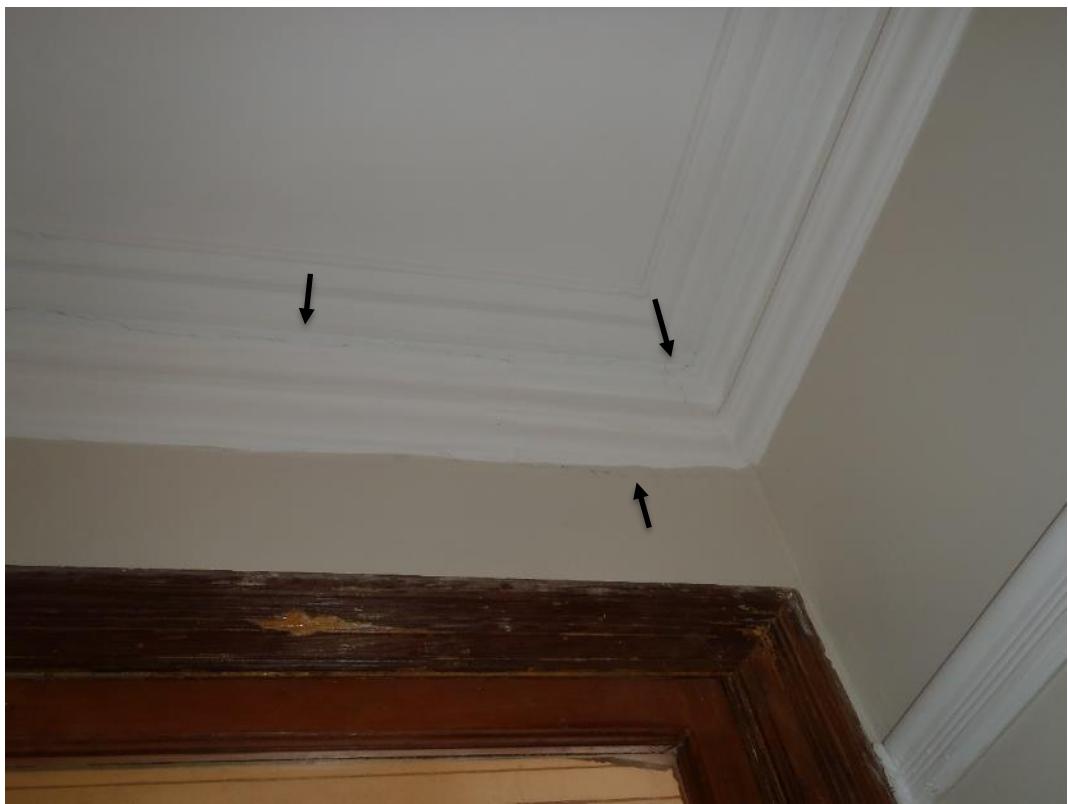
We noted separation cracking [<1.0 mm] of the cornice from the wall surface above the front entry door. We further noted horizontal cracking [<1.0 mm] of the plaster cornice. **[Photographs 31 & 32]**

Photograph 31 shows separation cracking [<1.0 mm] of the cornice from the wall surface above the front entry door and horizontal cracking [<1.0 mm] of the plaster cornice.

Photograph 32 shows separation cracking [<1.0 mm] of the cornice from the wall surface above the front entry door and horizontal cracking of the plaster cornice.

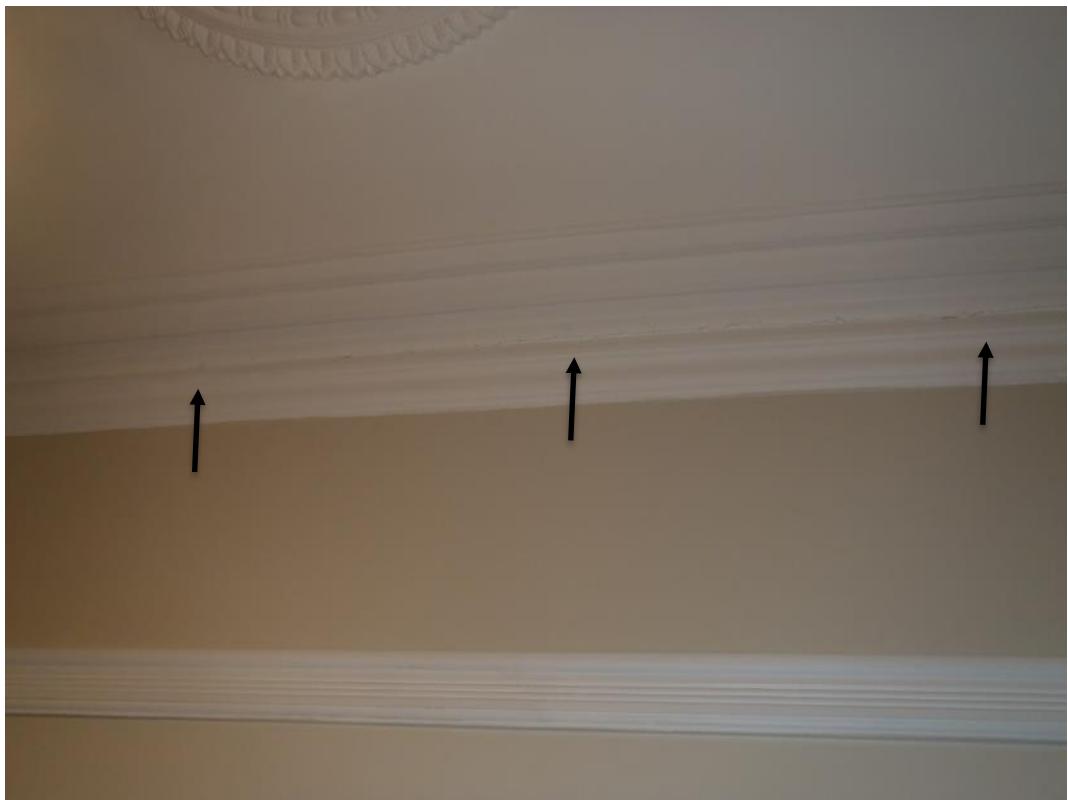
We noted horizontal cracking [<1.0 mm] of the plaster cornice along the *common party / separation* wall with the adjoining property, No. 260 Willoughby Road. **[Photograph 33]**

Photograph 33 shows horizontal cracking of the plaster cornice along the *common party / separation wall* with the adjoining property, No. 260 Willoughby Road.

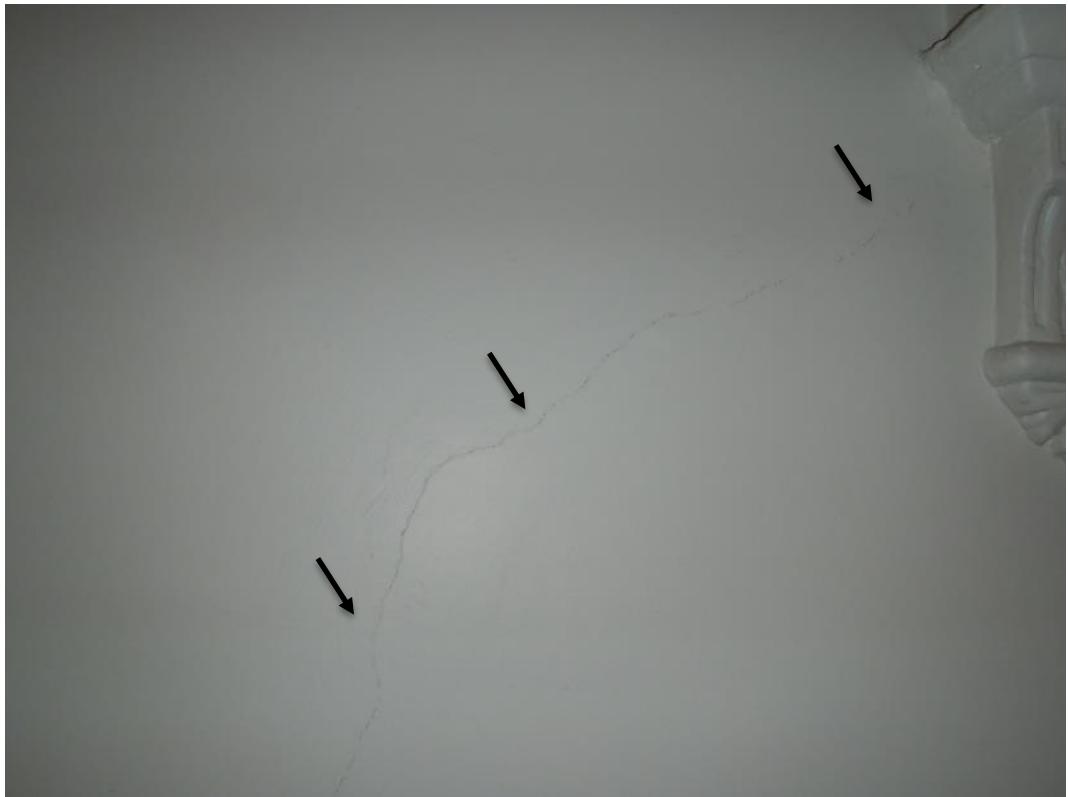
We noted radial cracking [<1.0 mm] of the cement rendered *common party / separation* wall with the adjoining property, No. 260 Willoughby Road extending down from the hallway arch. We further noted evidence of previous repairs. **[Photograph 34]**

Photograph 34 shows radial cracking of the cement rendered *common party / separation wall* and evidence of previous repairs to the existing crack.

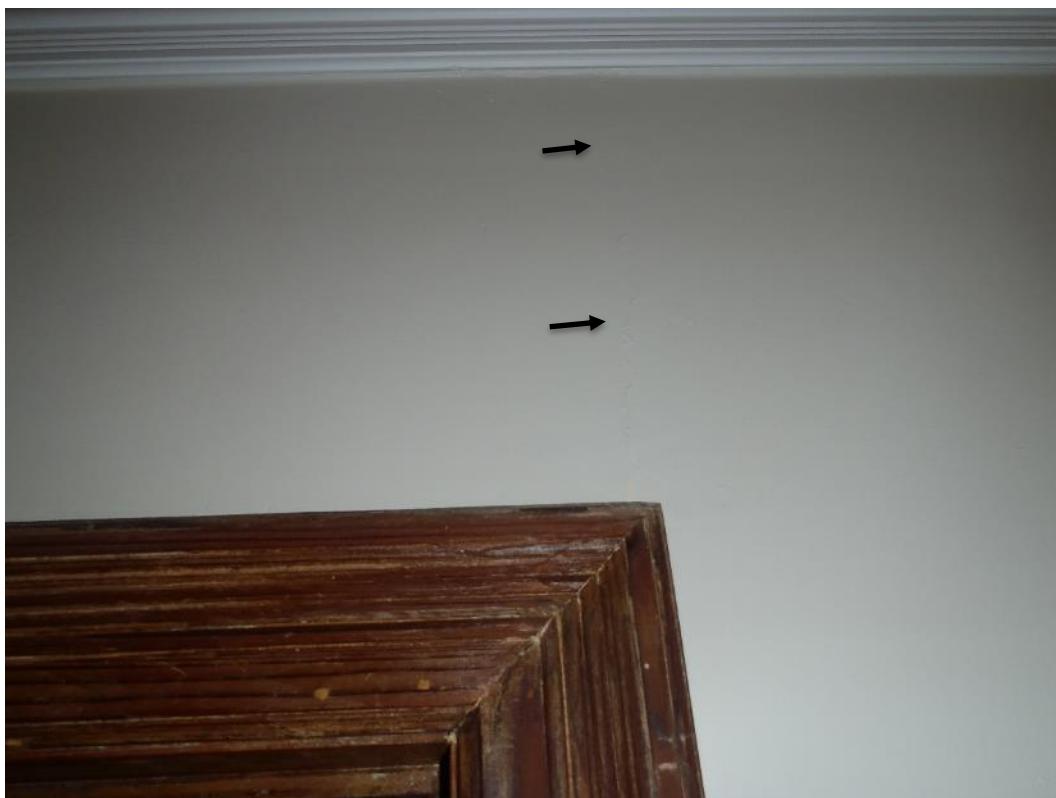
We noted hairline vertical cracking [<1.0 mm] of the cement rendered wall above the Bedroom 2 door. **[Photograph 35]**

Photograph 35 shows hairline vertical cracking of the cement rendered wall above the Bedroom 2 door.

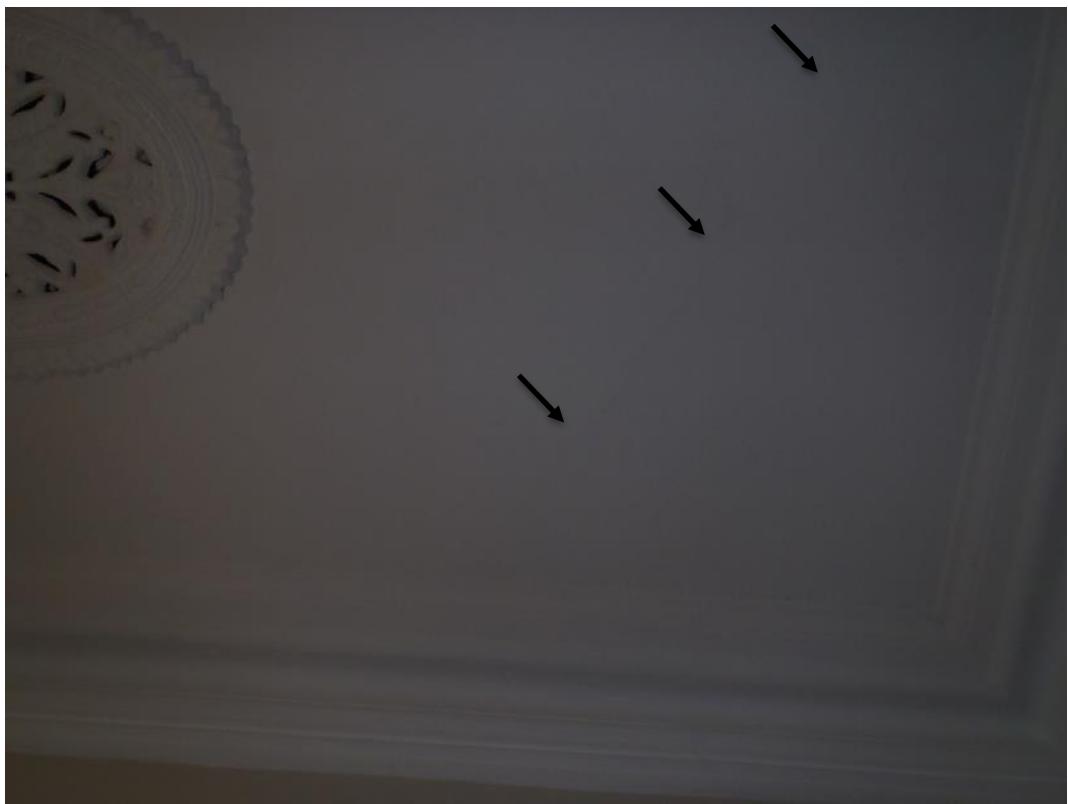
We noted hairline cracking [<1.0 mm] of the plaster ceiling outside Bedroom 2. **[Photograph 36]**

Photograph 36 shows hairline cracking of the plaster ceiling outside Bedroom 2 in the Hallway.

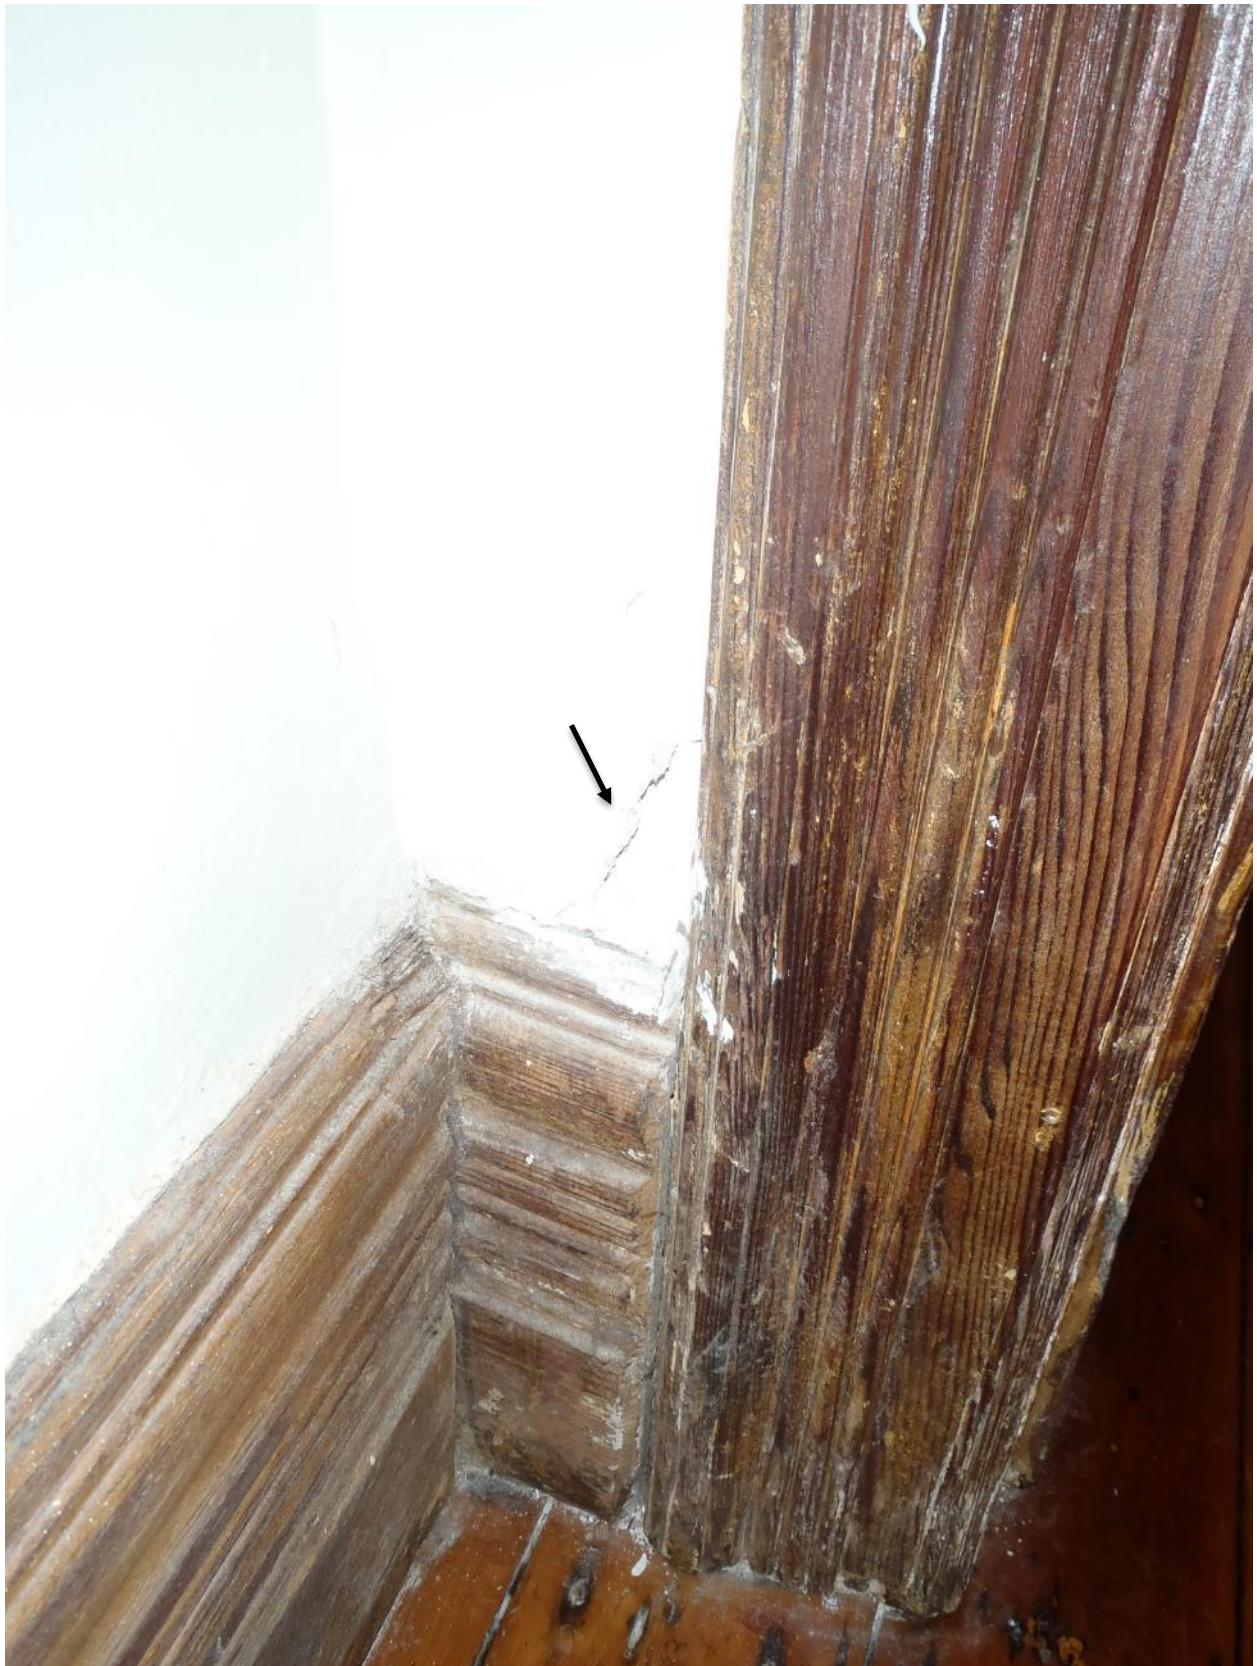
We noted radial cracking [<1.0 mm] of the cement rendered wall adjoining the door jamb at the western end. We further noted evidence of previous repairs. **[Photograph 37]**

Photograph 37 shows radial cracking of the cement rendered wall adjoining the door jamb at the western end and evidence of previous repairs to the existing crack.

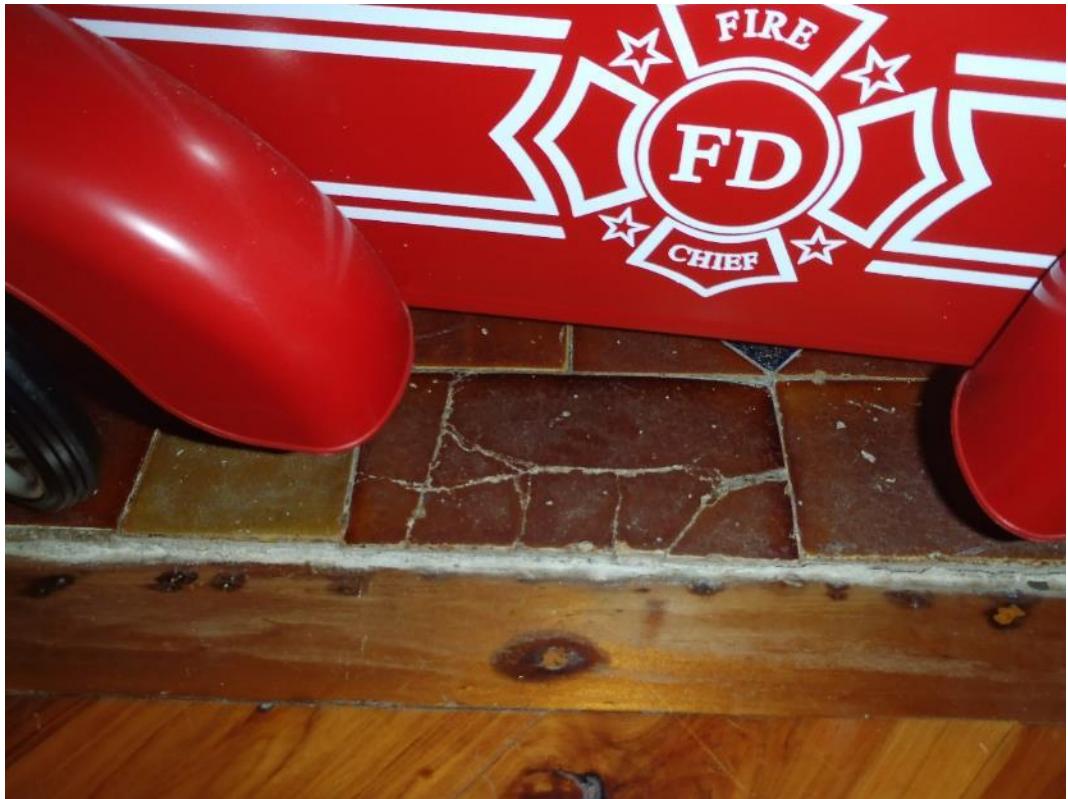
We noted cracking to the hearth tiles on the fireplace. **[Photograph 38]**

Photograph 38 shows cracking to the hearth tiles on the fireplace in Bedroom 1.

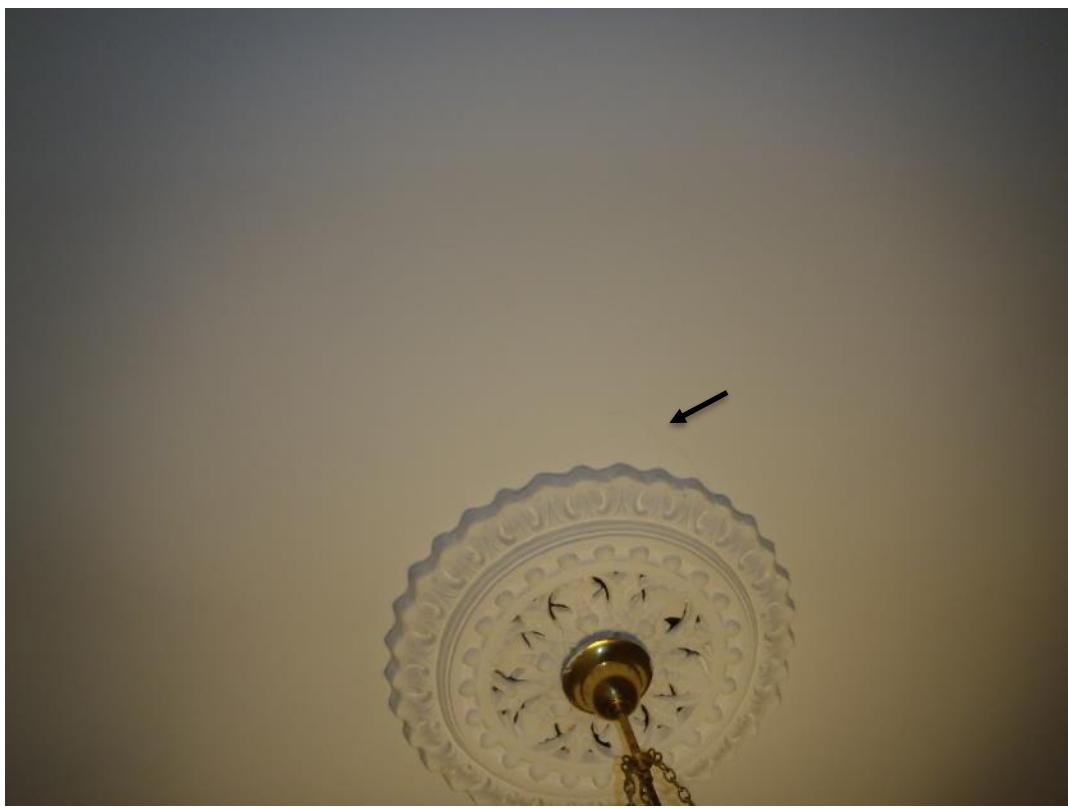
We noted hairline cracking [<1.0 mm] of the plaster ceiling lining around the decorative ceiling rose. **[Photograph 39]**

Photograph 39 shows hairline cracking of the plaster ceiling lining around the decorative ceiling rose in Bedroom 2.
