Dilapidation Assessment Report

Prepared for: Cape Cod Australia Pty. Limited

Job address: No. 258 Willoughby Road, Naremburn.

Date of assessment: 17th February 2017

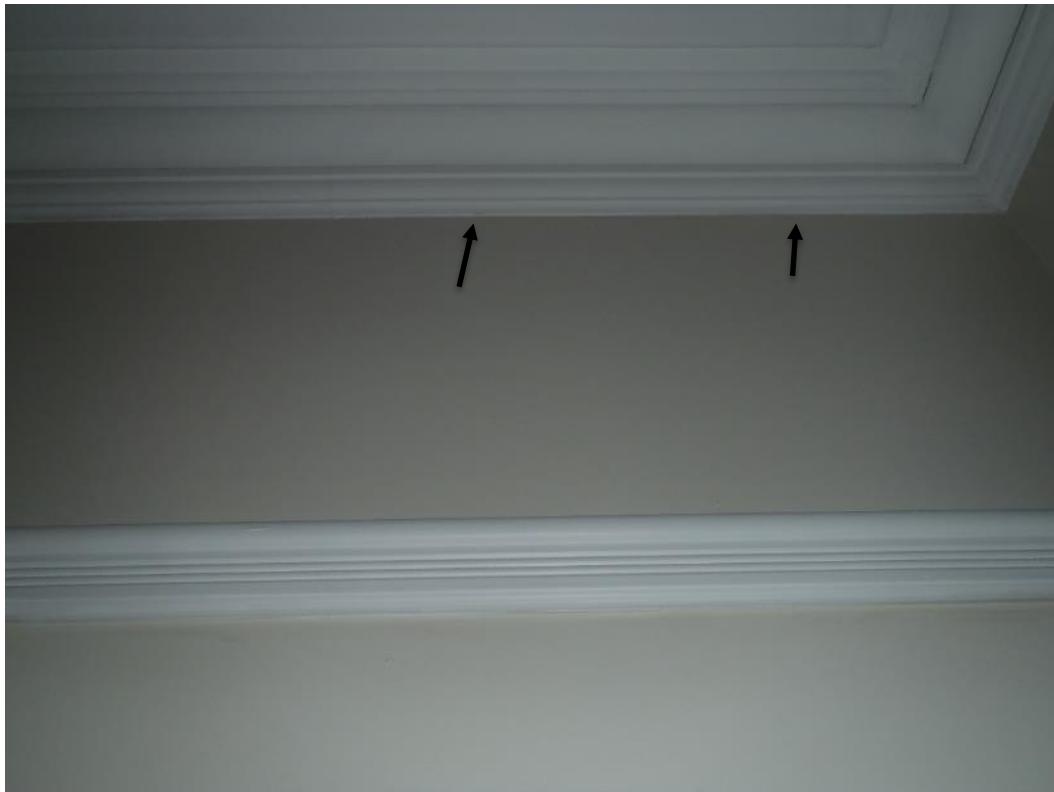
We noted radial cracking [<1.0 mm] of the cement rendered *common party / separation* wall with the adjoining property, No. 260 Willoughby Road extending from the cornice along the wall.

Photograph 40 shows radial cracking of the cement rendered *common party / separation wall* with the adjoining property, No. 260 Willoughby Road extending from the cornice along the wall.

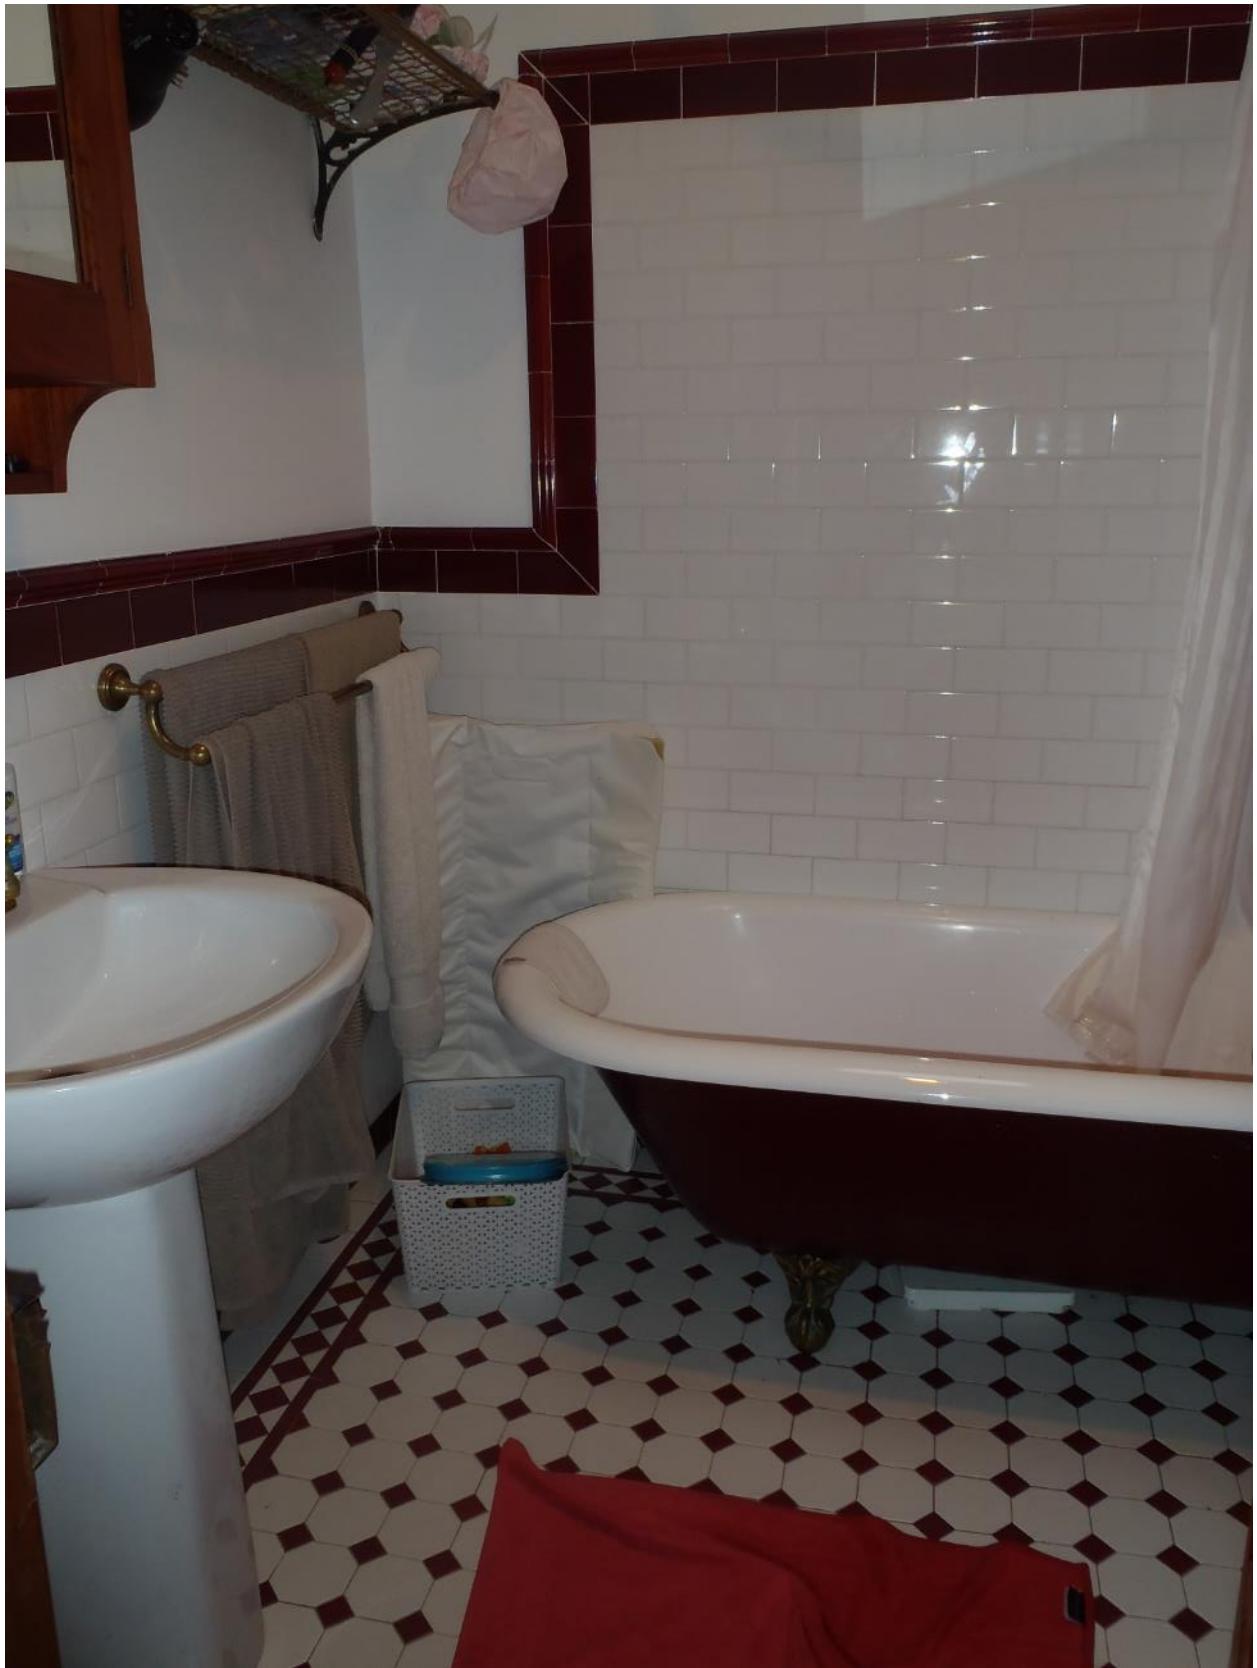
We noted that the grout to the wall and floor tiles is complete and that the wall and floor tiles when randomly “tap” tested appeared to be sound. We did not observe any recent cracking to the tile grout at the wall / wall, wall / floor junctions. **[Photograph 41]**

Photograph 41 shows the general condition of the Bathroom.

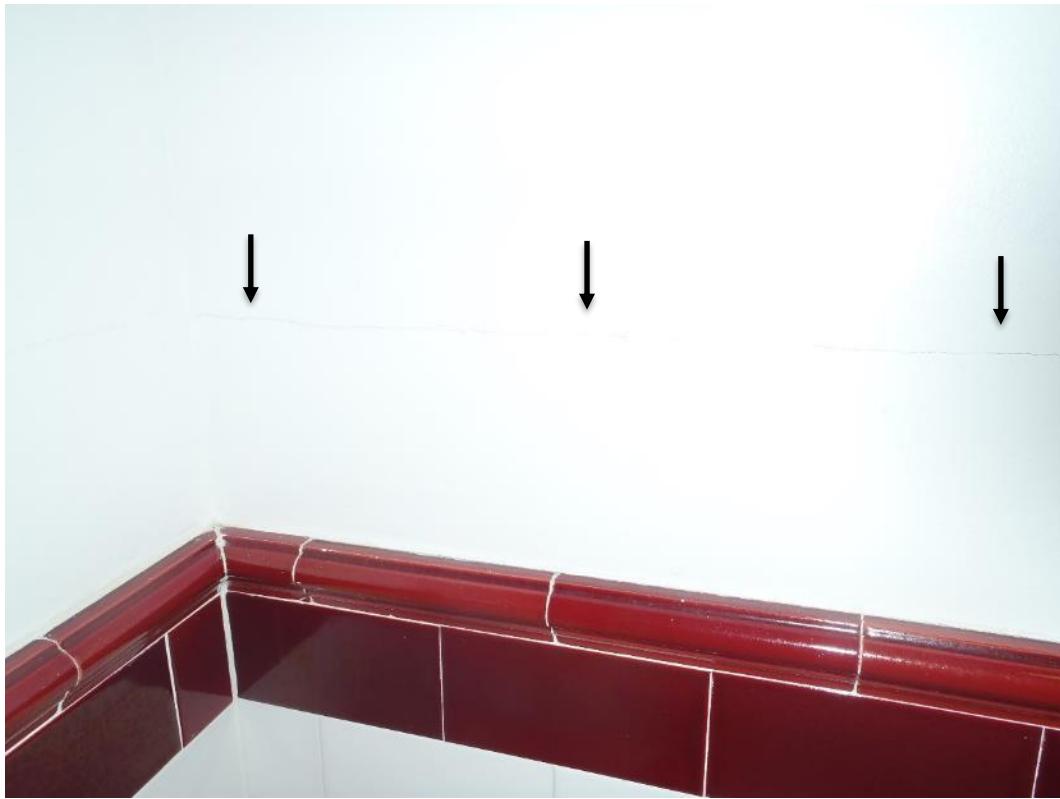
We noted horizontal cracking to the plasterboard wall above the wall tiles on the western wall. **[Photograph 42]**

Photograph 42 shows horizontal cracking to the plasterboard wall above the wall tiles on the western wall in the Laundry.

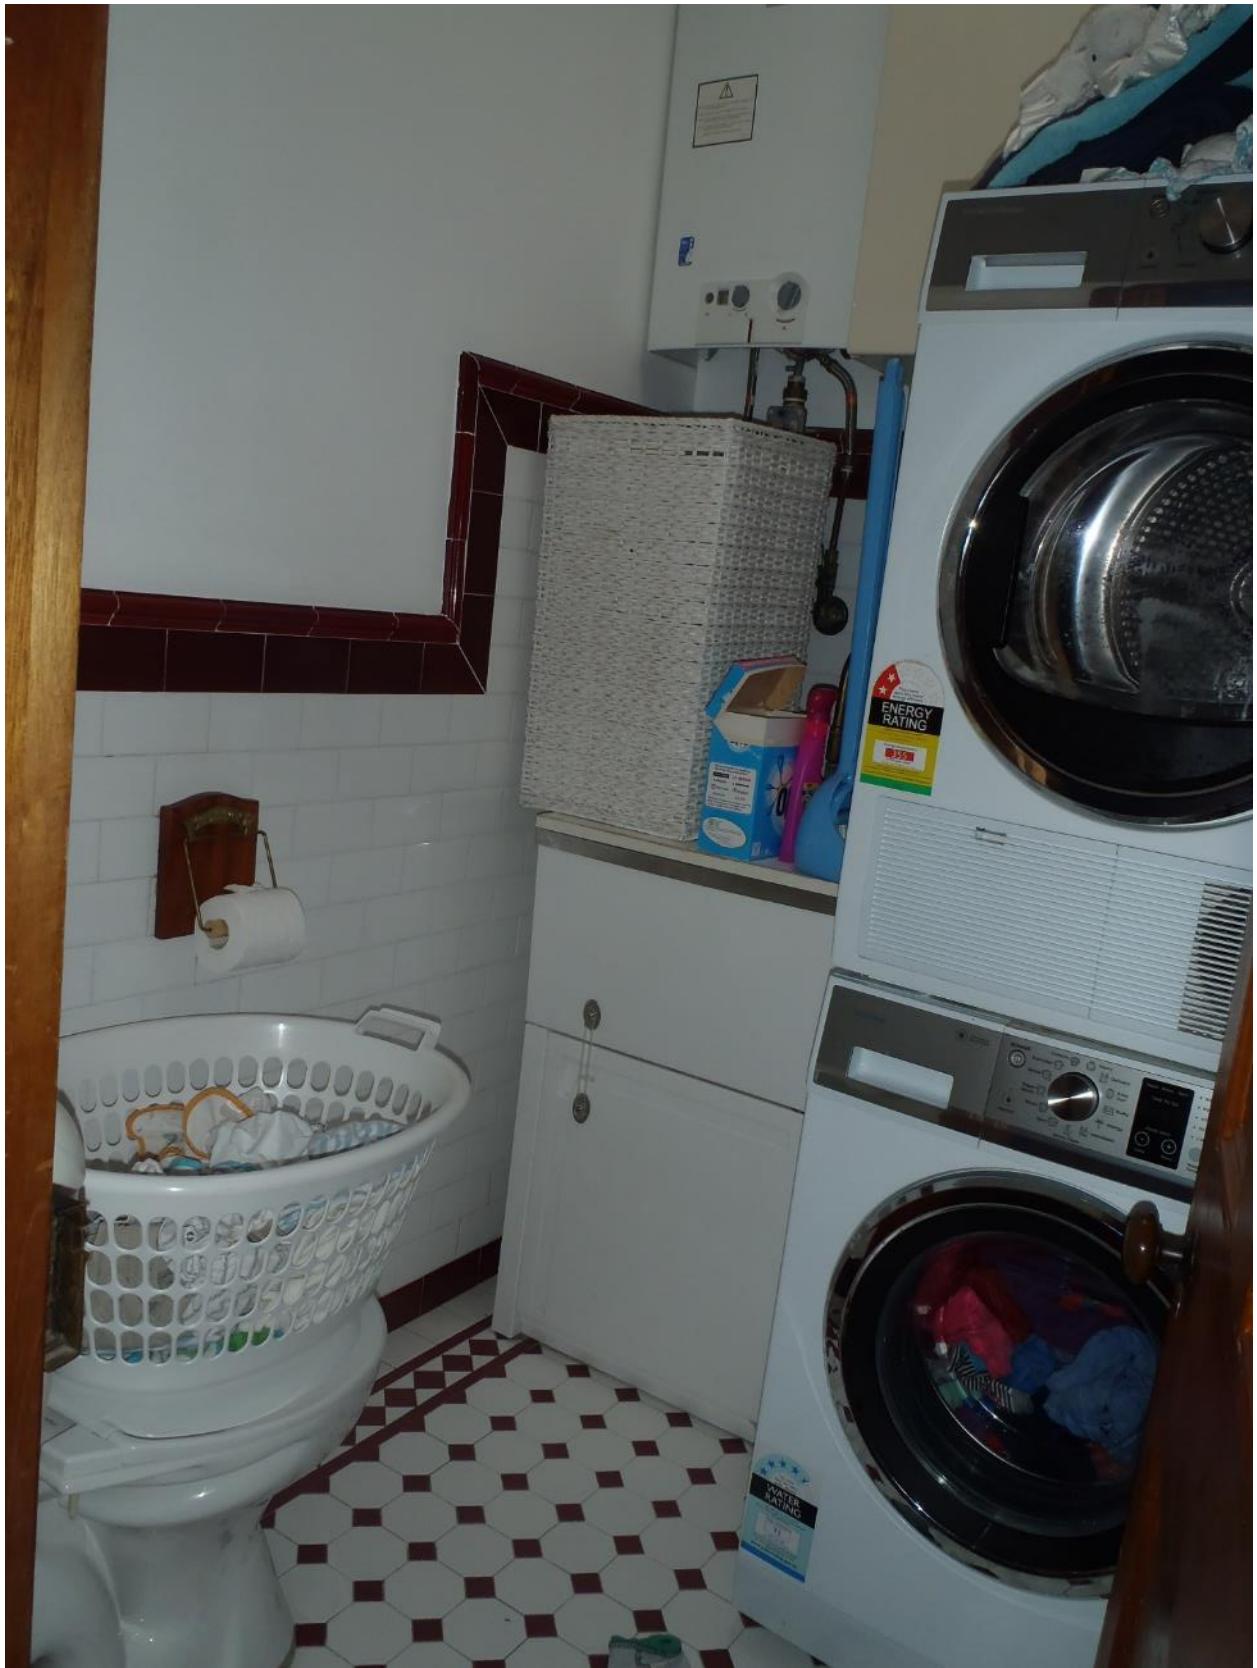
We did not observe any recent cracking to the ceramic wall tiles. **[Photograph 43]**

Photograph 43 shows the general condition of the Laundry.

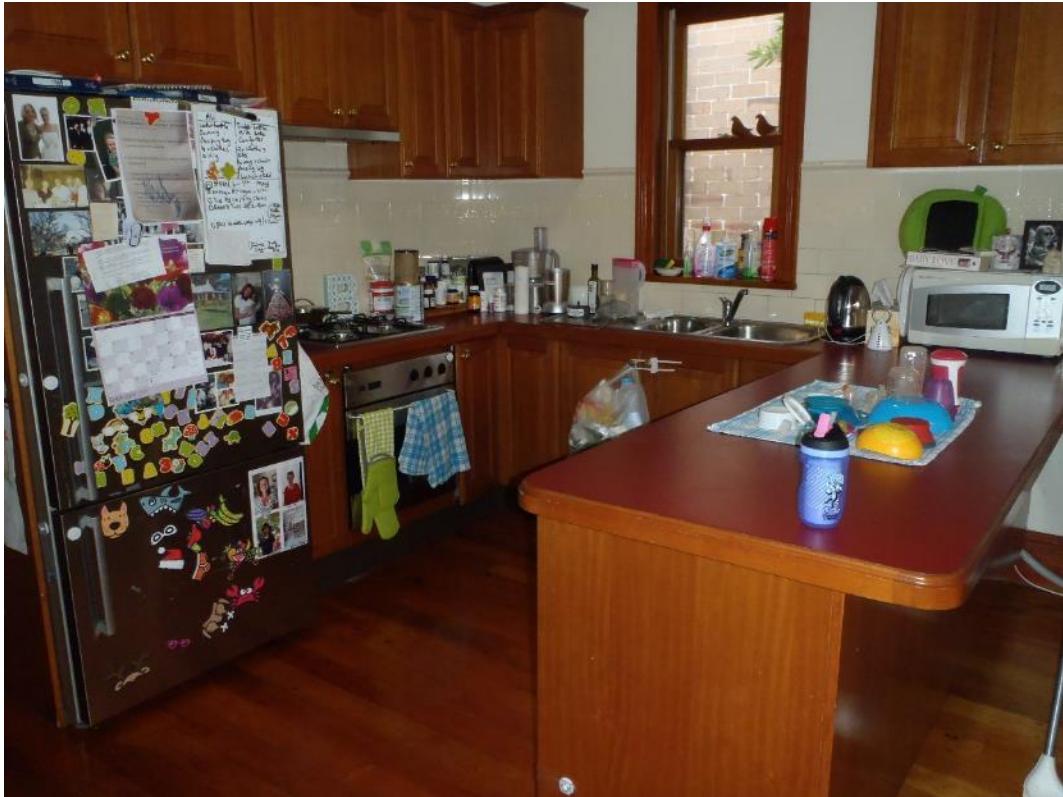
We noted that the room is open plan design. **[Photograph 44]**

Photograph 44 shows the general condition of the Kitchen.

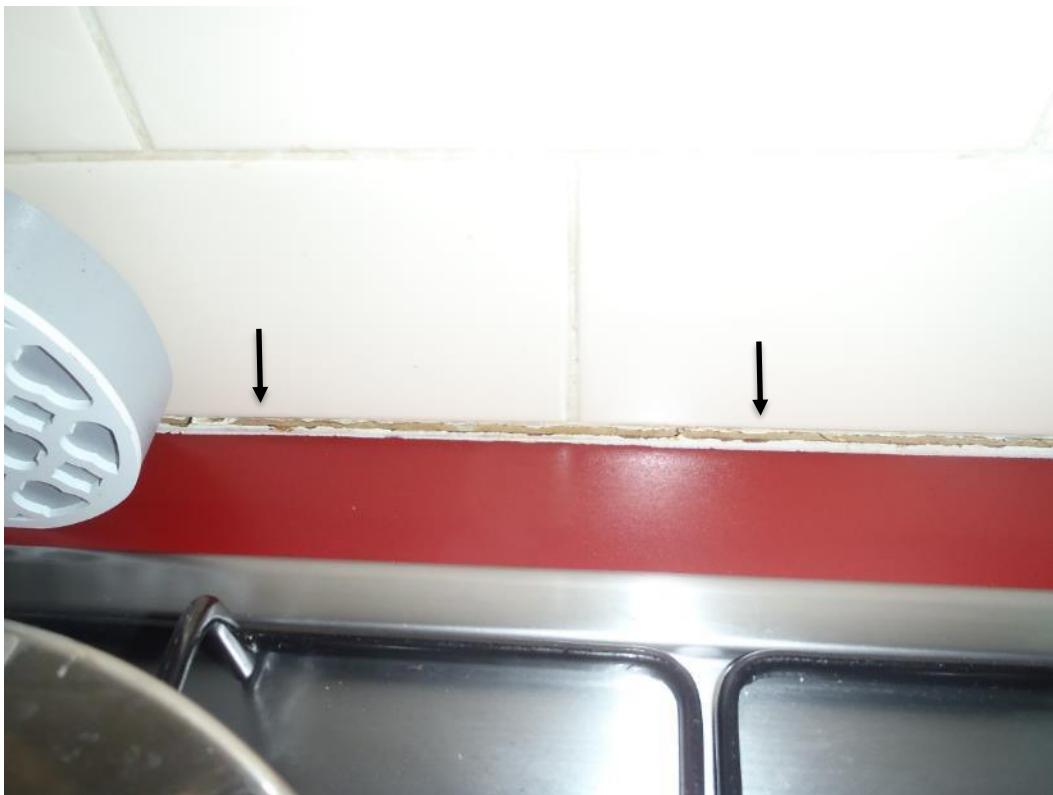
We noted separation cracking [1.0mm – 3.0mm] between the kitchen bench and the splashback tiles. **[Photograph 45]**

Photograph 45 shows separation cracking between the kitchen bench and the splashback tiles.

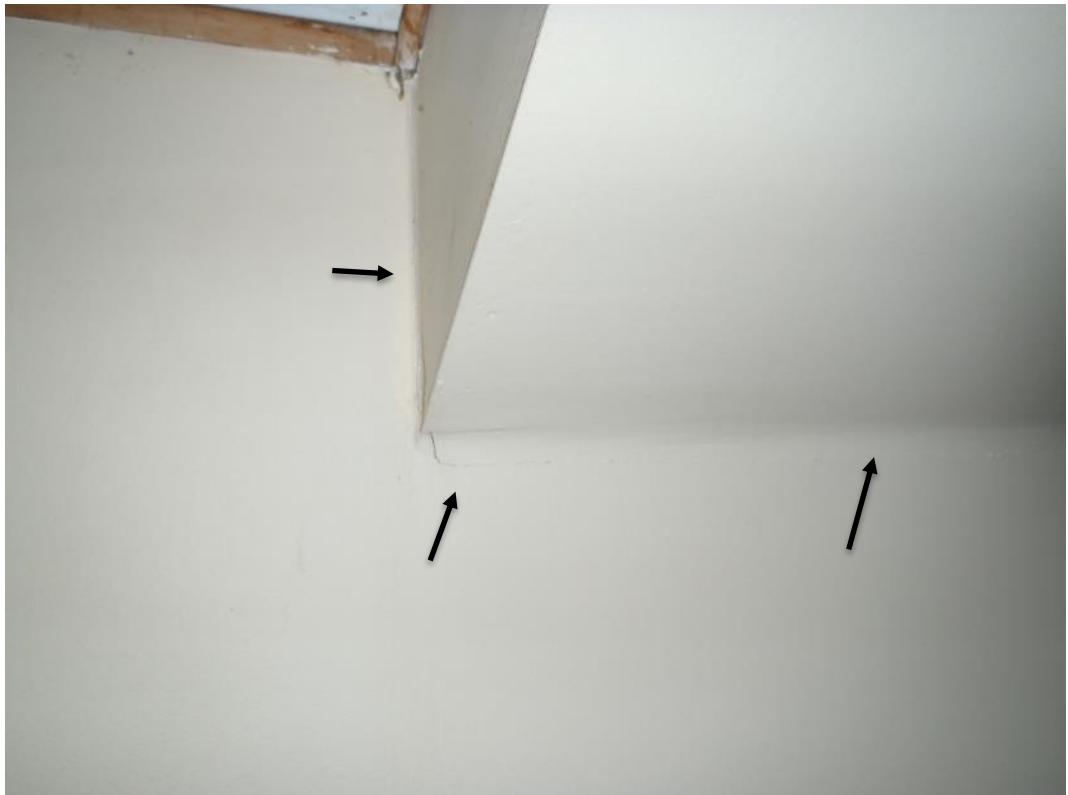
We noted separation cracking [<1.0 mm] at the square set wall and ceiling junctions adjacent to the western skylight. **[Photograph 46]**

Photograph 46 shows separation cracking at the square set wall and ceiling junctions adjacent to the western skylight in the attic.

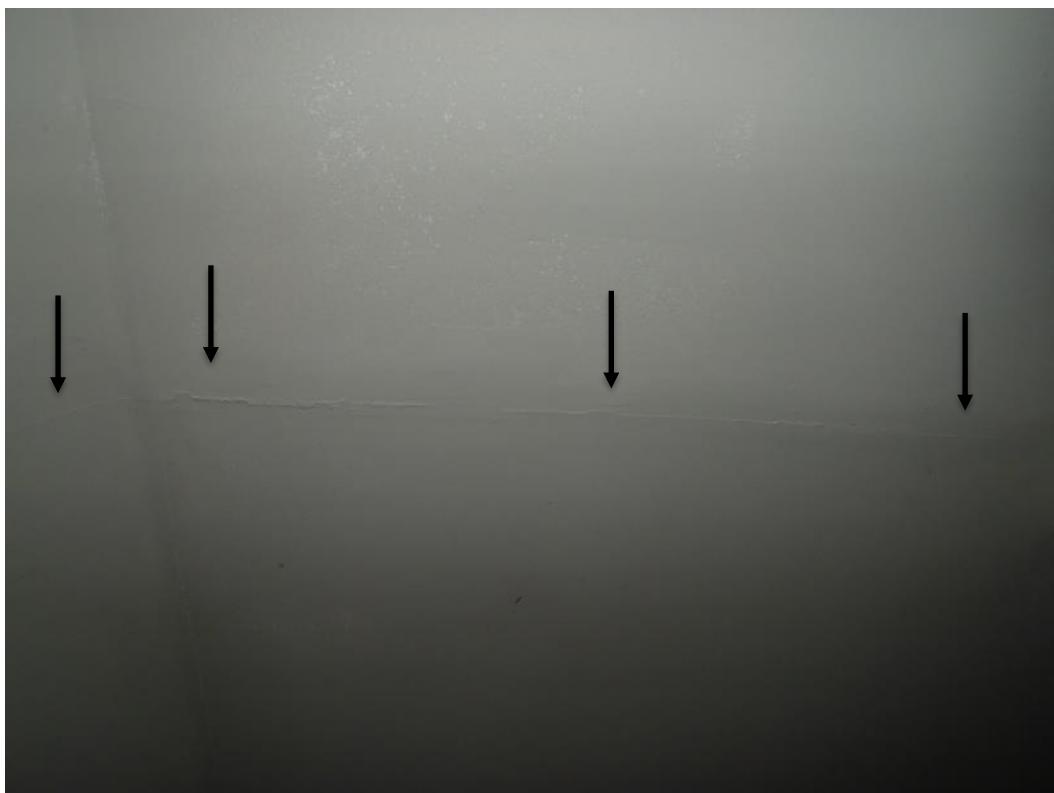
We noted hairline cracking [<1.0 mm] to the plasterboard ceiling lining extending across the room and down the southern plasterboard wall. **[Photographs 47 & 48]**

Photograph 47 shows hairline cracking to the plasterboard ceiling lining extending across the room in the attic.

Photograph 48 shows hairline cracking to the plasterboard ceiling lining extending across the room and down the southern plasterboard wall in the attic.
