# LAND AT GREAT HOUSE FARM, LLANDOUGH

## AN ARCHAEOLOGICAL ASSESSMENT

The Glamorgan~Gwent  
Archaeological  
Trust Ltd.

August  
1990

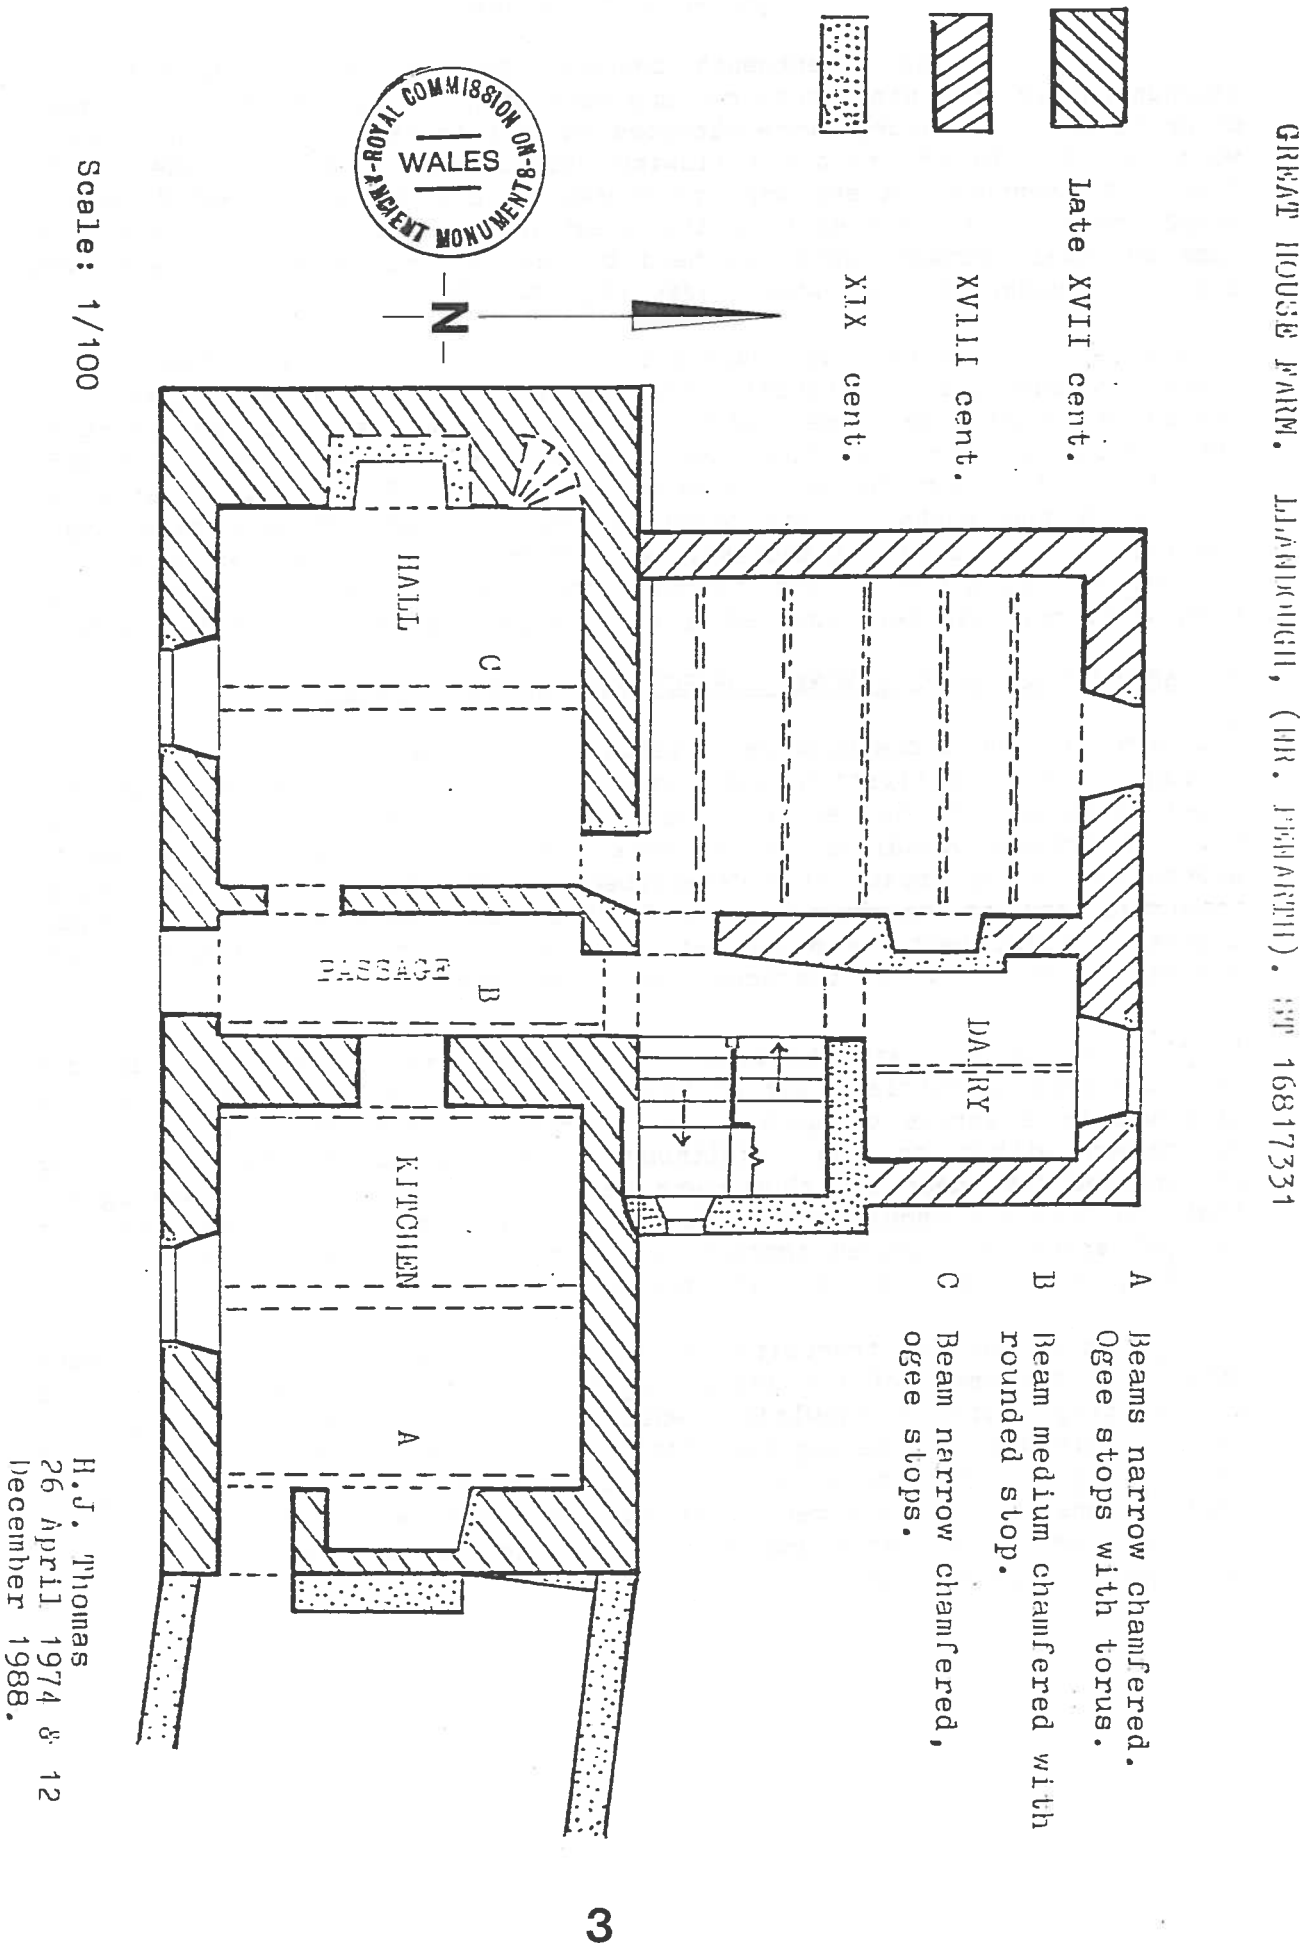
Fig 2: Great House Farm, Llandough. Survey of the farm reproduced by kind permission of H J Thomas and RCAHM(W).

Prior to the assessment the principal recorded archaeological interest on the redevelopment site itself was Great House Farm (SMR 2038s). Owing to an ownership dispute and the subsequent sudden destruction of the property in 1988 the building was incompletely understood. The RCAHMW nevertheless hold a certain amount of information on the farmhouse and barn. In summary, although both structures appeared outwardly to be of nineteenth century date, the farmhouse may have incorporated medieval fabric within parts of a seventeenth century house which had survived nineteenth century reconstruction.

The seventeenth century phase is associated with the Vaughan Family, the nineteenth century work with the Bute Estate. A number of architectural features were recorded in situ in 1974, (Fig 2) and others were observed in the rubble following demolition. Sherds of twelfth to fourteenth century pottery were recovered by E J Beare in 1962-3 on the slope immediately north-east of the Great House, while it is likely that some medieval ironwork which is held by the National Museum of Wales was discovered under the rear wing c 1880 (RCAHMW 1988).

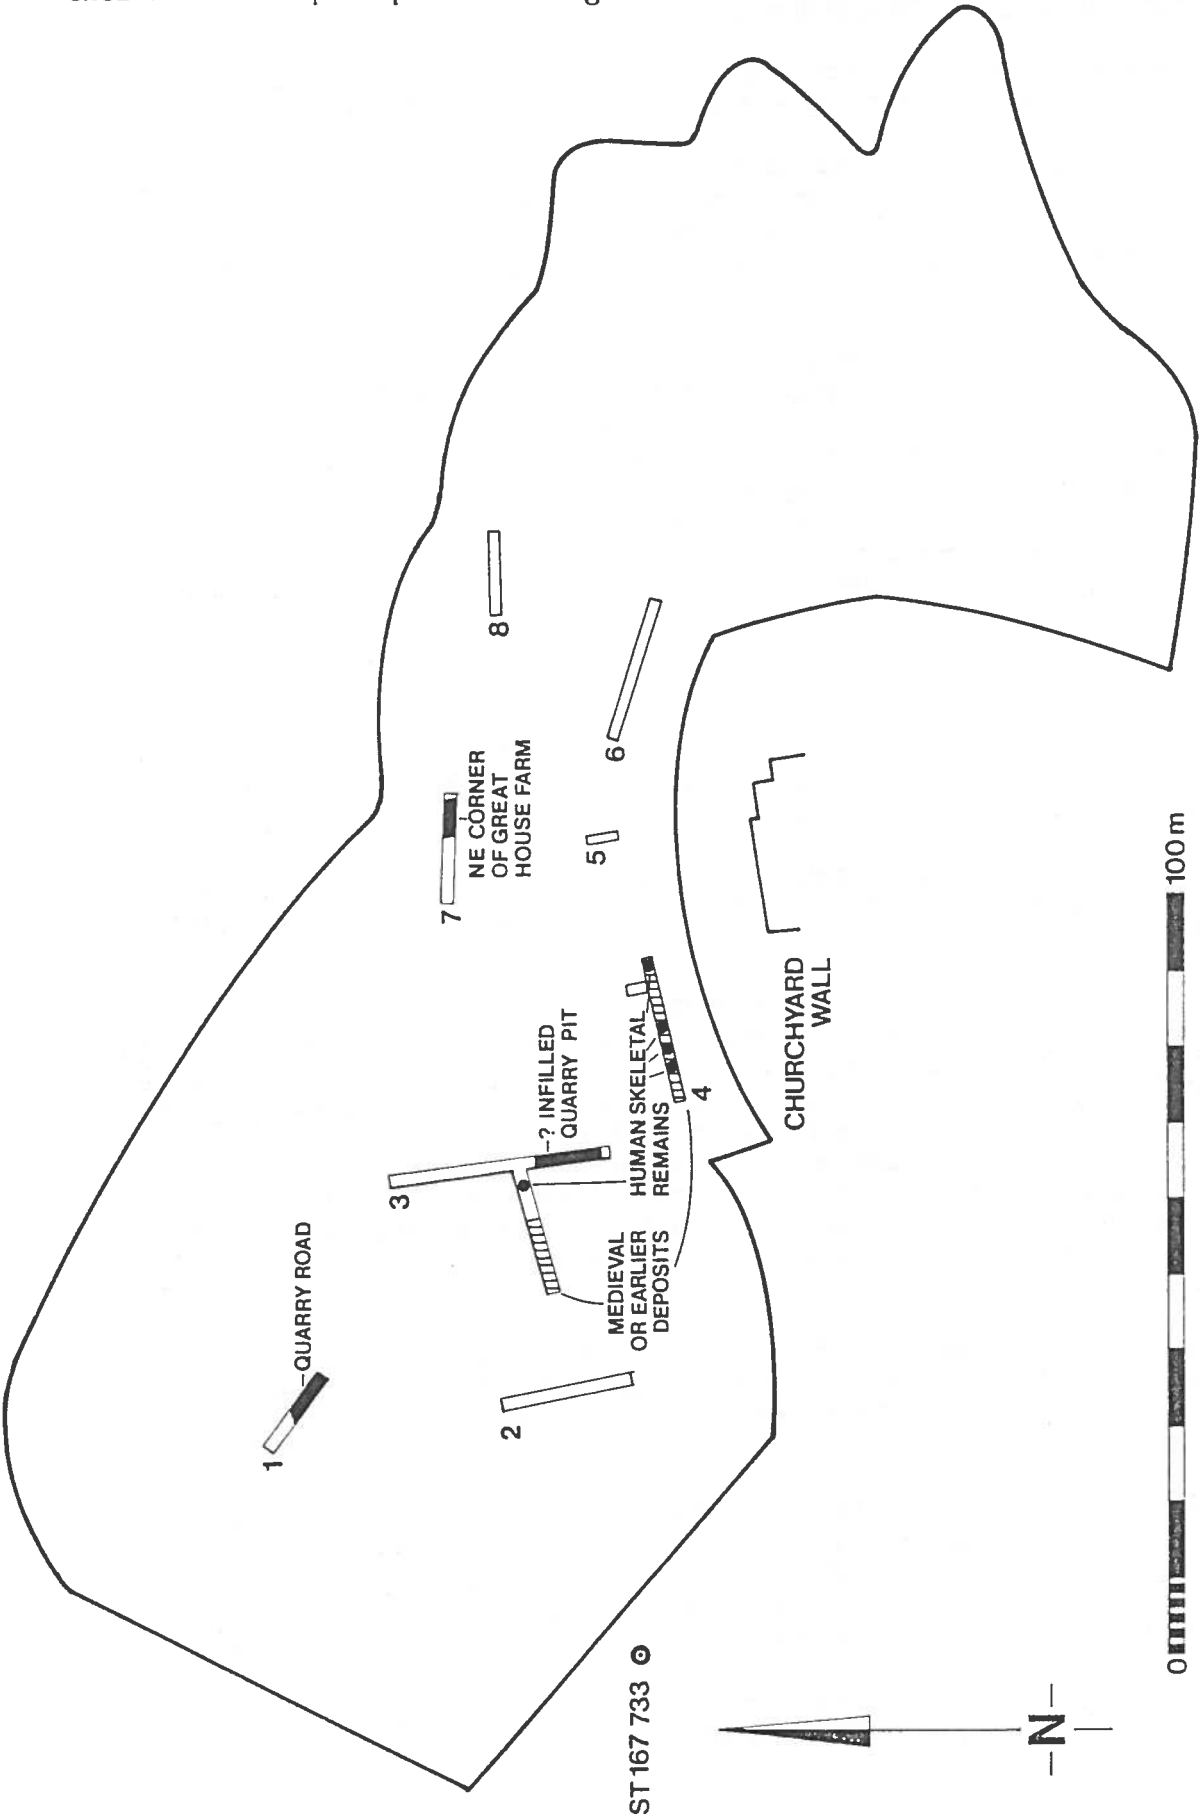
Fig 3: Great House Farm, Llandough. Approximate position of trial excavations and principal archaeological features.

The approximate location of the machine cut trenches is shown on Figure 3, and the trench numbers given below also correspond with Figure 3.

The principal feature was almost certainly the depression indicated on the OS map, which was formerly a quarry road. The depth of the road confirmed that it would have cut any earlier archaeological features which may have existed. The absence of any archaeological deposits between the substrate and the modern material in the north west part of the trench suggests that this area is likely to be sterile. Although based on a small sample we therefore believe that the area to the north west of and including the quarry road is unlikely to contain significant archaeological interest.

In summary the area which is presumed to have been quarried has low archaeological potential, but elsewhere it appears as if archaeological deposits pre dating the construction of the farm buildings, presumably in the 19th century at the behest of the Bute Estate, have survived.

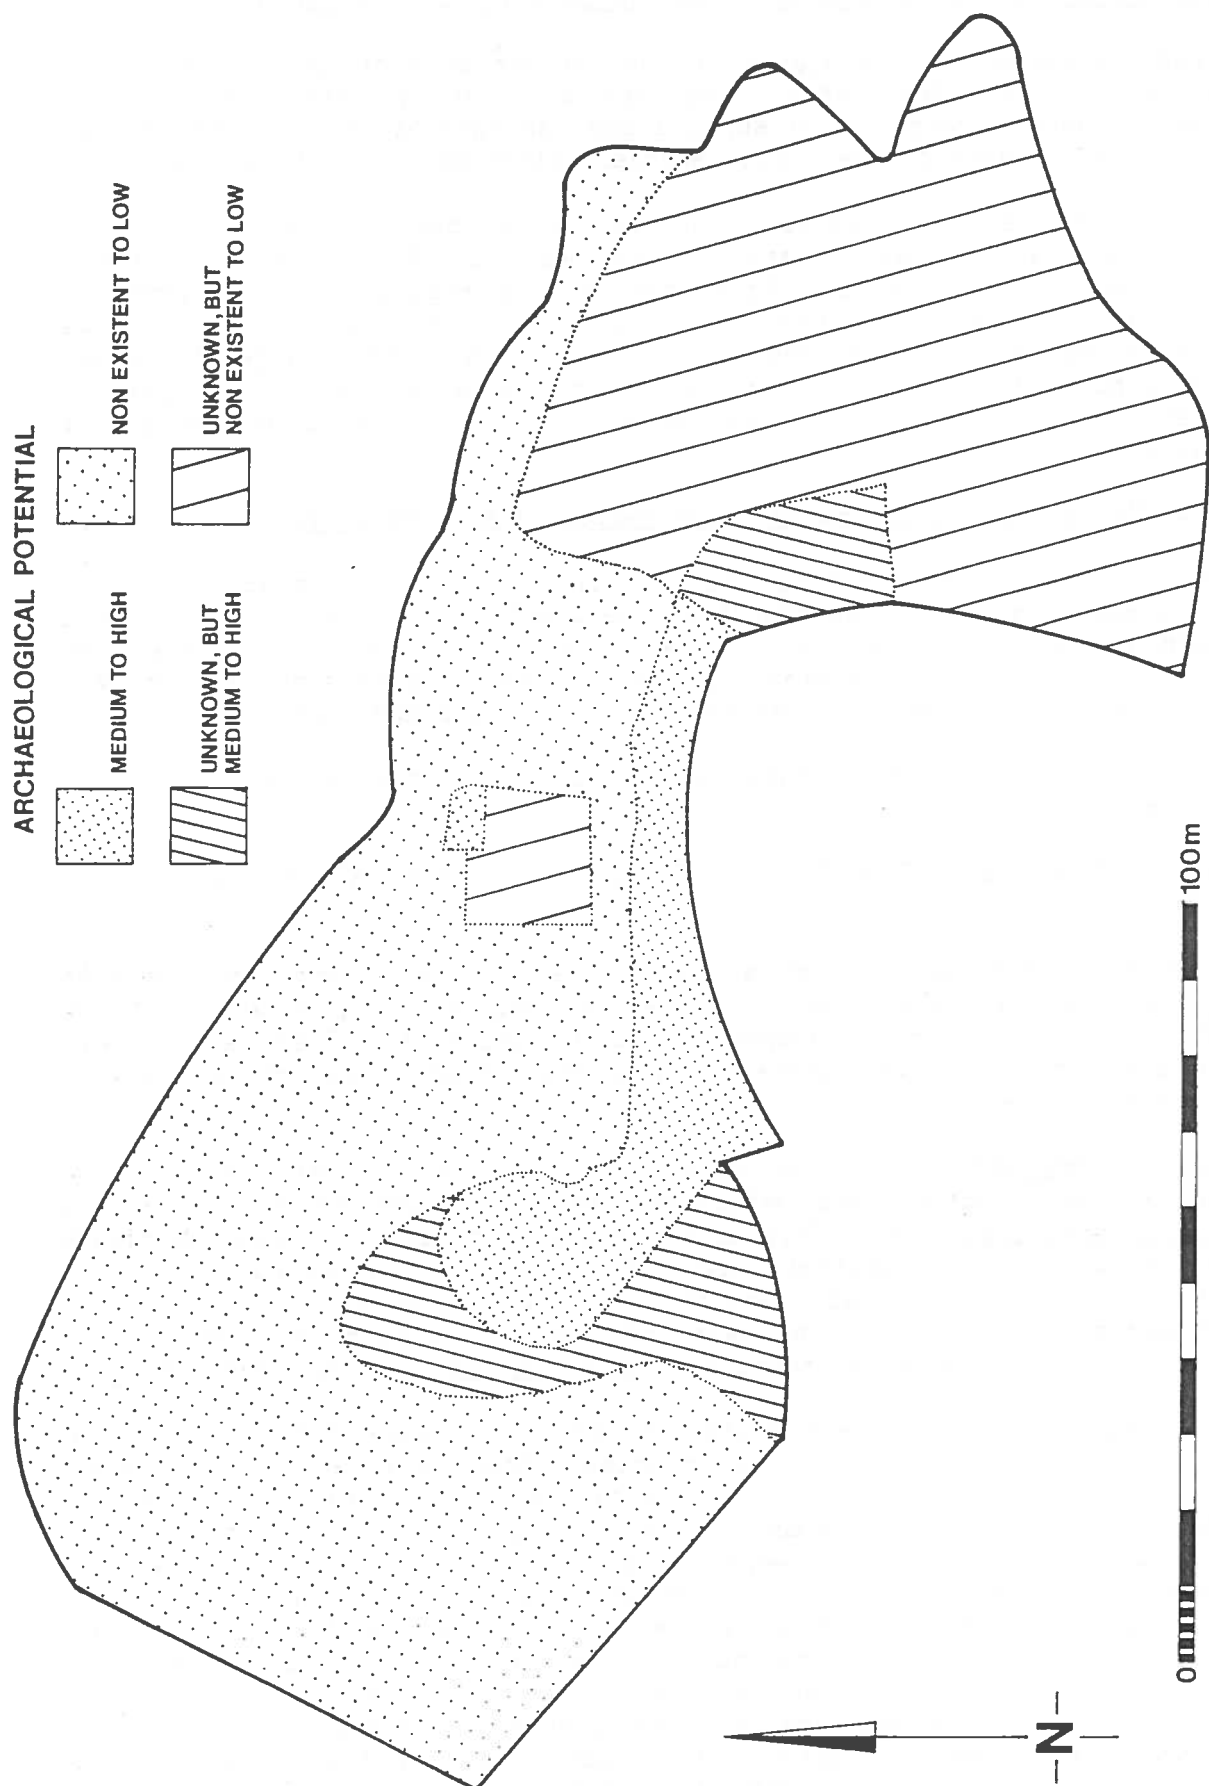
Fig 4: Great House Farm, Llandough. Archaeological Potential Zone.

The parts of the site which display these various characteristics are outlined below and illustrated in figure 4. It is this sub-division of the site which forms the basis of the recommendations for further action given below.

The east - west arm of trench 3, all of trench 4 except its northernmost projection and the central part of trench 7 all archaeological contained deposits of potential value. By taking account of the distribution of both positive and negative archaeological evidence it is possible to suggest a zone of non existent to low archaeological potential, which extends across most of the northern area of the site as shown on figure 4.

Trenches 3 and 4 both contained up to 0.2 m of archaeological deposits, which inter alia contained human bone, charcoal, etc. These layers must be regarded as of high archaeological potential on present evidence, although it should be noted that further excavation could either enhance or lower this perceived potential. By combining both positive and negative evidence as outlined above it is therefore possible to identify a zone of medium to high archaeological potential to the north of the churchyard as shown on figure 4.

In view of the archaeological deposits in trench 4 it is possible that other areas adjacent to the churchyard wall will have potential. The land between the churchyard and the former site of 'The Gardens' is one such area. There is also a possibility that the deposits recorded in the west arm of trench 3 extended further to the north, south and west.

It is recommended that those areas marked as of non existent to low potential (both actual and estimated) should be the subject of a low intensity watching brief. This exercise would act as a failsafe to record features cut into the substrate, eg, pits, the Ffynnon y Drindon well, etc which might have escaped detection during fieldwork. It is also recommended that the surviving parts of Great House Farm, eg, the north - east corner are recorded by means of a watching brief during development.

Those areas, both actual and estimated, shown on figure 4 as of medium to high potential present a different problem. The presumption in such cases should always be to protect archaeological deposits as far as is possible within the scheme of development. The archaeologically interesting layers in the west arm of trench 3 were buried below c 1.5 m of recent deposit. It may therefore be possible to ensure that the sensitive layers are protected from damage by ensuring that foundations, service trenches, etc are not cut to a greater depth than c 1.2 m. Whether this will be possible will depend on the load bearing capacity of the overburden which may be insufficient to carry the type of houses planned for the site, particularly bearing in mind the proximity of the loose infill of the probable quarry pit in the north - south arm of trench 3. An alternative means of protection would be if the layout of the development could be so designed as to make this area over to garden space.

In the part of the site surrounding the west arm of trench 3 we therefore recommend two options for further action:

(1) the protection of the archaeological interest by the minimization of ground disturbance,

(2) if (1) is not possible the archaeological layers should be excavated and recorded prior to development.

(1) the protection of the archaeological interest by the prevention of any further ground disturbance and the raising of the ground level by at least 0.5 m,
