# PADANG HOUSE BY HOUSE

## A HOUSING & VULNERABILITY ASSESSMENT

July 2010

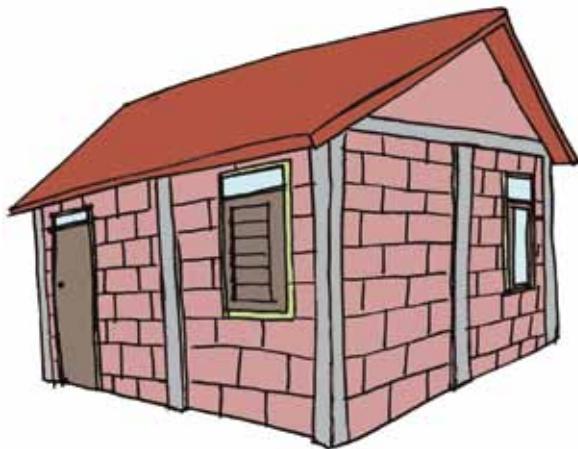
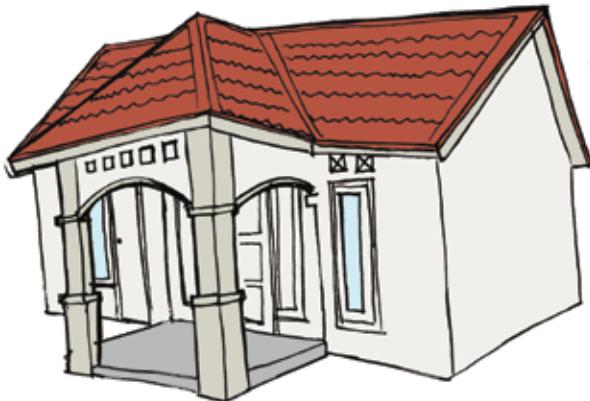
**Confined-Masonry House** – The design of this house is inherently vulnerable to earthquake, especially when constructed with poor quality materials. Because they are brick, their collapse causes injury.

Because confined-masonry buildings are made of heavy brick, serious injury is likely during collapse. The correlation between the high use of confined-masonry construction and high housing damage levels is especially clear in Purus and Parak Laweh.

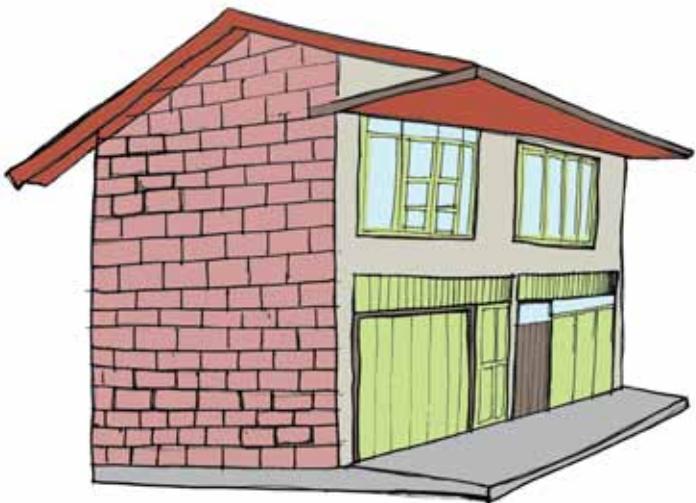
**Load-Bearing Wall** – The brick and timber in *rumah toko* are strong materials. Shared party-walls make them less likely to collapse, but many are damaged from both the earthquake and years of neglect.

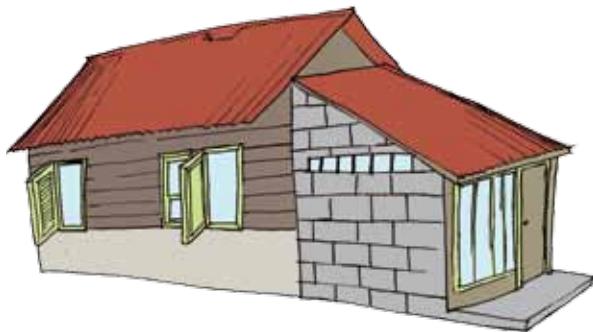
**Semi- and Non-Permanent House** – These houses have internal and roof damage, but the earthquake caused less damage since many have wood rather than confined-masonry frames.

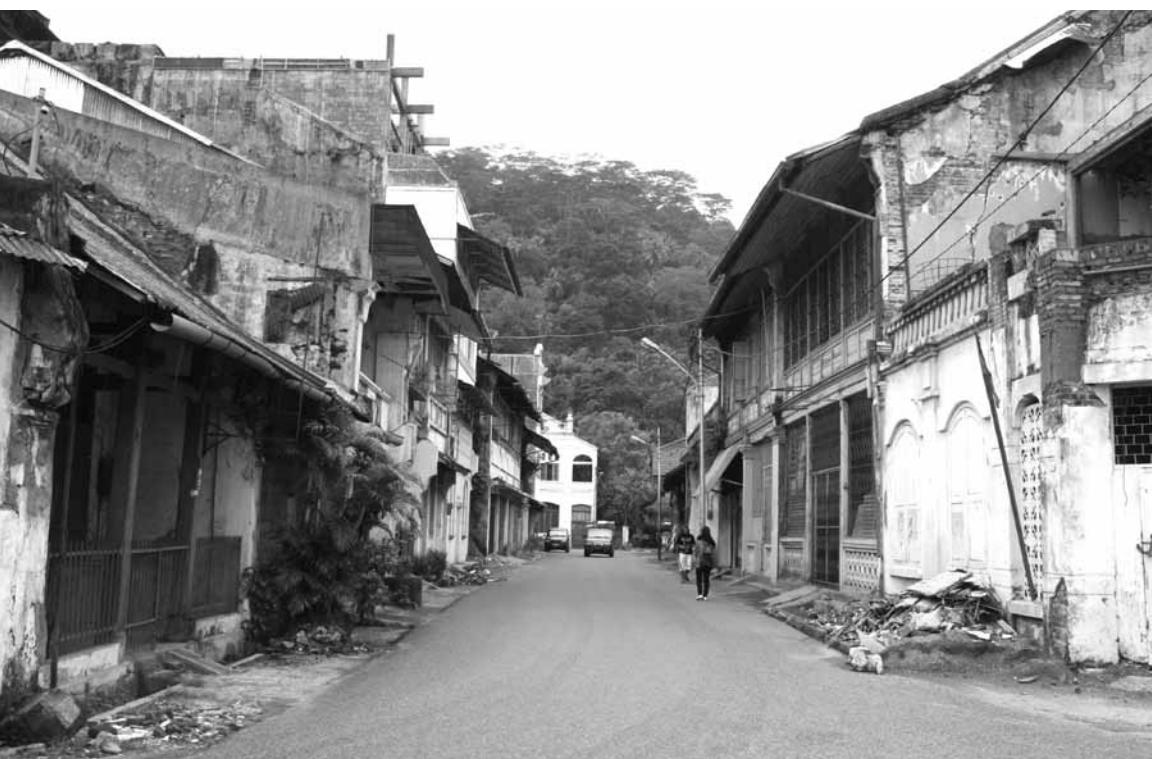
Many of the colonial-era *rumah toko*, an important source of cultural heritage, have significant damage from the earthquake.

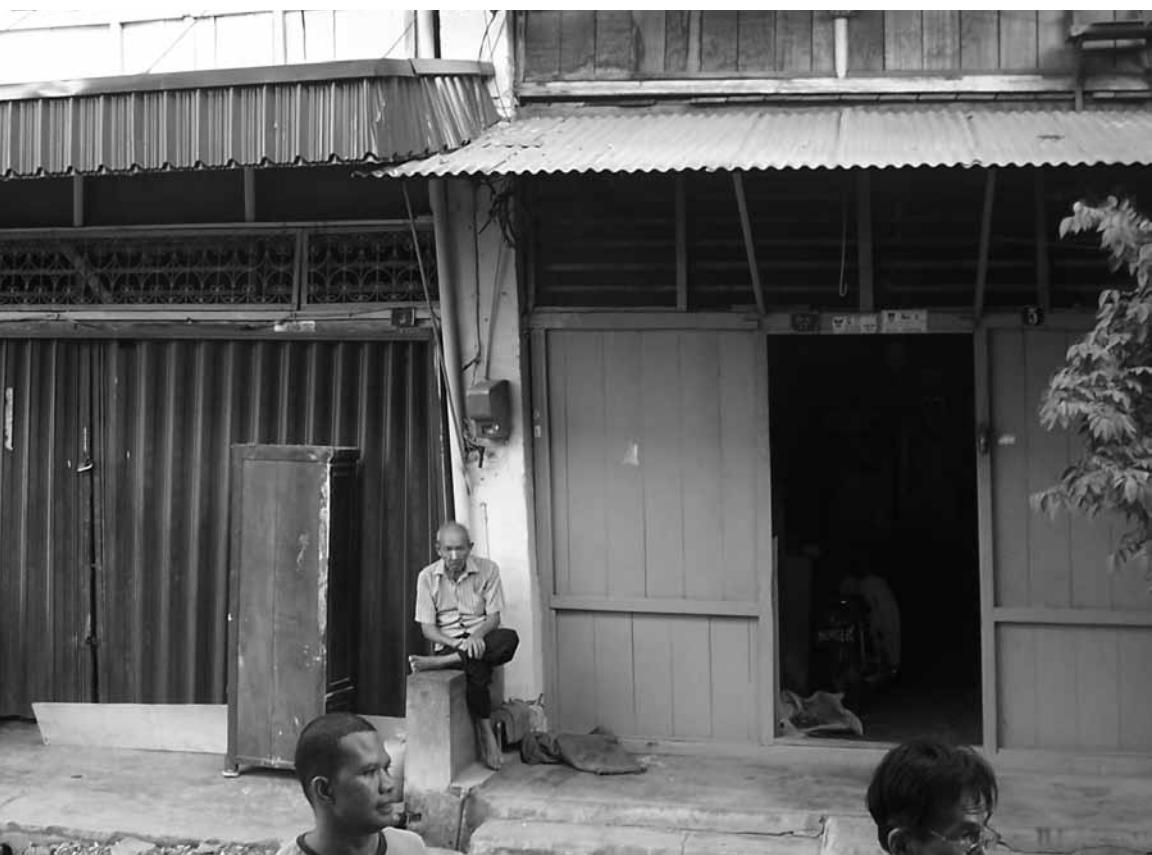
Traders who live in *rumah toko* face the complicated and expensive challenge of rebuilding severely damaged traditional buildings.

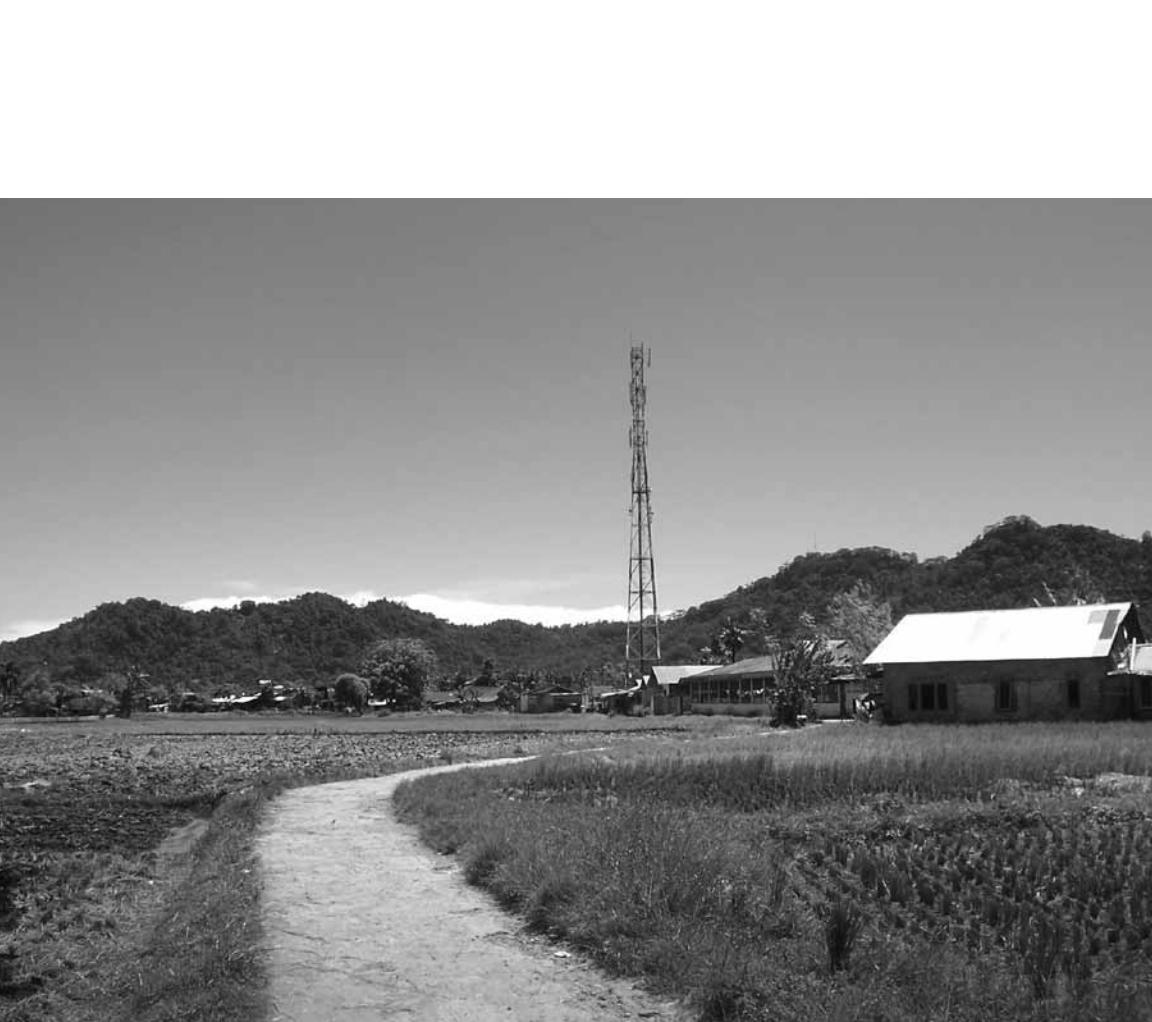
Three-fourths of the housing in Parak Laweh has earthquake damage. Most housing in Parak Laweh is confined-masonry. The physical vulnerability of these confined-masonry houses is increased by poor foundations laid on the improperly compacted soil of former rice fields.

**Rice fields in central Parak Laweh.**

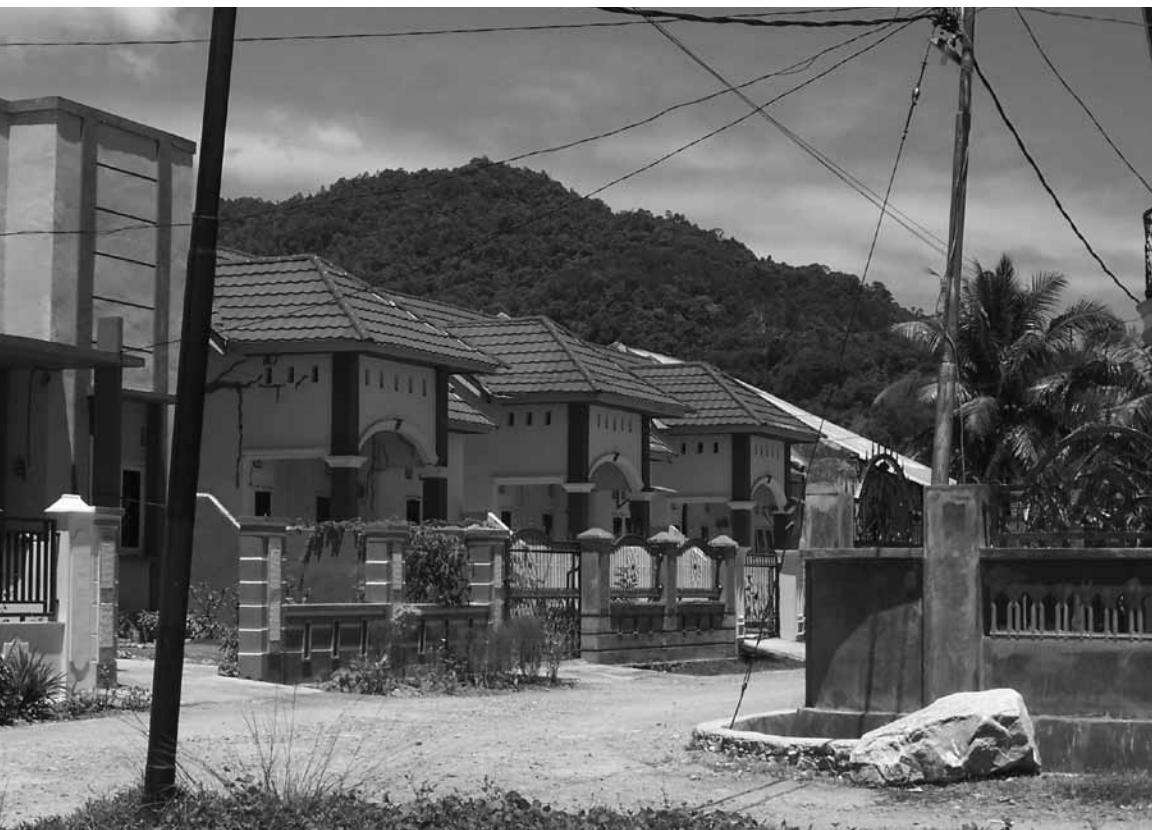
- People of all incomes lack resources to rebuild. People in poverty lack income and savings to invest in housing. Higher-income residents in Parak Laweh often have significant debt on their houses, which prevents them from spending income on rebuilding.
- Based on visual observation, damage is more severe in new housing districts than in older areas where housing is self-built.
- Information is available about earthquake-resistant construction, but the community perception is that it is too expensive to build.

New housing districts like this one are being constructed on former rice fields in Parak Laweh.

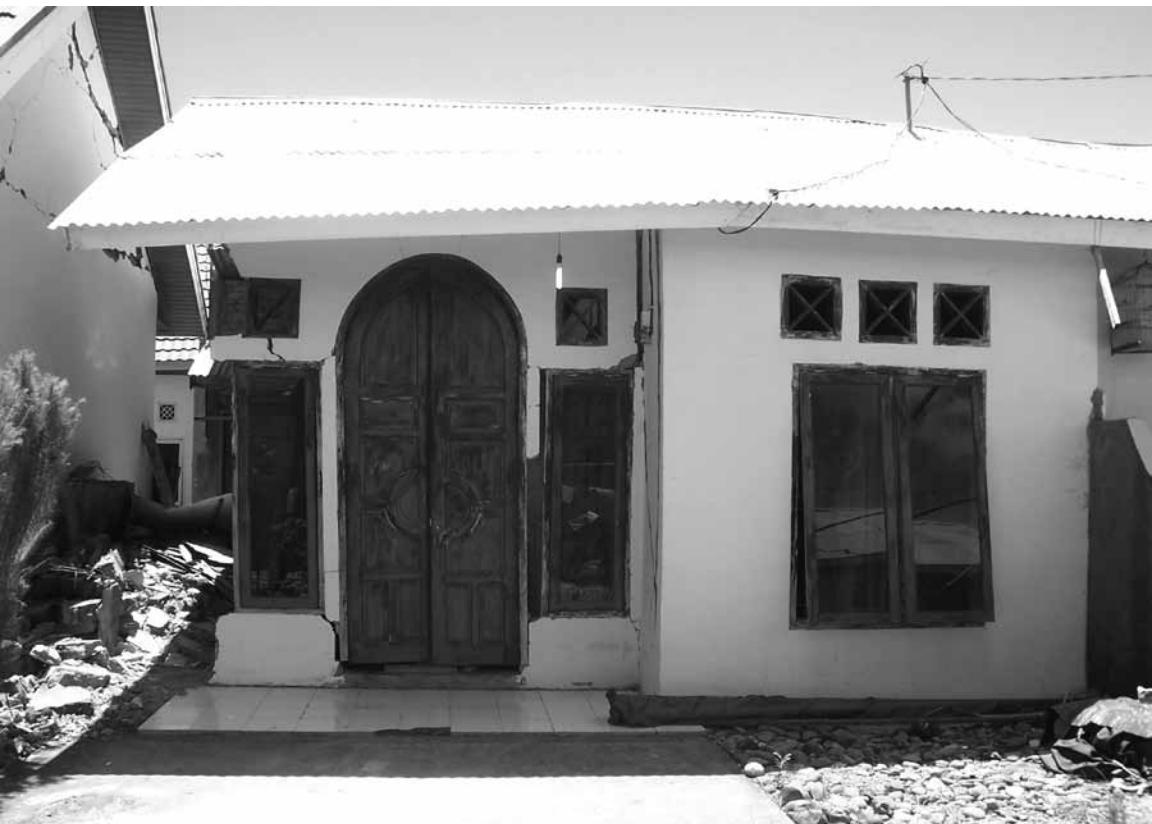
New confined-masonry housing in the new developments is severely damaged from the earthquake.
