# GAADI INSPECTOR

INSPECTION REPORT

GI-20260830-DEMO01

| REG. NUMBER | BA 01 PA 1234 | VEHICLE | 2020 Toyota Corolla |

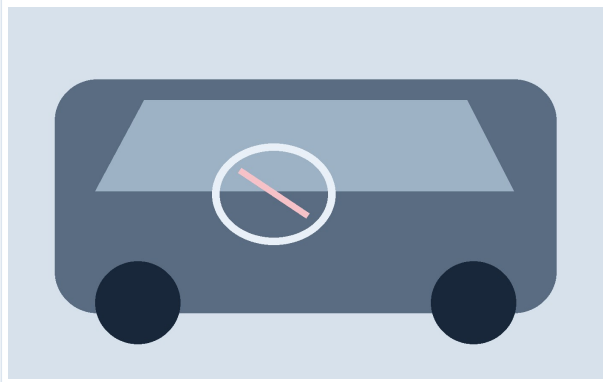
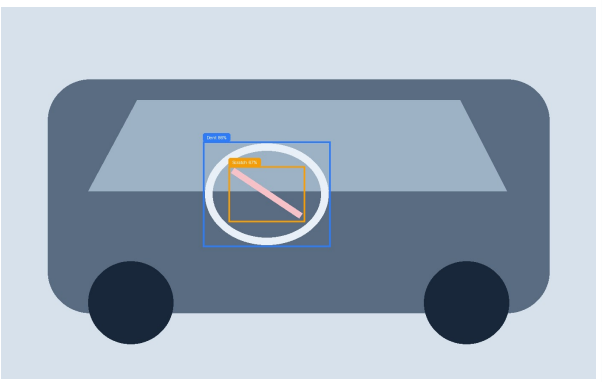
| ID | Damage | Confidence | Review | Inspector note |
|---|---|---|---|---|
| D-01 | Dent | 86.0% | Accepted | Visible deformation on the left door panel. |
| D-02 | Scratch | 67.0% | Needs review | Confirm under neutral lighting; reflection is present. |
