# INDEX INSTRUMENT SERVICE ADVISORY

PRODUCT: ALCYON (TM) 300 Rev 1 (119)	DATE: 17-AUG-1999
--------------------------------------	----------------------

## INSTRUMENT SERVICE ADVISORY

SUBJECT: Dual Voltage Heater	ISA#: 119-018
ORIGINATOR: Emil Jivan	PRODUCT: ALCYON® 300 Rev 1 (119)
APPROVED: Kathy Jennings 17-AUG-1999	EFFECTIVITY DATE: 17-AUG-1999

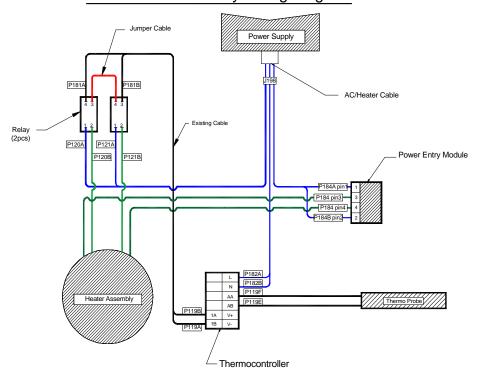
Figure 3

Dual Heater Assembly Wiring Diagram

4 Connect AC/Heater Cable to Both Reaction
Temperature Relays as follows:
Terminal P120A to Position 1 of the Left Relay
Terminal P121A to Position 1 of the Right Relay
See Electrical Schematic in Figure 3.

5 Connect AC/Heater Cable to Temperature Control
Module (Thermocontroller) as follows:
Terminal P182A to Line
Terminal P182B to Neutral
See Electrical Schematic in Figure 3.

1 Connect Heater Assembly Cables to Both Reaction
Temperature Relays as follows:
Terminal P120B to Position 2 of the Left Relay
Terminal P121B to Position 2 of the Right Relay
See Electrical Schematic in Figure 3.

Terminal P184 pin3 to Position 3 of PEM Terminal P184 pin4 to Position 4 of PEM See Electrical Schematic in Figure 3.

Terminal P181A to Position 4 of the Left Relay Terminal P181B to Position 3 of the Right Relay See Electrical Schematic in Figure 3.

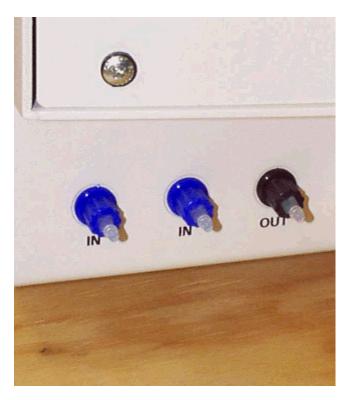
Blue (IN) Blue (IN) Black (OUT)

(Shown without external tubing connected)

Each colored tubing port at the rear panel has been cataloged as shown below and will be reflected in the next release of the FRU Database CD ROM. Orders and forecasts for these parts should be placed through normal logistics channels.

Color	Port	Cat. Number	Qty	Comment
Blue	IN (2)	2-83738-01	1 ea.	3 pieces make up this part
Black	OUT	2-83739-01	1 ea.	3 pieces make up this part

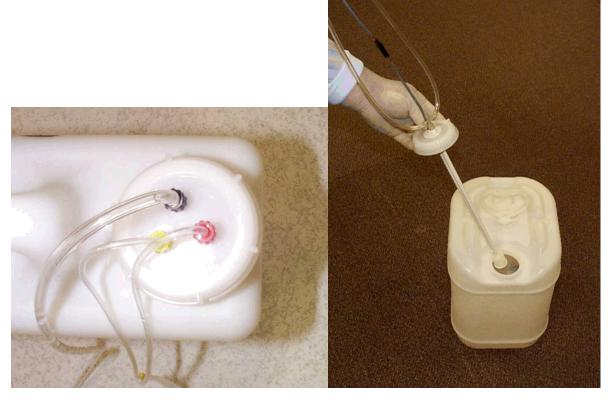
New style waste cap with colored connectors

New DI Water Container and new Water Gage and Cap (same new style container for Waste)

Other new part numbers (see pictures below). Orders and forecasts for these parts should be placed through normal logistics channels.

New Part	List Number	Comment
Water Gage (new float type)	05D01-02	Includes Gage, LS Cable, large and small
		Caps, and two IN line tubings with blue
		fittings. Gage height is adjustable and may be used
		with any water container.
		Old Water Gage is no longer available.
Water/Waste Container (2) (new type)	05D26-02	Original containers no longer available.
		Deeper than original container.
		Must use new Cap (01G81-01) in order to
		use new Water Gage (05D01-02).
		May use old Water Gage (05D01-01) with
		the new Water container.
Water Container Level Sense Cap	01G81-01	Cap with hole in it for new Water Gage.
Waste Container Cap	01G80-01	Cap with 3 color-coded ports for the 3
		waste tubes.
Water Container 70mm Cap	01G79-01	Cap without hole for Water Gage.
		(Optional)

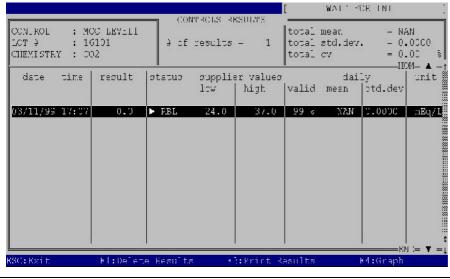
Version 1.5	New Version 1.6
The mean for control results is different on the Control Results screen and the <f4> Graph. The mean was calculated using the first 120 unflagged results.  (see graphic below)</f4>	The mean in both screens will be the same. The mean will be calculated using all unflagged results.  NOTE: The graph will include all results (both flagged and unflagged).

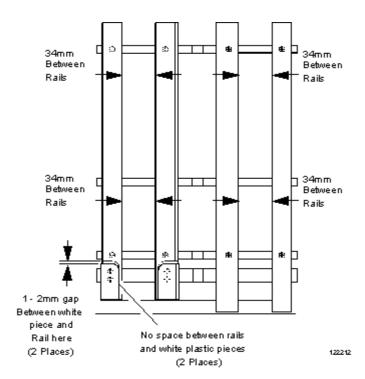
Figure 1

- 7. Pg. 5-101, For VP-44, refer to ISA 120-001.
- Pg. 5-105, Incorrect figure for the Load/Unload alignments, refer to figure #1 following this section.

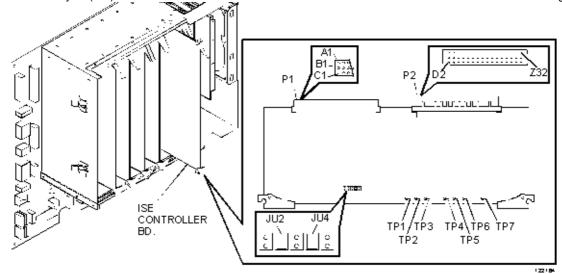
Figure 2

- 5. Pg. 4-225, Incorrect figure for ISE Controller BD., refer to figure #2 following this section.
- 6. Pg. 4-230 Replace existing text under verification step 1a, with 1) Initialize Sample Transfer Arm, 2) Initialize Sample Syringe and remove text in line #3.

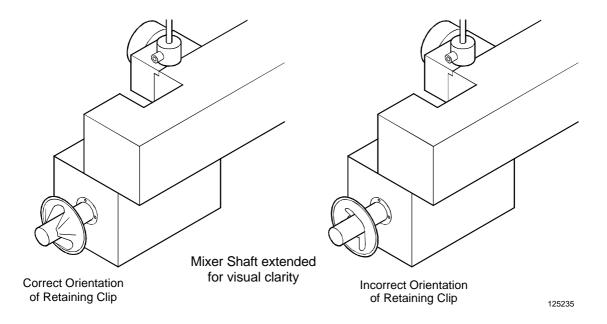
- a) The position and orientation of the clip are important to the Mixer operation. The clip should be positioned 3-4mm from the end of the shaft. If placed too far on the shaft, it will inhibit the operation of the Mixer.
- b) See the figure below for the correct *orientation* of the clip. If oriented incorrectly, the clip may, in time, slide out of position.
