# DUAL PRODUCT QUALITY COMPLAINT & SAFETY INCIDENT REPORT

## PART A: PRODUCT QUALITY COMPLAINT (PQC)

| Product Name: | SynthoVial |
| Batch / Lot Number: | Lot B9912 |

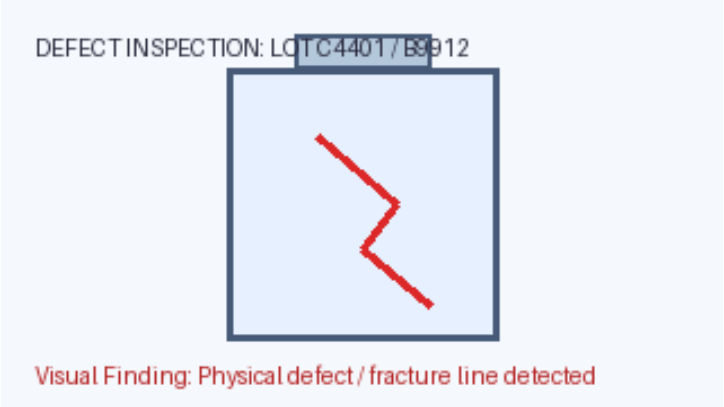
### ATTACHED DEFECT PHOTOGRAPH / SCHEMATIC:

| Defect Description: | Cracked glass vial neck with product leakage upon carton opening |
| Packaging Condition: | Damaged packaging / cracked vial |
