# E-900 Tilt-Up Door Repair

Progress report · San Leandro, CA · Customer identity and exact location redacted

E-900 tilt-up door structural repair progress

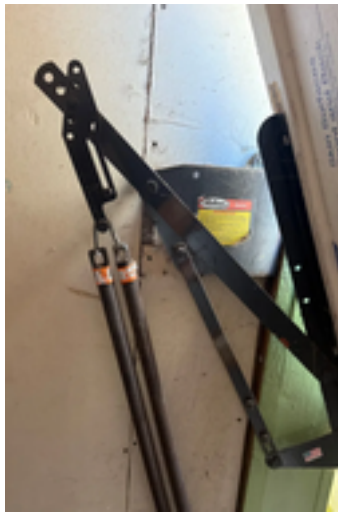
**Before: worn E-900 hinge and spring hardware**

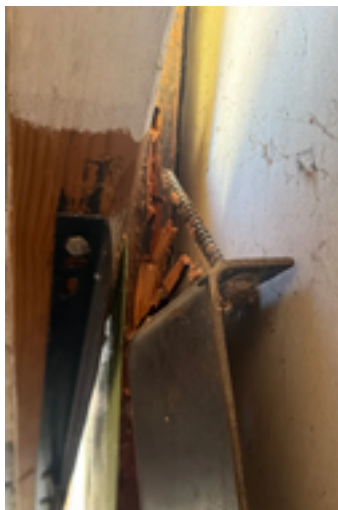
Worn E-900 hardware and a hinge pulling away from deteriorated wood.

**Failure: hinge pulling from damaged wood**

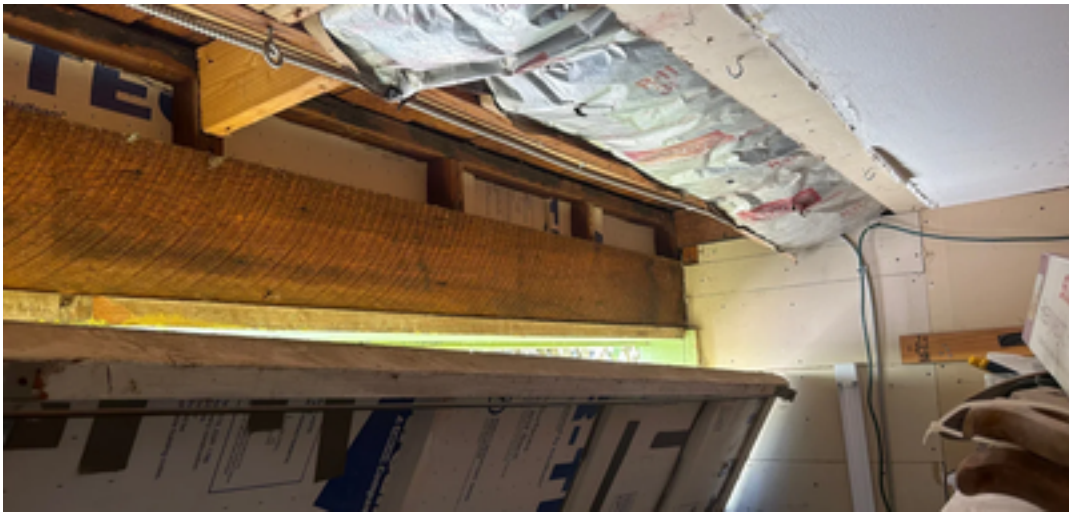
Low clearance and off-track condition documented before hardware removal and framing exposure.

**Condition: low clearance and door off track**

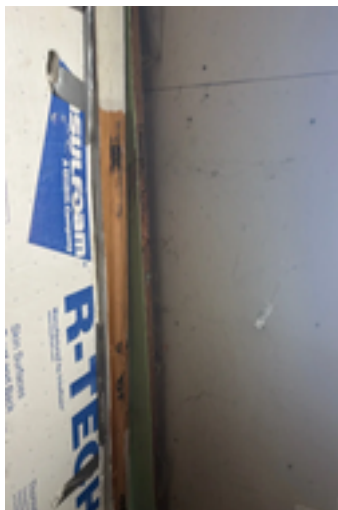
**Disassembly: E-900 hardware removed and framing exposed**
