Report Number: 076276

Town of Ladysmith  
PO Box 220, 410 Esplanade  
Ladysmith BC V9G 1A2

**Re: Non-compliance Advisory Letter, Permit 120, Ladysmith, BC, Effluent**

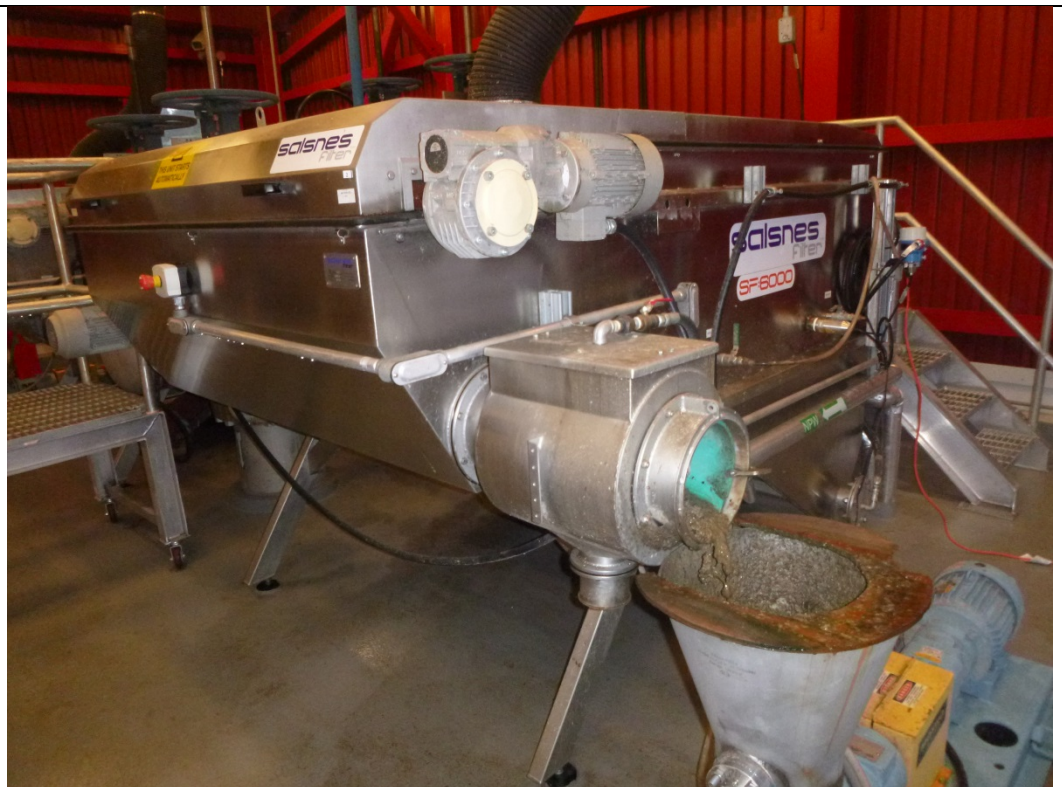
Photo 2

Two Salsnes  
Fliters used  
for primary  
treatment

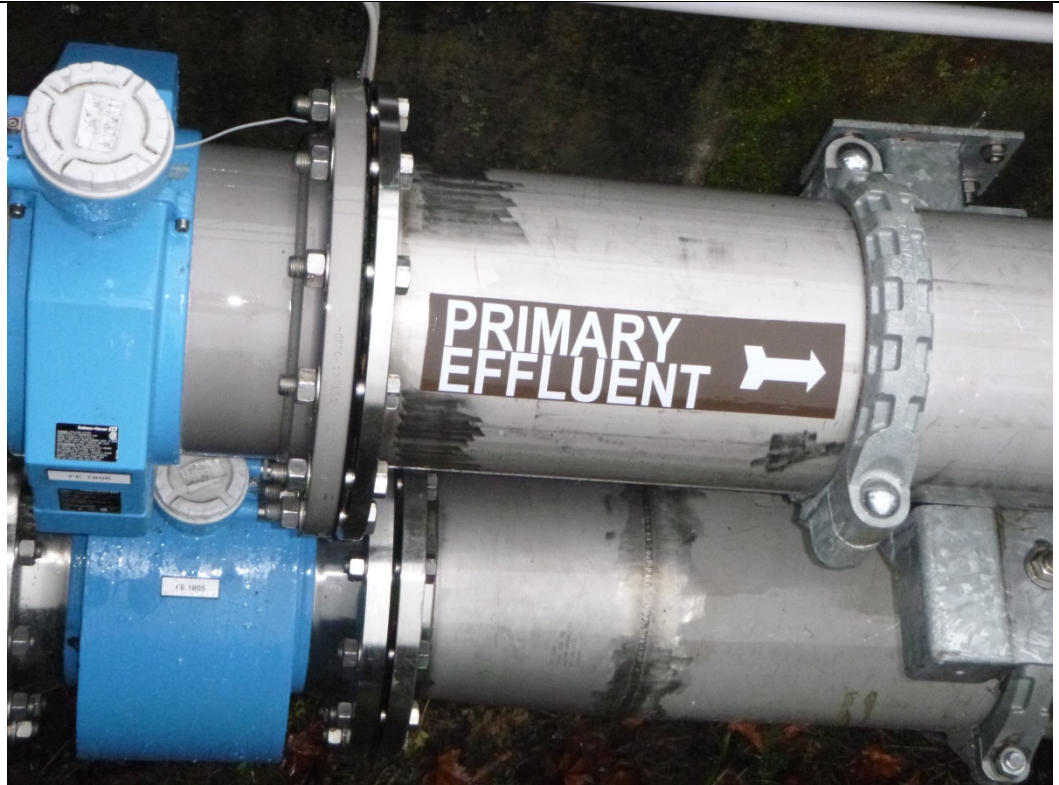
Photo 5

| Details/Findings: | <p>Officer Stewart observed a magmeter maintained as a suitable flow measuring device, which records once per day the effluent volume discharged over a 24-hour period.</p> |

Endress +  
Hauser Flow  
meters.

Lower pipe is  
the treated  
effluent  
discharge.
