Report Date: January 23, 2018

Report Number: 076276

**Re: Non-compliance Advisory Letter, Permit 120, Ladysmith, BC, Effluent**

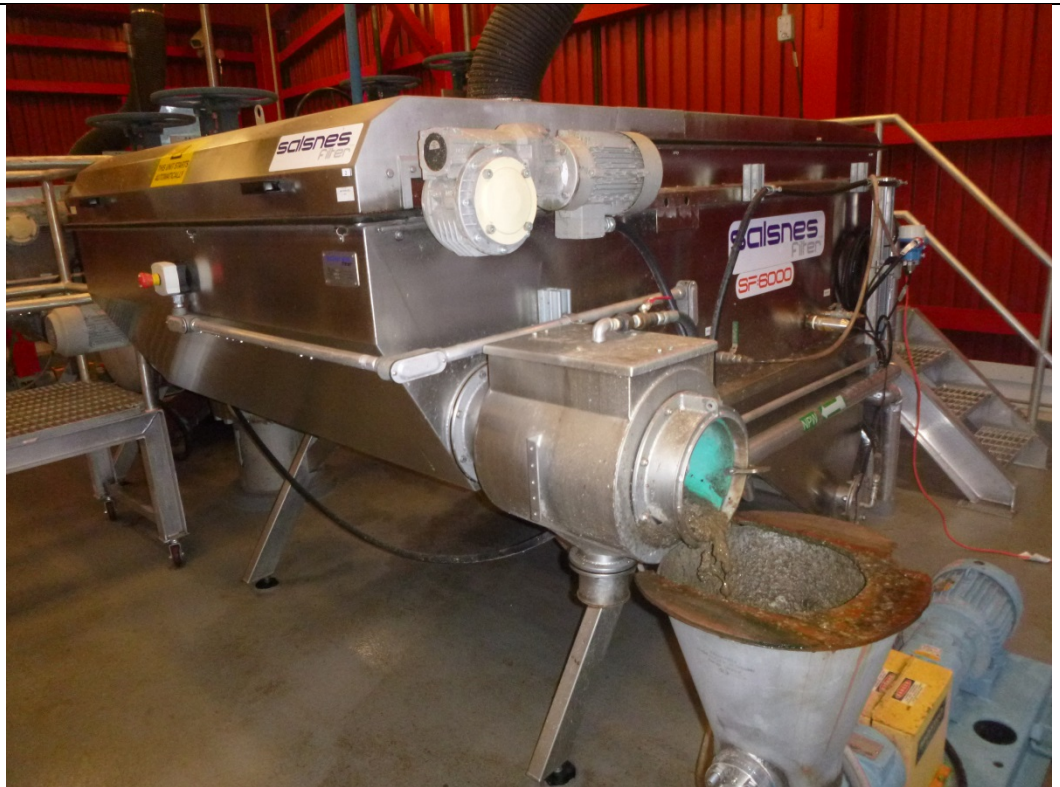
Photo 2

Two Salsnes  
Fliters used  
for primary  
treatment

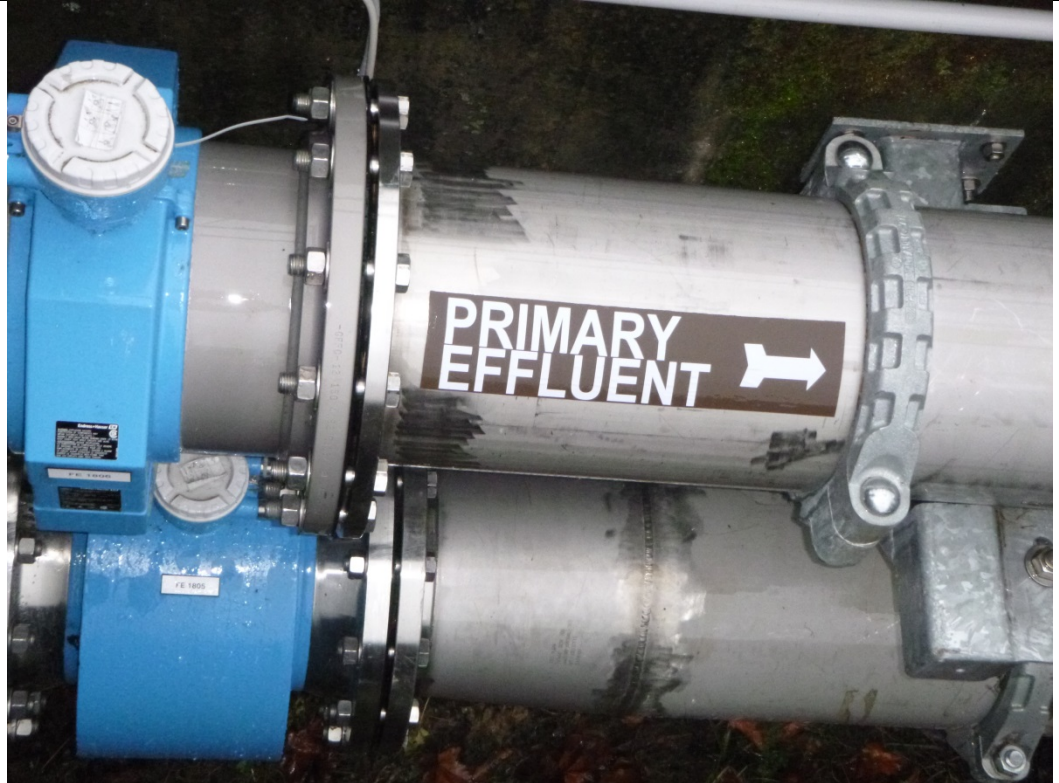
Photo 5

| Details/Findings: | <p>Officer Stewart observed a magmeter maintained as a suitable flow measuring device, which records once per day the effluent volume discharged over a 24-hour period.</p> |

Endress +  
Hauser Flow  
meters.

Lower pipe is  
the treated  
effluent  
discharge.
