Report Date: January 23, 2018

Report Number: 076276

**Re: Non-compliance Advisory Letter, Permit 120, Ladysmith, BC, Effluent**

| NRIS IR #: 76276 | Site Inspection Date: January 11, 2018 |

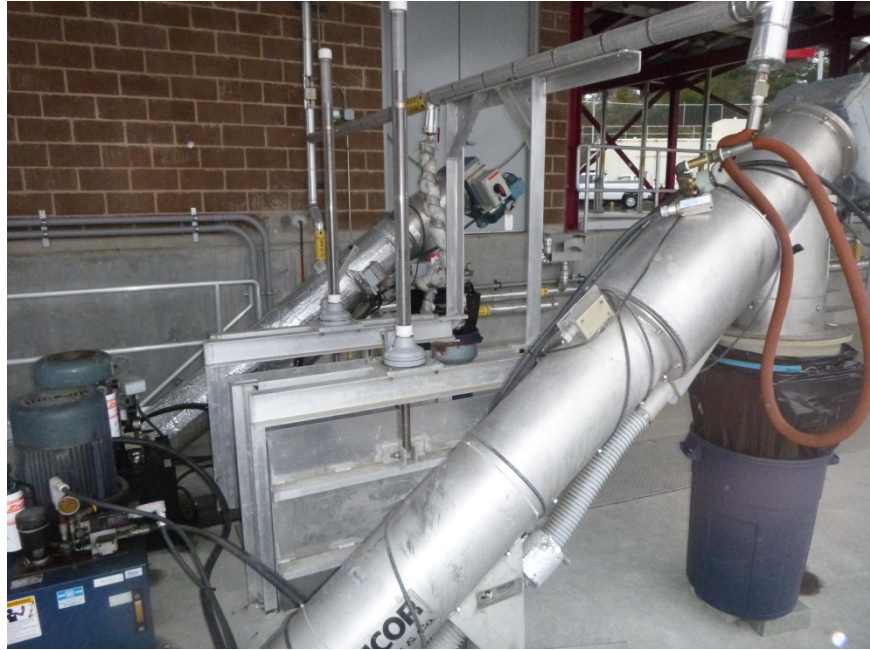
Photo 1

Influent  
Screening

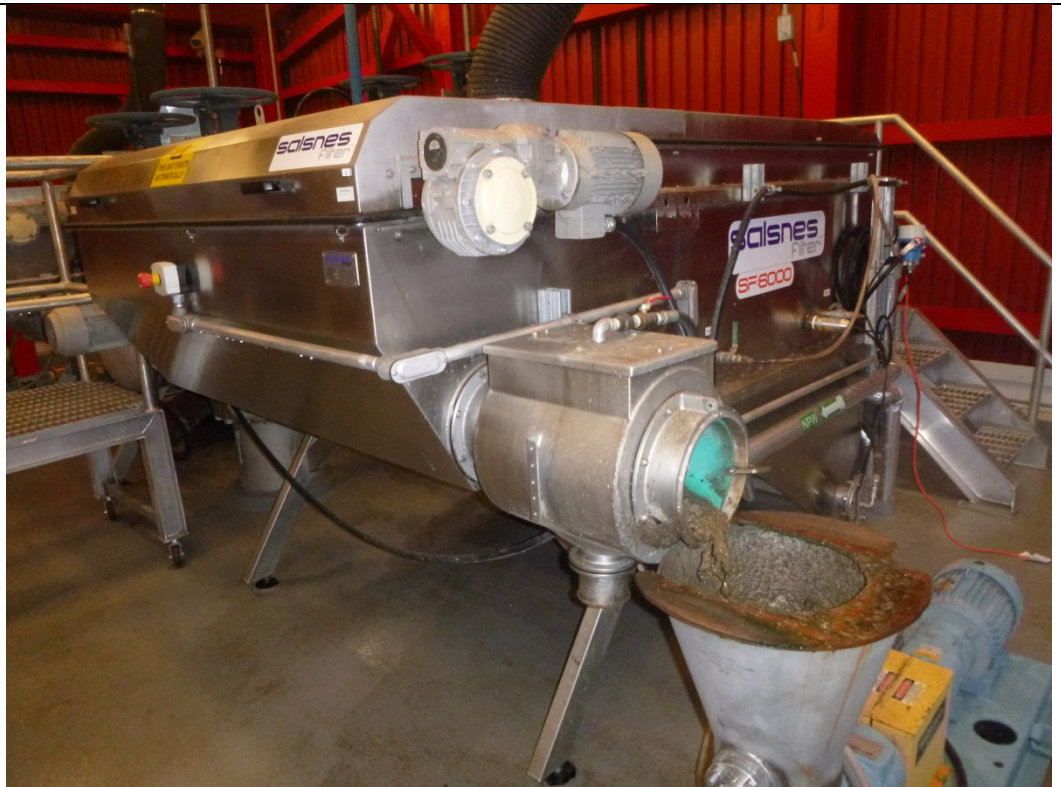
Photo 2

Two Salsnes  
Fliters used  
for primary  
treatment

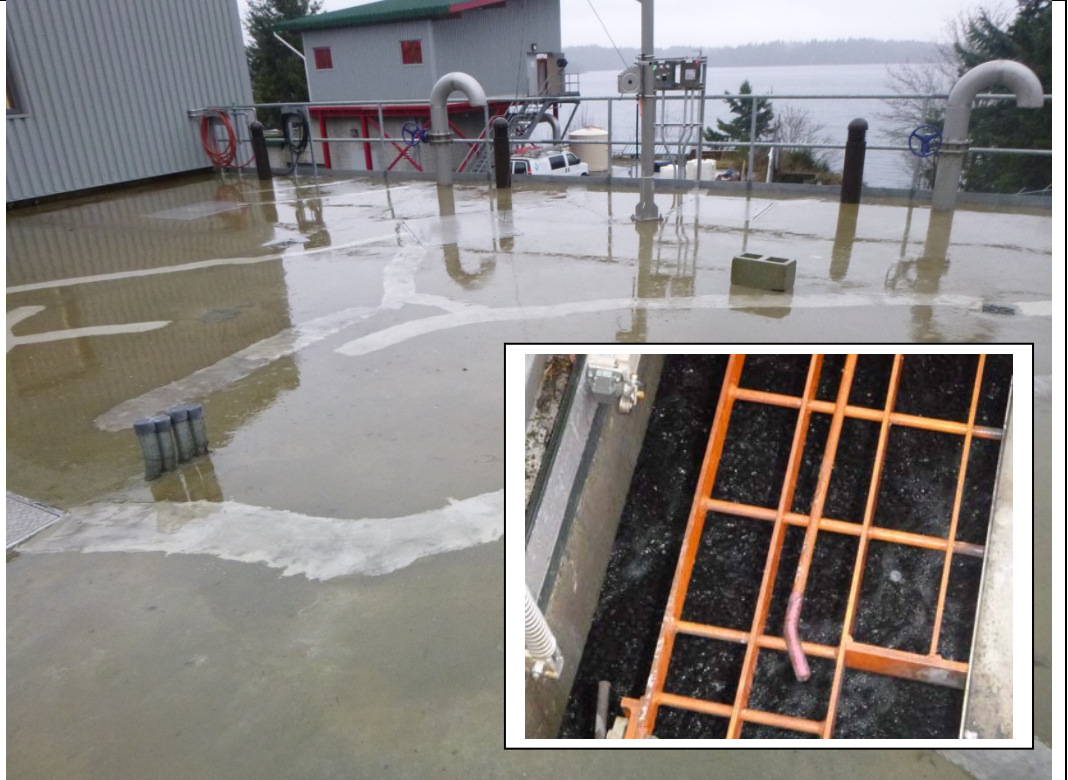
Photo 3

| Details/Findings: | <p>Mr. Goodall informed Officer Stewart that a new treatment plant consisting of a moving bed bioreactor ("MMBR") was constructed and operational as of June 2016, thus replacing the Spiragester primary type treatment plant. Officer Stewart observed the MMBR in operation during the inspection although it is not an authorized work as specified by this section.</p> <p>Due to changes in Ministry guidance and direction for the Town of Ladysmith regarding an updated authorization either via a registration under the Municipal Wastewater Regulation ("MWR"), an Operational Certificate under a Liquid Waste management Plan ("LWMP") or a permit amendment, compliance with this requirement was not determined.</p> |

Secondary (biological) treatment using a moving bed bioreactor (MMBR) inside large tank.

Inset:  
View inside the MMBR

| Actions to be taken: | <p>Follow up with the BC Ministry of Environment and Climate Change Strategy, South Authorizations section which will provide guidance and recommendations for the appropriate form of authorization for this facility.</p> <p>Please contact the South Authorizations Section Head, Bryan.Vroom@gov.bc.ca for further information.</p> |

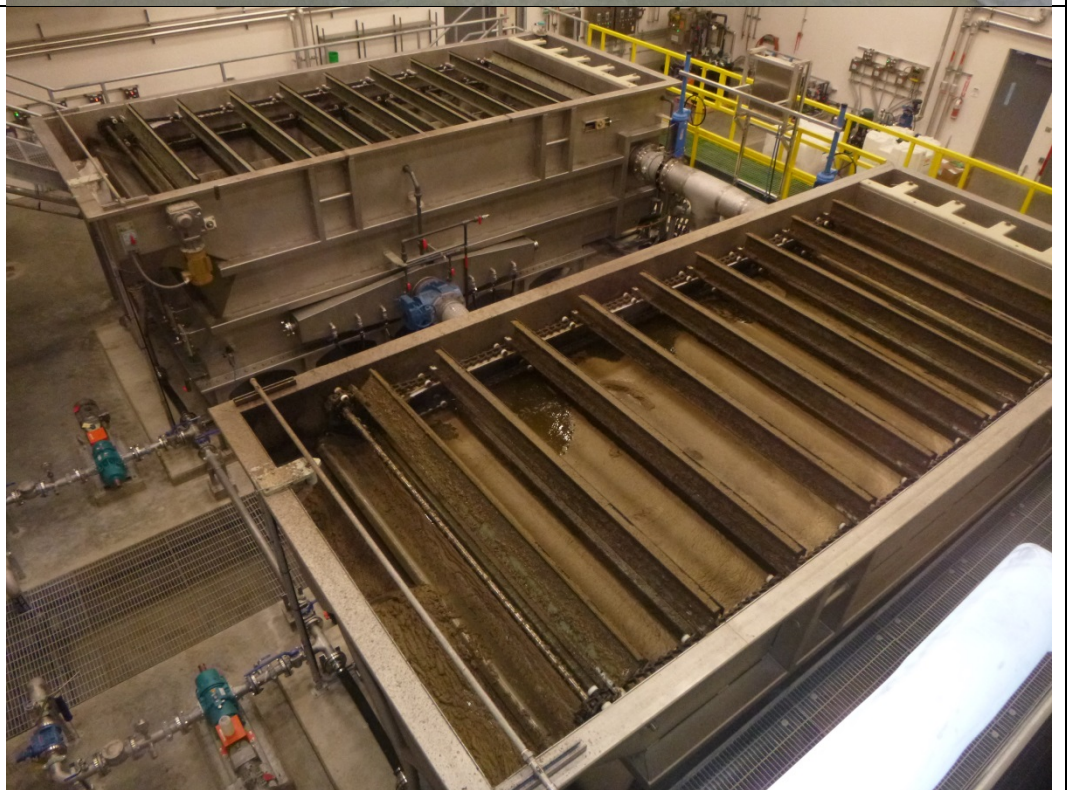
Photo 4.

Dissolved air flotation (DAF) tanks and skimmers for clarification (separation and removal of biological solids).

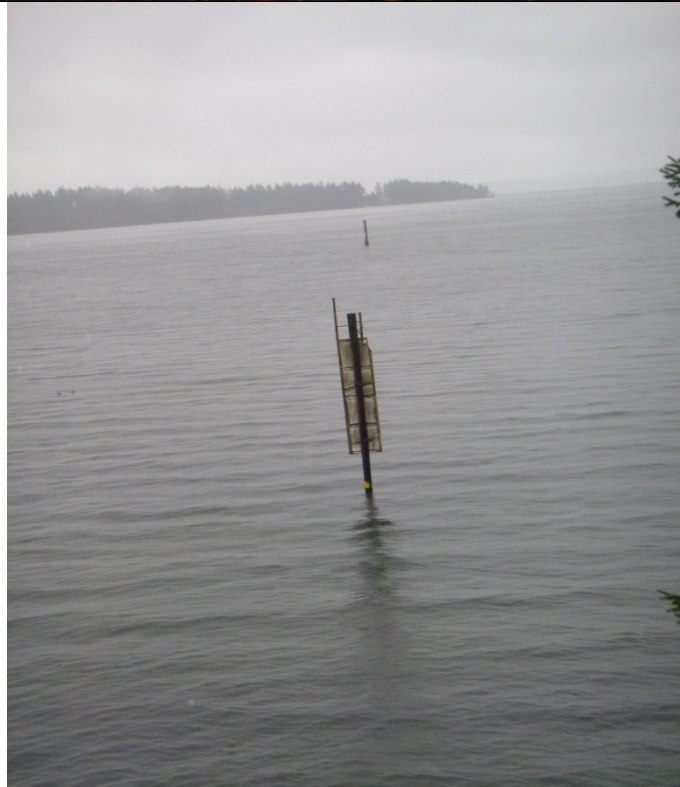
Photo 6

| Details/Findings: | <p>Officer Stewart observed a sign in the waters of Ladysmith Harbour that Mr. Baker confirmed was the outfall sign for the wastewater treatment facility.</p> <p>However, due to access issues Officer Stewart did not assess the shoreline for a sign erected along the alignment of the outfall above the high water mark, therefore compliance with this requirement was not determined.</p> |

Outfall  
signage in the  
water.

Required  
signage on  
shore above  
the high water  
mark was not  
confirmed.
