CASE STUDY: Rotor Bar Fault in AC Induction

Pioneer was working with a client in the coal-fired power plant industry to identify a malfunction in one of their AC induction motors. This AC induction motor was fitted with journal bearings and was the driver for a Primary Air Fan. The client had proximity probes and case mounted accelerometers installed on the AC induction motor. At first, the proximity probes seemed to indicate a rotor bar fault, while the accelerometers gave the impression of some kind of impact event happening. After analyzing the data and correctly identifying the malfunction as a rotor bar fault, Pioneer wanted to help their client get better data on their assets and capture data on their uncovered equipment to help them run their plant with more efficiency. Pioneer recommended that their client test the Insight Force Detection System (FDS) on the AC induction motor with the known rotor bar fault in conjunction with the proximity probes and accelerometers to see that they could have better data and less installation costs if they had used the Insight FDS. The customer ordered 40 more Insight FDS to install throughout their plant.

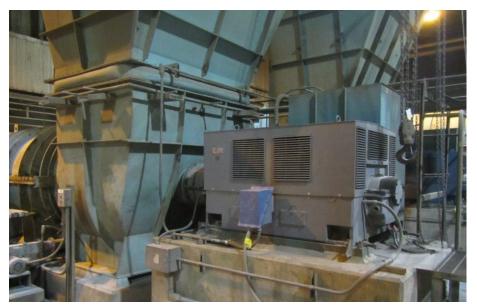
Figure 1 - Primary Air Fan

A 1500 HP AC induction motor is the driver for a Primary Air Fan at a coal-fired power plant. The motor rotor is supported with two journal bearings. The fan, shown in *Figure 1*, is critical to operations and is scheduled to run continuously.

As a result, the customer replaced the motor at the next shutdown. Additionally, they placed an order for 40 Insight FDS to be installed in the plant on ID fans, FD fans, PA fans and Boiler Feed Pump motors.
