### Summary

Pioneer was working with a client in the coal-fired power plant industry to identify a malfunction in one of their AC induction motors. This AC induction motor was fitted with journal bearings and was the driver for a Primary Air Fan. The client had proximity probes and case mounted accelerometers installed on the AC induction motor. At first, the proximity probes seemed to indicate a rotor bar fault, while the accelerometers gave the impression of some kind of impact event happening. After analyzing the data and correctly identifying the malfunction as a rotor bar fault, Pioneer wanted to help their client get better data on their assets and capture data on their uncovered equipment to help them run their plant with more efficiency. Pioneer recommended that their client test the Insight Force Detection System (FDS) on the AC induction motor with the known rotor bar fault in conjunction with the proximity probes and accelerometers to see that they could have better data and less installation costs if they had used the Insight FDS. The customer ordered 40 more Insight FDS to install throughout their plant.

A 1500 HP AC induction motor is the driver for a Primary Air Fa

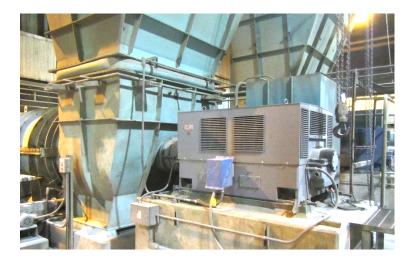
Figure 1 - Primary Air Fan

As a result, the customer replaced the motor at the next shutdown. Additionally, they placed an order for 40 Insight FDS to be installed in the plant on ID fans, FD fans, PA fans and Boiler Feed Pump motors.
