Summary

Pioneer was working with a client in the coal-fired power plant industry to identify a malfunction in one of their AC induction motors. This AC induction motor was fitted with journal bearings and was the driver for a Primary Air Fan. The client had proximity probes and case mounted accelerometers installed on the AC induction motor. At first, the proximity probes seemed to indicate a rotor bar fault, while the accelerometers gave the impression of some kind of impact event happening. After analyzing the data and correctly identifying the malfunction as a rotor bar fault, Pioneer wanted to help their client get better data on their assets and capture data on their uncovered equipment to help them run their plant with more efficiency. Pioneer recommended that their client test the Insight Force Detection System (FDS) on the AC induction motor with the known rotor bar fault in conjunction with the proximity probes and accelerometers to see that they could have better data and less installation costs if they had used the Insight FDS. The customer ordered 40 more Insight FDS to install throughout their plant.

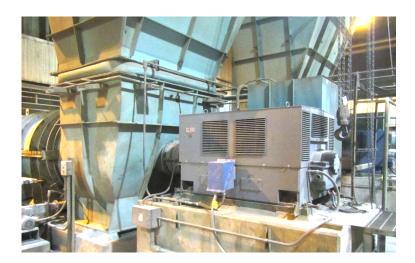
Figure 1 - Primary Air Fan

A 1500 HP AC induction motor is the driver for a Primary Air Fan at a coal-fired power plant. The motor rotor is supported with two journal bearings. The fan, shown in Figure 1, is critical to operations and is scheduled to run continuously.

As a result, the customer replaced the motor at the next shutdown. Additionally, they placed an order for 40 Insight FDS to be installed in the plant on ID fans, FD fans, PA fans and Boiler Feed Pump motors.
