## 4201 E 72ND AVE

COMMERCE CITY CO 80022

PROPERTY TYPE  
Commercial Government Building

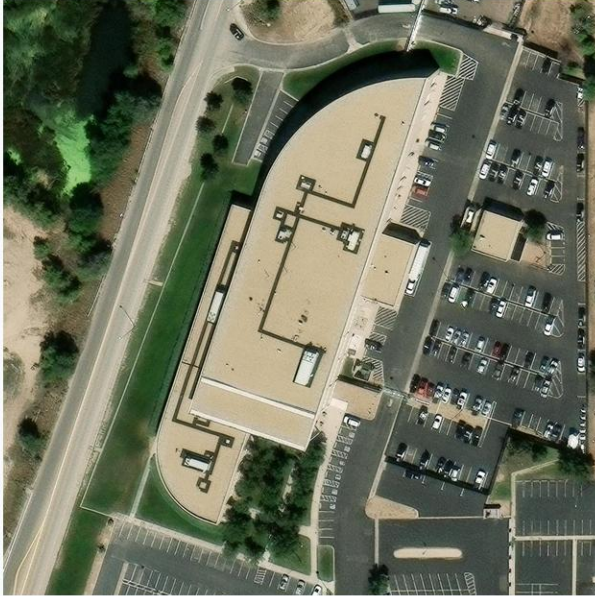
SELECTED AERIAL IMAGE - ESRI WORLD IMAGERY AS OF 11/13/2025

1. Visible risk factors include dark staining or inconsistent roof color, high penetration or rooftop-unit density, tree overhang or roof debris exposure.
2. The roof is predominantly a low-slope, light-colored membrane surface with parapet-like edges and multiple rooftop appurtenances.
3. Visible dark linear and patch-like features suggest seams, transitions, or maintenance-related components; exact system type cannot be confirmed from aerial imagery alone.
4. Localized discoloration is present in several areas, especially near roof sections and transitions, but no clear large-scale ponding is evident from this view.
5. Rooftop equipment, vents, and curbs are present and increase leak-prone detail density.

This commercial low-slope roof appears serviceable but not pristine. The aerial view shows a generally intact light-colored membrane with multiple rooftop penetrations and several darkened/discolored areas that could reflect prior repairs, localized moisture retention, or surface wear. No obvious large ponding areas are visible, but the roof has enough detail and perimeter vegetation exposure to elevate maintenance and leak-risk concerns. The image date is 11/13/2025. Visible risk factors include dark staining or inconsistent roof color, high penetration or rooftop-unit density, tree overhang or roof debris exposure.

Continue routine roof inspections and maintenance, with emphasis on seams, flashing, curbs, penetrations, and areas of discoloration. Verify whether stained/darkened zones are cosmetic, repaired areas, or signs of recurring moisture. Trim nearby trees/vegetation where practical, and monitor drainage around roof transitions and equipment supports. Field inspection should verify drainage, moisture, penetrations, flashing, and debris-related damage.
