## 4451 E 72ND AVE

COMMERCE CITY CO 80022

OVERALL ROOF CONDITION SCORE

**69** /100  
FAIR

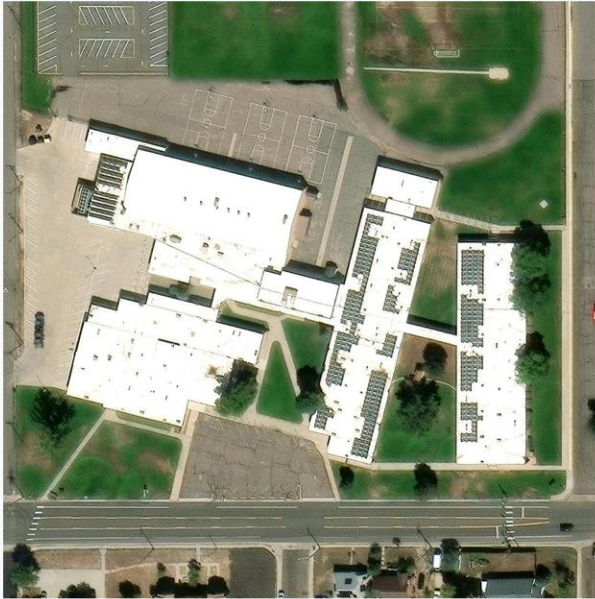
SELECTED AERIAL IMAGE - ESRI WORLD IMAGERY AS OF 11/13/2025

1. Visible risk factors include dark staining or inconsistent roof color, high penetration or rooftop-unit density, tree overhang or roof debris exposure.
2. The building has multiple connected low-slope roof sections with a predominantly white roof surface.
3. Several large solar panel arrays are present on the roof, especially on the right-side wings, adding penetrations and service complexity.
4. Darkened patches and uneven coloration are visible on portions of the roof, especially near edges and around some roof field transitions.
5. No obvious widespread ponding is visible in this image, though flat areas and staining suggest localized moisture-management concerns.

This appears to be a low-slope commercial school roof with a predominantly white roof covering and multiple solar arrays. Visible staining, uneven roof tone, and numerous roof-mounted elements suggest a serviceable but not pristine roof with moderate leak-path and maintenance risk. The imagery supports a fair condition assessment, with concern focused more on maintenance complexity and localized discoloration than on obvious widespread failure. Visible risk factors include dark staining or inconsistent roof color, high penetration or rooftop-unit density, tree overhang or roof debris exposure.

Schedule a closer rooftop inspection to verify membrane type, check seams/flashing at solar mounts and other penetrations, and evaluate the darker stained areas for prior repairs or moisture intrusion. Trim back nearby trees where feasible and confirm drainage remains clear. Because the aerial view is dated 11/13/2025, current conditions may differ from what is visible here. Field inspection should verify drainage, moisture, penetrations, flashing, and debris-related damage.
