## 5075 HIGHWAY 224

COMMERCE CITY CO 80022

PROPERTY TYPE  
Commercial Storage Warehouse

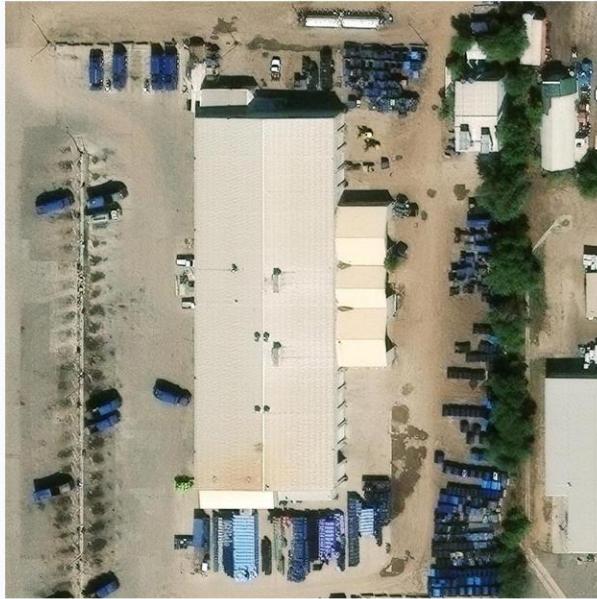
SELECTED AERIAL IMAGE - ESRI WORLD IMAGERY AS OF 11/13/2025

1. Visible risk factors include high penetration or rooftop-unit density, tree overhang or roof debris exposure.
2. Large rectangular low-slope commercial roof with a bright, light-colored surface.
3. Surface appears relatively uniform with no clear widespread blistering, tears, or open seams visible from this height.
4. Multiple small penetrations and rooftop appurtenances are visible, which increases flashing and seal risk.
5. Vegetation is close to the roof edge on the right side, increasing debris accumulation and access/maintenance concerns.

The roof appears to be a low-slope commercial membrane-style system with a light, uniform surface and generally serviceable appearance in the 11/13/2025 aerial image. Visible condition is reasonably good overall, but the roof has multiple penetrations/apurtenances and adjacent trees/vegetation that increase maintenance and leak-management risk. No clear widespread ponding or severe staining is apparent from the aerial view. Visible risk factors include high penetration or rooftop-unit density, tree overhang or roof debris exposure.

Continue routine roof inspections and preventive maintenance, with attention to flashing around penetrations, edge details, and any areas near vegetation exposure. Trim back adjacent trees where feasible and monitor for debris accumulation. A closer field inspection is recommended to verify membrane type, evaluate sealant/flashing condition, and confirm there are no localized leaks or hidden deterioration not visible in aerial imagery.
