## 7200 QUEBEC PKWY

COMMERCE CITY CO 80022

OVERALL ROOF CONDITION SCORE

**62** /100  
FAIR

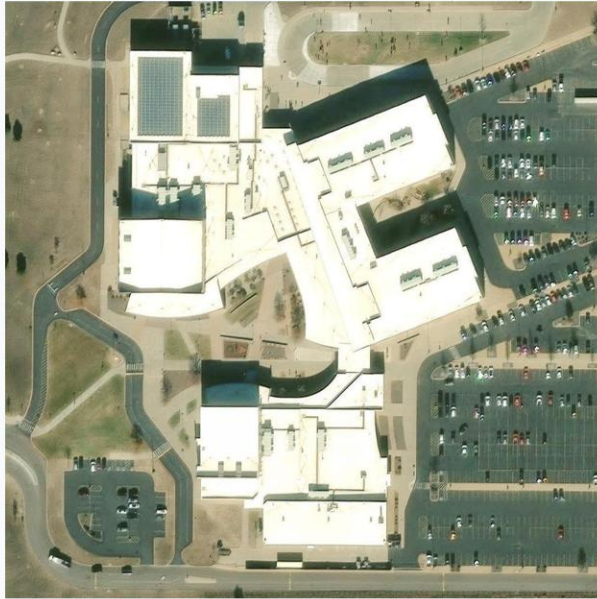
SELECTED AERIAL IMAGE - ESRI WORLD IMAGERY AS OF 11/13/2025

| VISIBLE CONCERNS | dark staining/color variation; possible ponding; many penetrations/units |

1. Visible risk factors include dark staining or inconsistent roof color, possible ponding or drainage stress, high penetration or rooftop-unit density.
2. Large commercial school building with multiple interconnected low-slope roof sections.
3. White roof surfaces appear generally uniform and serviceable overall, with no widespread blistering or obvious catastrophic membrane failure visible from aerial view.
4. Localized darker patches and uneven coloration are present on some roof areas, especially near transitions and along portions of the roof perimeter.
5. Several rooftop mechanical units, vents, and penetrations are visible, increasing maintenance and flashing attention needs.

The aerial image shows a large, low-slope commercial school roof that appears generally maintained and reflective, likely a white single-ply membrane or coated membrane system. Condition is tempered by localized dark staining/discoloration, possible minor ponding or retained moisture at select areas, and a complex roof layout with multiple penetrations and transitions. Overall risk is moderate rather than severe based on visible evidence. Visible risk factors include dark staining or inconsistent roof color, possible ponding or drainage stress, high penetration or rooftop-unit density.

Continue routine roof inspections and maintenance, with emphasis on drainage, perimeter/transitional areas, and flashing around rooftop units and penetrations. Investigate the darker stained sections for signs of recurring moisture, ponding, or repaired areas. Because the report uses 11/13/2025 aerial imagery, a current field inspection is recommended to confirm whether the visible discoloration represents active water intrusion or benign staining.
