## 5585 E 56TH AVE

COMMERCE CITY CO 80022

PROPERTY TYPE  
Commercial Transit Warehouse

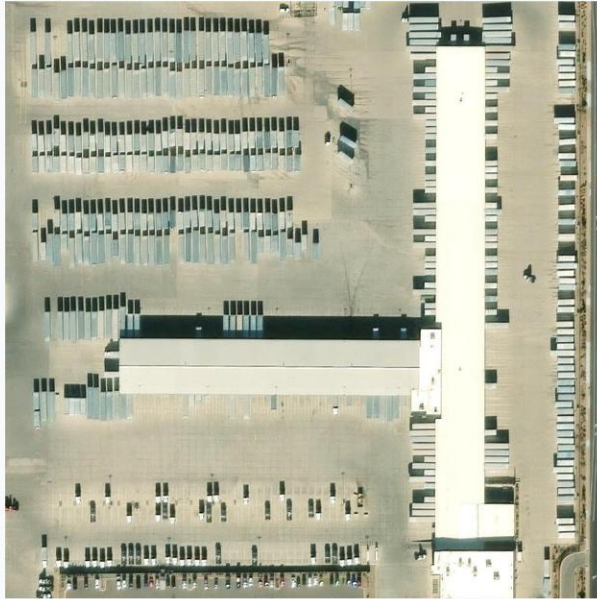
SELECTED AERIAL IMAGE - ESRI WORLD IMAGERY AS OF 11/13/2025

| VISIBLE CONCERNS | dark staining/color variation; many penetrations/units; Widespread tonal variation and darker bands/patches are visible across portions of the roof, which may indicate prior repairs, membrane aging, or localized moisture-related staining. |

1. Visible risk factors include dark staining or inconsistent roof color, high penetration or rooftop-unit density.
2. Large commercial warehouse roof with extensive low-slope coverage and multiple rooftop mechanical units.
3. Roof surface shows broad light-colored field areas with darker lines, patches, and varied panel-like sections, suggesting multiple roof sections and/or repair areas.
4. Perimeter conditions and many rooftop penetrations increase maintenance and leak-management complexity.
5. A long central roof section appears brighter and more uniform than surrounding areas, while adjacent fields show more discoloration and tonal inconsistency.

The aerial imagery shows a large low-slope commercial warehouse roof with a likely single-ply membrane or coated membrane appearance, extensive rooftop equipment, and noticeable roof color variability across multiple sections. The roof appears serviceable overall, but darker patches, mixed surface tones, and numerous penetrations suggest elevated maintenance and leak-monitoring needs. No obvious heavy ponding or debris accumulation is visible in this image. Visible risk factors include dark staining or inconsistent roof color, high penetration or rooftop-unit density.

Continue routine roof inspections and prioritize close-up review of flashing, unit curbs, seals, and areas with darker staining or color variation. Given the number of penetrations and the mixed surface appearance, a field inspection is advisable to verify whether any discoloration reflects benign aging versus localized moisture intrusion or prior repairs.
