## 5200 E 56TH AVE

COMMERCE CITY CO 80022

PROPERTY TYPE  
Commercial Service Garage

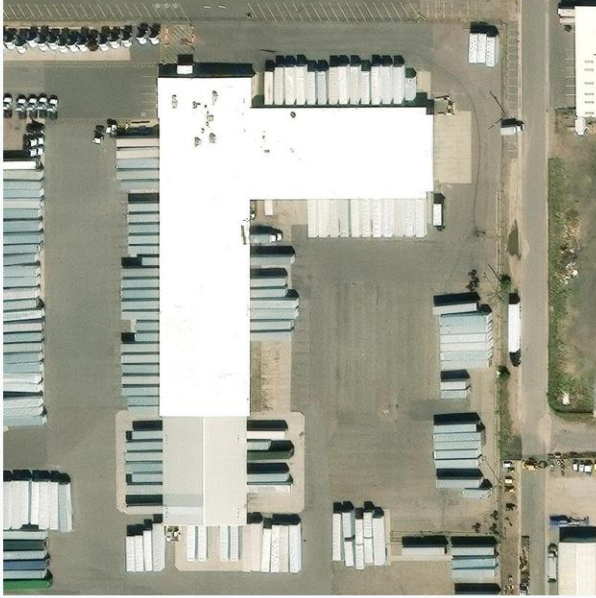
SELECTED AERIAL IMAGE - ESRI WORLD IMAGERY AS OF 11/13/2025

| VISIBLE CONCERNS | many penetrations/units; Several rooftop units, vents, and curbs are present, increasing flashing and seal maintenance demand.; A few small dark rooftop features and localized rooftop equipment shadows are visible, but no clear widespread staining or ponding patterns are apparent. |

1. Visible risk factors include high penetration or rooftop-unit density.
2. Commercial service garage with extensive low-slope roof area and multiple adjoining roof sections.
3. Main roof surfaces appear bright, uniform, and generally clean in the aerial image.
4. Multiple rooftop mechanical units/vents are distributed around roof edges and at roof transitions, creating additional penetration and flashing locations.
5. No obvious membrane tears, severe blistering, or major ponding areas are visible from this overhead view.

The roof appears to be a generally well-maintained low-slope commercial roof with a bright reflective surface and no clear signs of widespread ponding or heavy discoloration in the aerial image dated 11/13/2025. Serviceability risk is driven more by the number of rooftop units, vents, and roof transitions than by visible membrane distress. The imagery supports a likely reflective single-ply or coated roof assembly, but exact membrane chemistry cannot be confirmed from overhead imagery alone. Visible risk factors include high penetration or rooftop-unit density.

Continue routine roof inspections and preventive maintenance, with particular attention to flashing, curbs, and sealant at mechanical penetrations. Monitor roof drains and low areas after storms for any developing ponding or discoloration. Reinspect in close-up if a field visit can confirm membrane type and verify seal conditions around rooftop equipment. Field inspection should verify drainage, moisture, penetrations, flashing, and debris-related damage.
