## 5501 BRIGHTON BLVD

COMMERCE CITY CO 80022

PROPERTY TYPE  
Commercial Mega Warehouse

OVERALL ROOF CONDITION SCORE

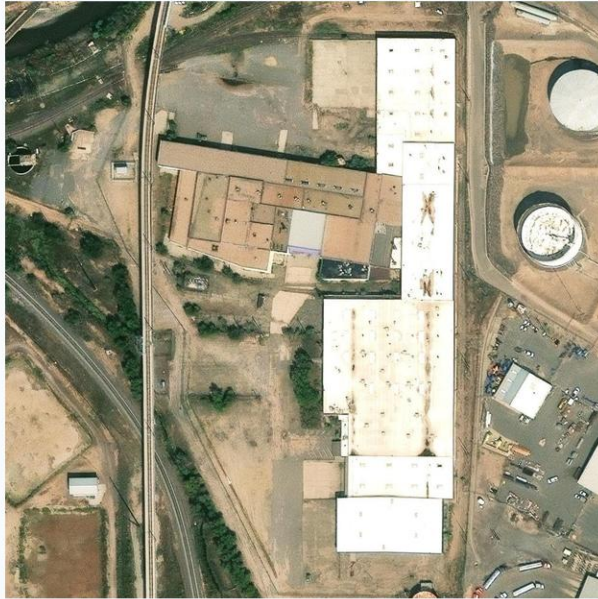
SELECTED AERIAL IMAGE - ESRI WORLD IMAGERY AS OF 09/06/2025

| VISIBLE CONCERNS | dark staining/color variation; possible ponding; many penetrations/units |
| ROOF AGE EST. | appears mid-life to older in service, with some sections showing wear and discoloration |

1. Visible risk factors include dark staining or inconsistent roof color, possible ponding or drainage stress, high penetration or rooftop-unit density.
2. The property is a large commercial warehouse with multiple connected roof sections and a low-slope profile.
3. White roof segments are visible on the main buildings, with scattered dark stains and localized discoloration across several areas.
4. Tan/brown roof sections on the western/northern portions appear older or differently finished than the white sections.
5. Numerous small rooftop penetrations are visible, including vents/curbs, especially across the larger white roof areas.

Aerial imagery dated 09/06/2025 shows a large low-slope commercial warehouse roof with multiple connected sections and a likely single-ply membrane roof system, though exact chemistry cannot be confirmed from overhead imagery alone. The roof appears generally serviceable, but visible dark staining, uneven coloration, and several roof penetrations suggest moderate maintenance and leak-management risk. Some sections appear newer or more reflective than others, indicating possible mixed-age roof areas or prior repair/recoat work. Visible risk factors include dark staining or inconsistent roof color, possible ponding or drainage stress, high penetration or rooftop-unit density.

Perform a close-up rooftop inspection to verify membrane type, check all flashing and penetration seals, and evaluate the stained/darker areas for active leaks, wet insulation, or drainage-related wear. Prioritize review of older-looking roof sections and any areas with concentrated discoloration or patch history. Field inspection should verify drainage, moisture, penetrations, flashing, and debris-related damage.
