## 5455 BRIGHTON BLVD

COMMERCE CITY CO 80022

PROPERTY TYPE  
Commercial Office Building

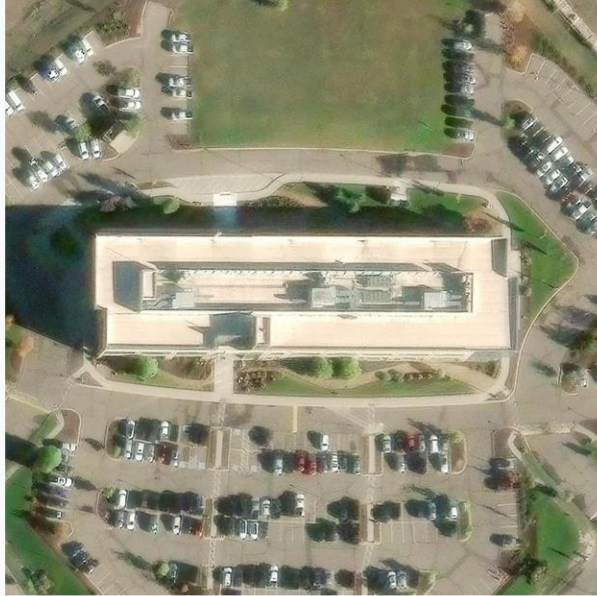
SELECTED AERIAL IMAGE - ESRI WORLD IMAGERY AS OF 09/06/2025

| VISIBLE CONCERNS | many penetrations/units; Central rooftop equipment creates multiple penetrations and flashing locations.; No clear ponding, major staining, or widespread discoloration visible in the roof field. |

1. Visible risk factors include high penetration or rooftop-unit density.
2. Roof appears broadly uniform and reflective with no obvious tears, open seams, or extensive patching visible at this altitude.
3. Several rooftop units/curbs and service areas are concentrated along the central spine of the roof, increasing flashing and seal complexity.
4. The roof surface does not show pronounced dark staining or obvious ponded water signatures in the visible image.
5. Perimeter vegetation is present nearby, but no tree contact or debris accumulation on the roof is clearly visible.

On the 09/06/2025 Esri aerial image, the roof presents as a generally well-kept low-slope commercial roof with a light-colored, uniform surface and no clear evidence of widespread staining or ponding. The main risk driver is the central cluster of rooftop equipment and associated penetrations, which increases flashing and leak potential. Overall visible condition appears good, though membrane type cannot be confirmed from aerial imagery alone. Visible risk factors include high penetration or rooftop-unit density.

Maintain routine roof inspections and preventive maintenance, with particular attention to equipment curbs, seams, and penetrations around the central mechanical area. Continue to monitor for staining, sealant failures, or ponding after storms. A field inspection is recommended to confirm membrane type and verify the condition of flashings and rooftop units.
