## 9800 E IKEA WAY

CENTENNIAL CO 80112

### OVERALL ROOF CONDITION SCORE

**69** /100  
FAIR

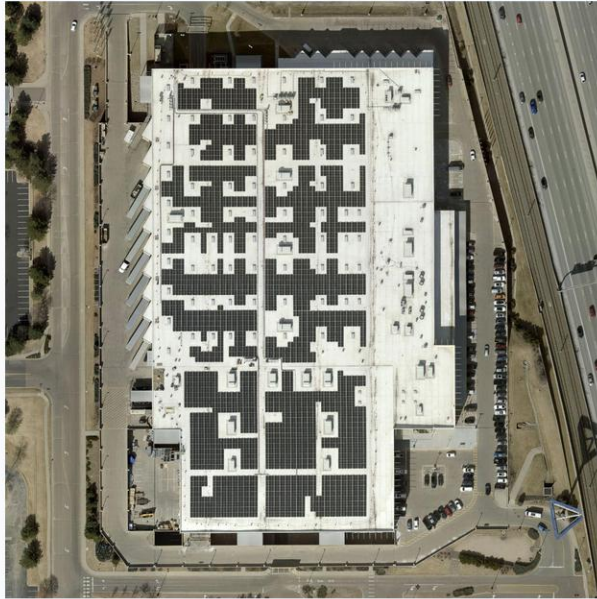
SELECTED AERIAL IMAGE - ARAPAHOE COUNTY AERIALS AS OF 03/01/2024

| VISIBLE CONCERNS | dark staining/color variation; many penetrations/units; Localized dark streaking/discoloration is visible on the white field membrane, especially toward the right side and along some seams/penetration areas. |

1. Visible risk factors include dark staining or inconsistent roof color, high penetration or rooftop-unit density.
2. Extensive solar PV coverage across most of the roof; the exposed membrane remains visible in multiple open areas.
3. White roof surface appears generally intact and uniformly reflective overall, but with scattered dark marks, streaking, and localized discoloration.
4. Multiple rooftop penetrations and mechanical/vent curbs are visible throughout the roof field.
5. No clear standing water or obvious severe membrane failure is visible from this aerial image.

The 03/01/2024 aerial image shows a large low-slope commercial roof with a white reflective membrane and extensive solar panel coverage. Visible evidence suggests generally serviceable roof condition, but localized discoloration/streaking and many penetrations reduce confidence in long-term watertightness from aerial review alone. The roof presents moderate maintenance and flashing risk typical of a heavily penetrated low-slope commercial roof. Visible risk factors include dark staining or inconsistent roof color, high penetration or rooftop-unit density.

Continue routine roof inspections and preventative maintenance, with close attention to seams, flashings, curbs, and penetrations around the solar array and rooftop equipment. Investigate the darker stained areas during a field inspection to determine whether they reflect dirt, prior repairs, or moisture-related issues. Keep drains and rooftop details clear, and verify condition beneath and around solar attachments during the next service visit.
