## 13300 W 2ND PL

LAKEWOOD CO 80228

PROPERTY TYPE  
Public School, Entire Elementary...

### OVERALL ROOF CONDITION SCORE

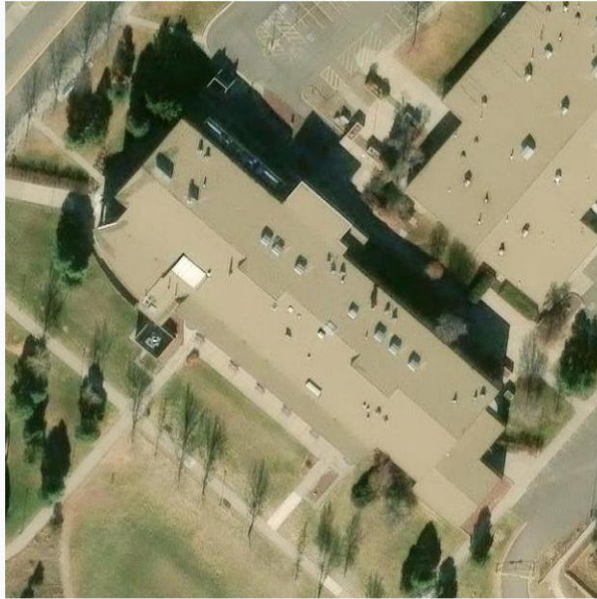
### SELECTED AERIAL IMAGE - ESRI WORLD IMAGERY

| VISIBLE CONCERNS | dark staining/color variation; possible ponding; many penetrations/units; tree/debris exposure |

1. Visible risk factors include dark staining or inconsistent roof color, possible ponding or drainage stress, high penetration or rooftop-unit density, tree overhang or roof debris exposure.
2. Large low-slope roof with multiple connected sections on a school campus.
3. Roof surface is generally light-colored and mostly uniform, but there are scattered darkened patches and tonal variation.
4. Numerous small vents/penetrations are visible across several roof areas.
5. Roof edges are bordered by mature trees and landscaped areas, with some overhanging proximity.

Aerial imagery shows a large low-slope school roof that appears serviceable overall, with a generally uniform light-colored surface. Visible darkened areas, tonal irregularities, and the density of rooftop penetrations suggest moderate maintenance and leak-monitoring needs. Trees near the roof perimeter add debris and abrasion risk. Exact membrane chemistry cannot be confirmed from overhead imagery alone. Visible risk factors include dark staining or inconsistent roof color, possible ponding or drainage stress, high penetration or rooftop-unit density, tree overhang or roof debris exposure.

Perform a close-up roof inspection to verify membrane type, check all penetrations and flashing terminations, and evaluate the darkened areas for recurring ponding, trapped moisture, or prior repairs. Trim back overhanging vegetation where needed and confirm drainage paths remain clear. Consider preventative maintenance and targeted repairs if the darkened areas correspond to chronic wet spots or seam/flashing distress. Field inspection should verify drainage, moisture, penetrations, flashing, and debris-related damage.
